**Remarkable historic timber roofs. Knowledge and conservation practice.
PART 2 - Investigation, analysis, and interventions**

HISTORIC TIMBER ROOFS, A KNOWLEDGE-BASED APPROACH TO STRENGTHENING: THE CASE STUDY OF A RENAISSANCE PALACE IN FERRARA

Lia Ferrari

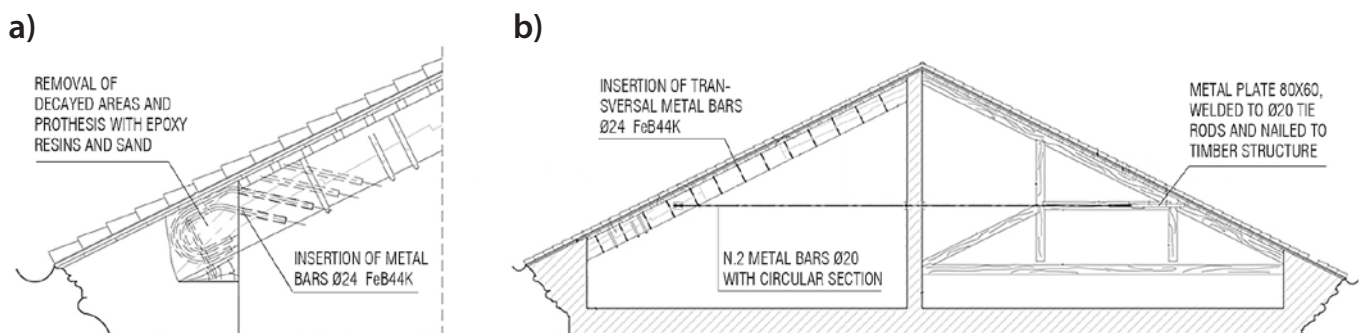
later, in 1994, strengthening interventions concerned the southern gable roof of the building: a steel cross bracing was inserted [21]. In 1999, the timber structure of the southeastern block was subject to other invasive reinforcements. The decayed extremities of the rafters were replaced by epoxy resins prosthesis and strengthened by internal Ø28 metal bars (Fig. 2a), while Ø24 metal bars were inserted along the rafters to improve the connection between the components of *trave composta* and metal tie-rods were used to enhance the connection between rafters and the central wall (Fig. 2b). The queen trusses of the opposite pitch were also reinforced by the insertion of fitch plates at the joints and a double layer of metal tie-rods for the connection with the central wall.

Fig. 2. Strengthening of the E-S timber roof carried out in 1999: (a) replacement of decayed extremities with epoxy resins prosthesis reinforced with metal bars; (b) insertion of metal bars along "trave composta" and connection between rafters and central wall with metal tie-rods. (Image source: SBAP-FE-ADOC – Mezzadringegneria – FE-ADOC, Tav. 42, Pos. 2955).

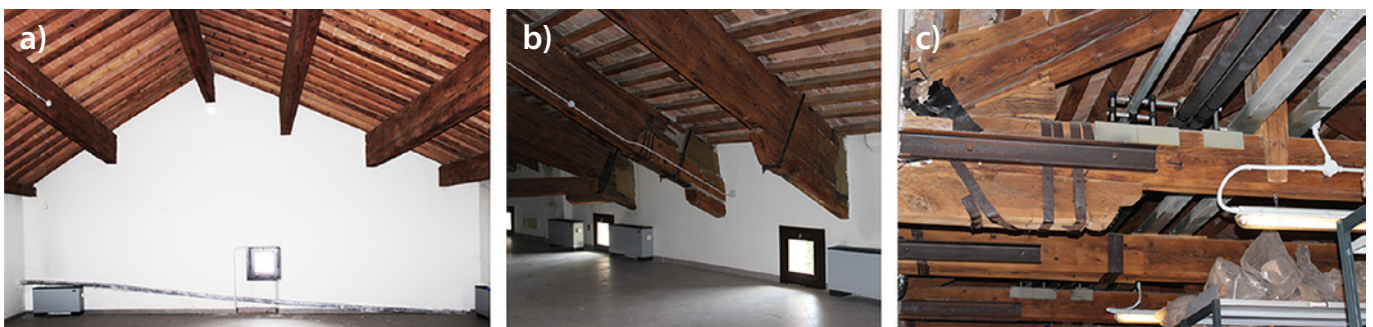
cross-section (17 cm x 50 cm), and the distance (175 cm) of purlins was increased. In this latter case, the technique of *trave composta* is used (Fig. 4a).

strips (Fig. 4b). As previously described, metal elements have been inserted, and double tie-rods connect the rafter with the central wall, probably replacing the previous wooden collars.

Fig. 4. Timber roofs types: (a) large-span timber purlin roof built with the "trave composta" technique; (b) timber rafters roof made with the "trave composta" technique; (c) a small-span king trusses roof with reinforcement.

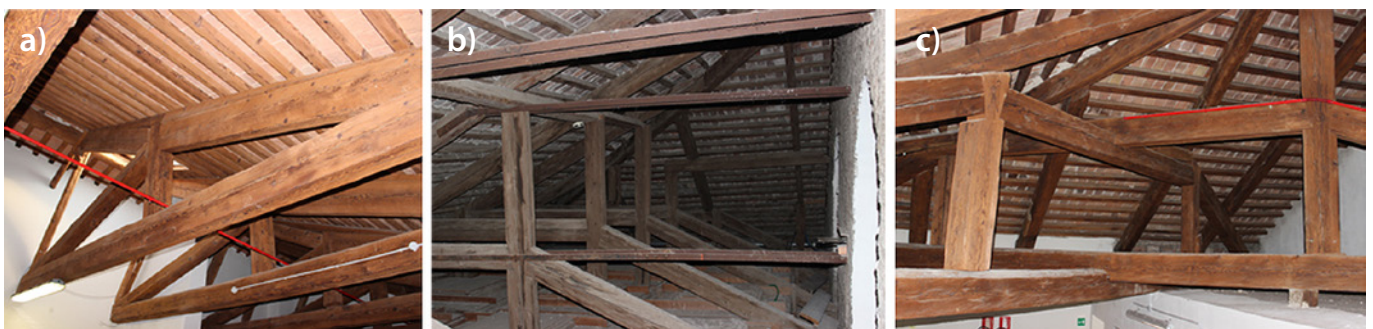
Fig. 5. Timber roofs types: (a) asymmetrical king trusses; (b) asymmetrical queen trusses reinforced with fitch plates at the joints and a double layer of tie rods; (c) intersection between asymmetrical queen trusses.

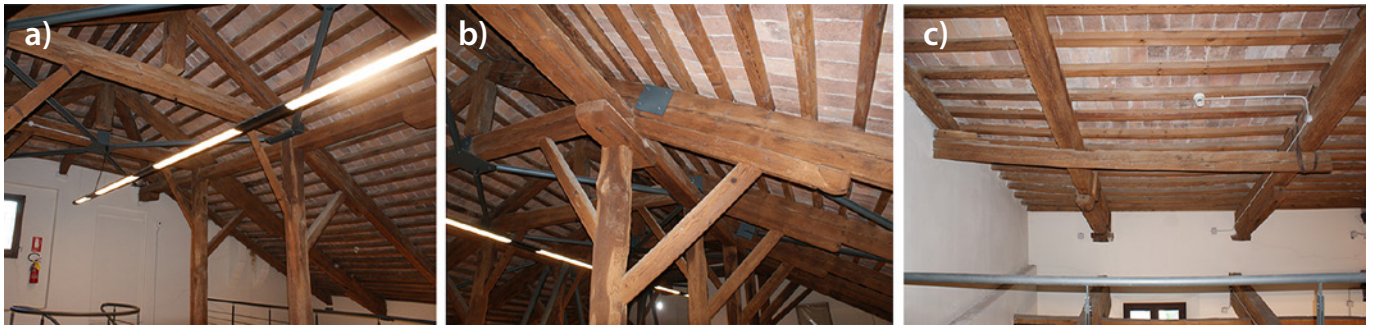
The gabled roof of the southern area of the building consists of long and slender rafters that join the small king trusses towards the ridge area (Fig. 6a). The joint between them is obtained through a groove in the support, which guarantees both compression and traction resistance. Each truss rests on two crown posts by means of collar purlins composed of two beams connected with a particular scarf joint known as *dardo di Giove* (Fig. 6b). The central mezzanine is supported by tie beams that lay on two longitudinal wooden beams resting on pillars. The tie beams are located under the rafters but are not connected to them. The rafters and the tie-beams rely on the external masonry wall, to which they are connected with metal anchorages. Instead, the rafters are nailed to a 2-meter-long wooden corbel protected with a bitumen coating only on the eastern side. Despite the wide span (1,650 cm), the rafters' cross-section is only 15 cm x 30 cm, and the distance between them is about 220 cm. These elements are, therefore, significantly slender compared to the loads they bear (previous interventions added a reinforced concrete slab to the flat tiles layer). Therefore, all the rafters show severe bending and deformation since they were already undersized when the palace was built (Fig. 6c). This timber structure already underwent several strengthening interventions: wooden elements were installed to reinforce existing beams, metal elements (plates, strips, etc.) were inserted to improve the connections both between the beams and among them and the supporting masonry, a cross-bracing system, was added to increase the roof stiffness.

Fig. 6. (a) Timber rafter roof with crown posts; (b) connection between collar purlins highlighted by the presence of a wooden capital; (c) previous reinforcement for excessive deformation.

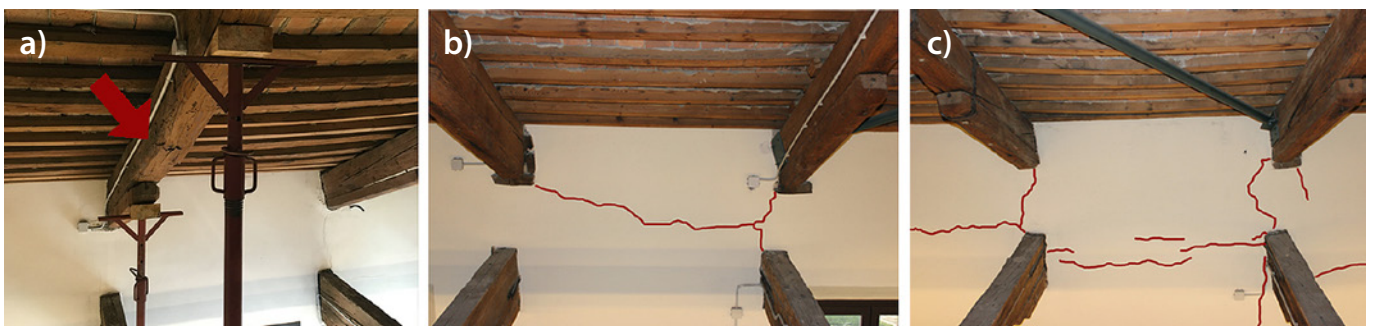
The survey on Palazzo Costabili's timber roof structure was first limited to essential features (geometrical configuration, technology, and general state of conservation) to identify the most critical points. A more detailed analysis was later carried out on the structures that showed significant degradation, more specifically on the timber roof of the southern building, which was the most hit by the 2012 earthquake. The structural seismic response of timber roofs to an earthquake is extremely interesting as it highlights weaknesses that do not appear with ordinary loads [5]. The excessive static deflection of the rafters worsened after the earthquake, and one showed bending cracks due to the vertical component of the seismic action. First aid interventions propped the structural element using metal supports (Fig. 7a). Still, masonry also presented severe crack patterns: vertical cracks in the corners reveal the activation of a tilting mechanism, whereas horizontal cracks in the upper area, all along the longitudinal walls, in correspondence of timber rafters and beams point to a slide of the upper part of the roof (Fig. 7b, c). Previous seismic re-

inforcements from the 1990s featuring reinforced concrete slabs, tie-rods, metal anchorages, and a bracing system, didn't do much against earthquake damage.

Fig. 7. Seismic damages: (a) cracked rafter; (b, c) horizontal masonry cracks on longitudinal walls.

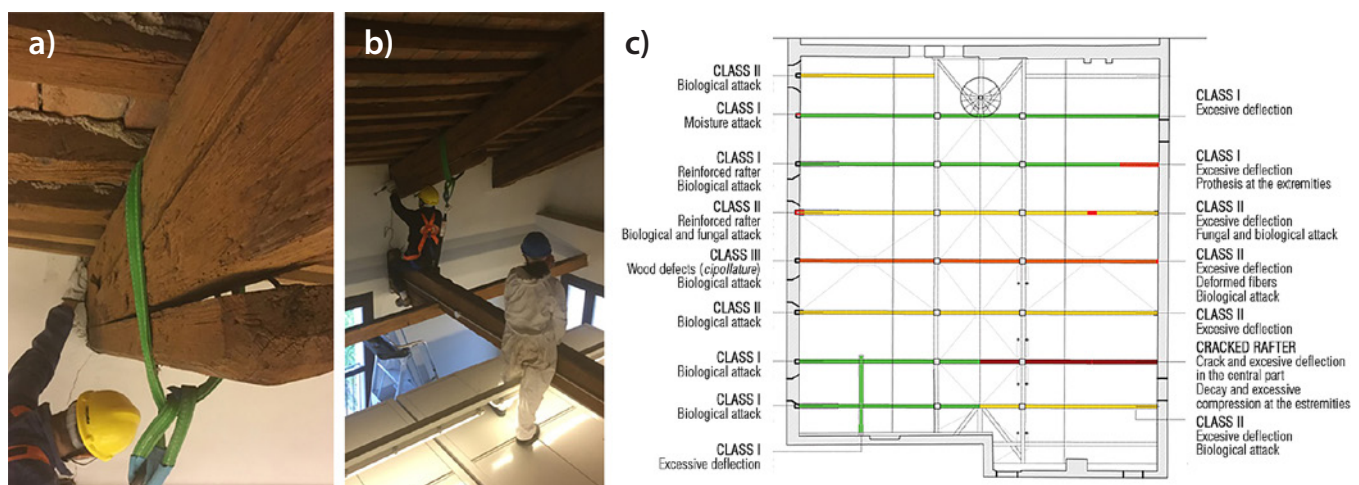
For this reason, further analyses were performed by specialists (Fig. 8a, b), who assessed the materials' consistency and the actual strength with a combination of visual inspection of timber features and defects (visual grading) and instrumental non-destructive measurements of physical-mechanical properties (mechanical grading), according to the UNI 1119:2004 standard [22]. The visual assessment was carried out on all physically accessible parts, whereas the less accessible areas (such as the ends of the beams inserted into supporting walls) were investigated employing alternative inspection methods (e.g., by resistance drilling methods) to define their state of conservation.

Non-destructive tests were performed with a drilling device (*IML Resi B-400 dynamometric drill*®) to define the effective (residual) cross-section. The investigation focused on the weakened parts, such as the extremities of the timber beams, close to masonry supports, which are also at higher risk of decay. The analysis found fibers with helical conformation and *cipollature* (ring shake) in several timber components, which is worrying as it compromises their earthquake and static strength performances. Finally, the mechanical properties were defined according to the classification of timber elements, based on wooden defects and decays, following the UNI 11119:2004 standard (Fig. 8c).

Fig. 8. (a, b) The on-site assessment; (c) the classification of timber components with different colors (green class I, yellow class II, orange class III, red cracked rafter) according to their state of conservation (excessive deflection, biological attack, and wooden defects).
