BRICK MASONRY STAIRCASES OF THE EARLY 20TH CENTURY: HISTORICAL RESEARCH, CONDITION ASSESSMENT AND DIAGNOSTIC INVESTIGATION OF A “TRANSITION” CONSTRUCTION TYPE

Mariella De Fino, Fabio Fatiguso

DOI: 10.30682/tema0802b

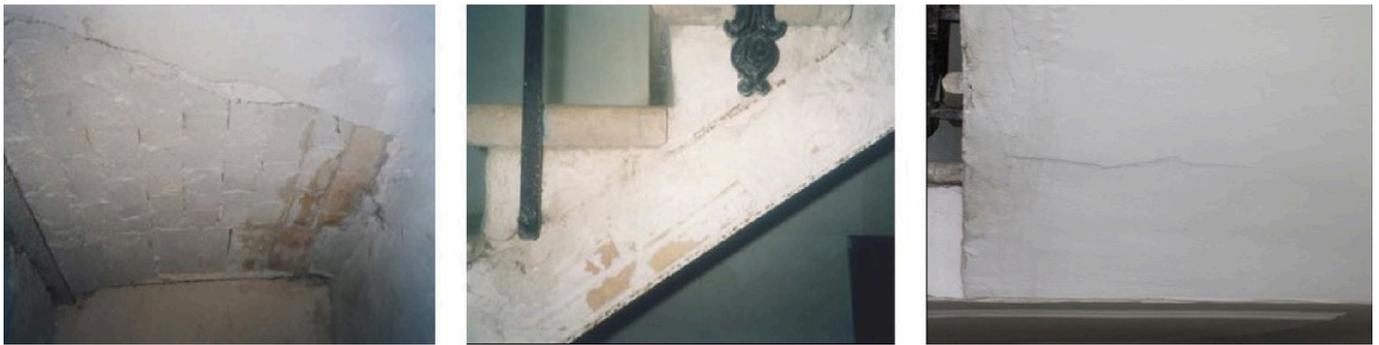
as well as to international guidelines *ICOMOS-ISCS. Illustrated glossary on stone deterioration patterns*. Aside from manufacturing defects, the most recurrent phenomena may concern erosion and disintegration due to the crystallisation of salts, especially at the interface with the mortar, as well as freezing, biological colonisation and efflorescence; the latter is less frequent for indoor components unless exposed to aggressive atmospheric agents due to disuse and abandonment. The aforementioned signs of deterioration also extend to the joints and coatings, with possible pulverisation of the mortar and deformation/detachment of the plaster (Fig. 4 left).

Fig. 4. Examples of decay patterns and pathologies.

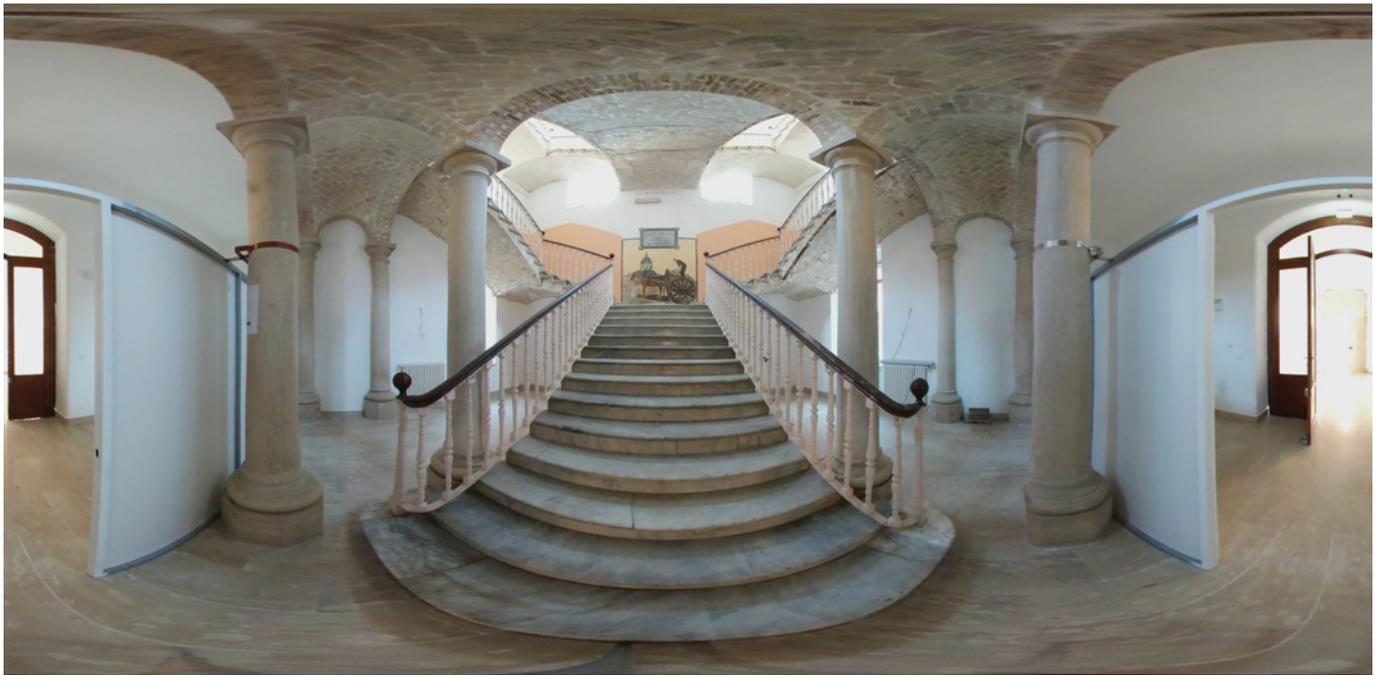
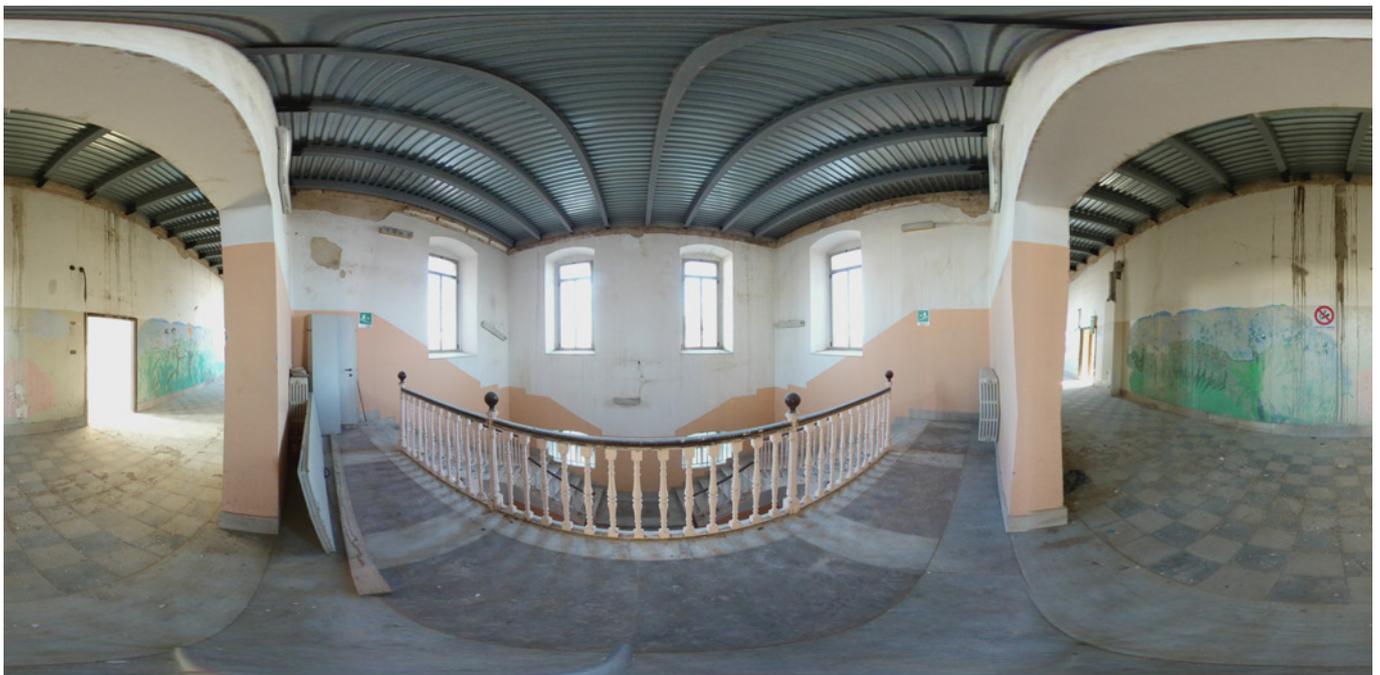
The monumental staircase under study (Fig. 6) develops on two floor levels. It is arranged according to a “pincer” scheme: for each floor, from the central starting flight (span 2.1 m), free on both sides, one arrives at the first intermediate landing, from which two transversal symmetrical flights (span 1.6 m) develop, each one connected,

Fig. 6. Equirectangular 360° panoramas of the ground floor starting flight (left) and second floor landings (right).

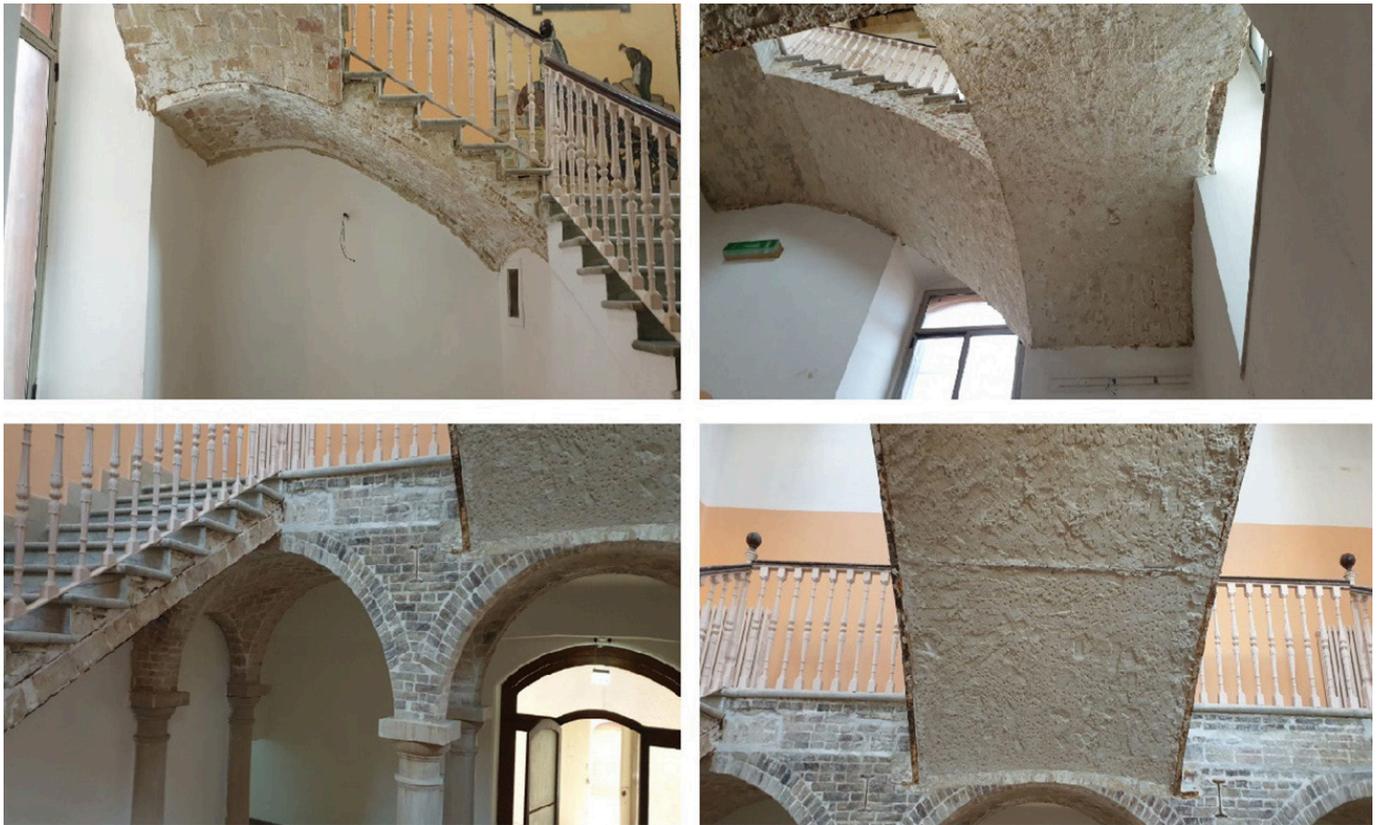
Fig. 7. Construction details: transversal flight from the ground to the first floor (top left); flights ending on the second floor (top right); flights showing metal edge beams (bottom left) and connecting tie rods (bottom right).

acterised by the presence of some visible metal elements, including a longitudinal edge beam on the free ending of one of the two flights leading to the first floor, as well as two beams on both free endings of the central flight starting from the first-floor landing. Moreover, the latter two beams are connected by transverse tie rods, visible on the intrados. The state of conservation was found to be generally good, except for the detachment and deterioration of the thin coating plaster and some infiltration humidity stains on the second floor, which probably developed before the original roof was repaired by a metal one.

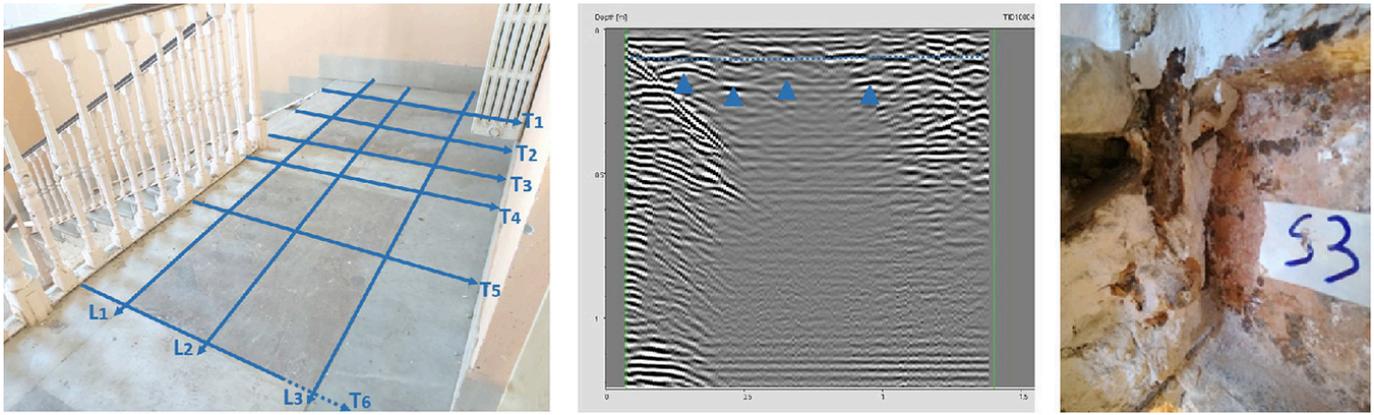
essment of the masonry stratigraphy, and the detection of metal elements of the flights enabled the identification of the inner configuration through the cross-section. Specifically, two continuous reflection planes were generally visible, one at the interface between the steps and underlying filling materials and the other at the interface between the filling materials and underlying masonry support. In no case were there any echo signals due to the presence of metal elements, except in situations already visible from a direct survey. On the other hand, in some cases, areas of high reflection could be found due to possible repairs/replacements of elements carried out after the original construction. In contrast, radar scanning of the landings (Fig. 8 left) revealed the presence of several metallic elements. In fact, as expected, in the recently built slab on the second floor, small and regularly spaced reflection hyperbolas were detected that are typical of the metal bars in reinforced concrete structures and are arranged in both directions of the component. Moreover, similar echoes were identified on the extrados of the vaults that support the first-floor landing. However, in this second case, the distance between the hyperbolas (about 50 cm) and the wider amplitude of the reflected signals led to the hypothesis that the inclusions were due to metal beams running in the longitudinal direction of the landing.

Fig. 8. From the left: radar scanning grid of the first-floor landing; transversal profile T6 showing reflection hyperbola due to iron beams in the longitudinal direction; direct survey showing the connection between two iron beams at the flight/landing interface.

landing (Fig. 8 middle). The outcome of the diagnostic investigation for the identification of construction materials and techniques, integrating the above-mentioned radar scanning tests and direct essays, resulted in thematic 2D and 3D drawings, documenting the layout of each flight and landing (Fig. 9).

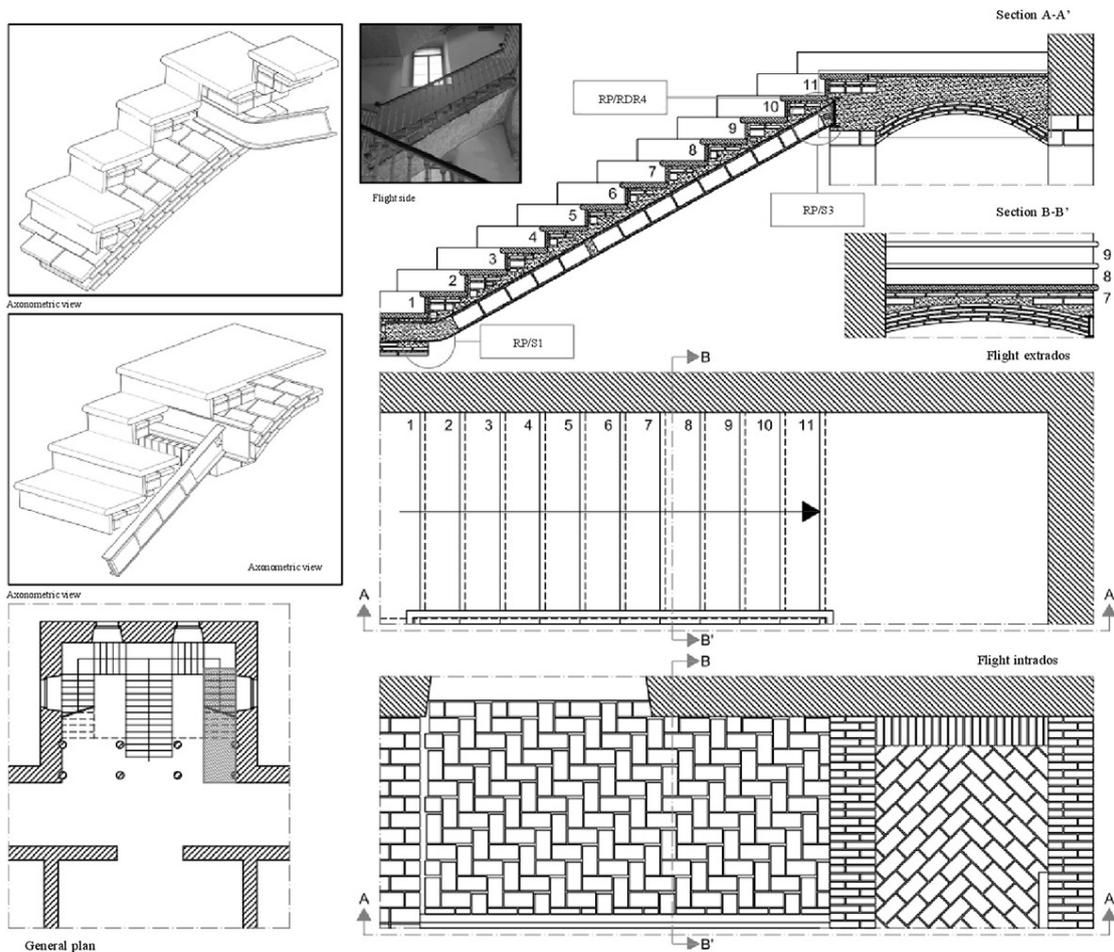
Fig. 9. Example of datasheet with morpho-typological and material-constructional identification of a flight.

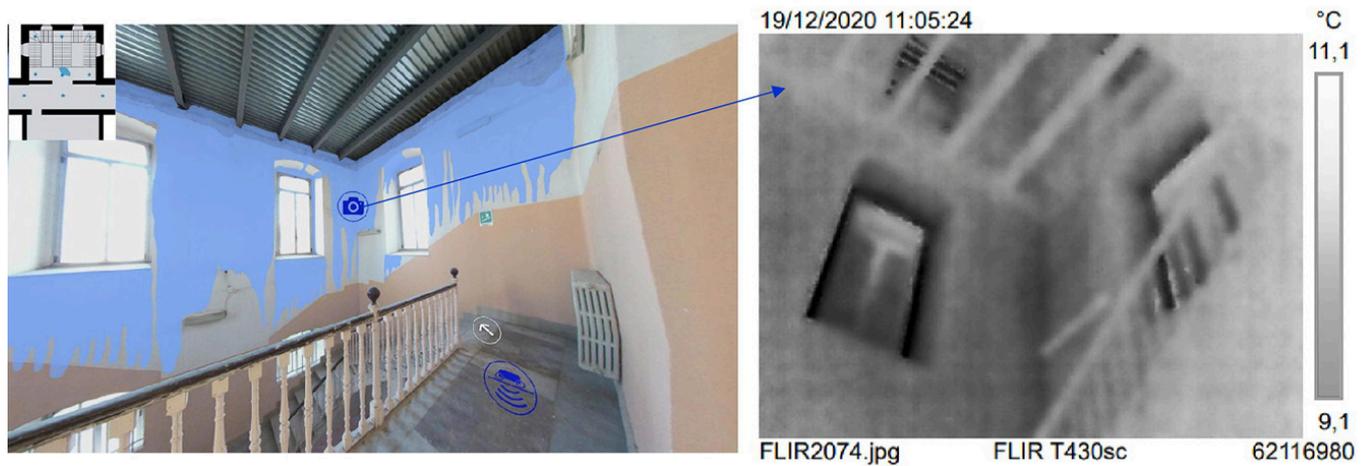
Furthermore, concerning the detection of decay and pathologies, the virtual tour (Fig. 10) displaying the decay textures enabled rapid and comprehensive documentation of current conditions, remote inspection and analysis of the visible surface alterations and localisation of the areas investigated by diagnostic tests through

Fig. 10. From the left: virtual tour displaying the decay maps and localising the diagnostic report; thermographic survey showing no active infiltration phenomena.

hotspots to external links. The thermographic survey of the surfaces showing infiltration humidity stains on the second floor ruled out the occurrence of active phenomena since only localised variations in temperature due to constructional thermal bridges were found.
