Grazia Lombardo

This study is part of a research, aimed at the definition of a new expeditious method, in the pre-seismic phase, for the analysis and assessment of the seismic vulnerability of the historical urban centers. The typological-probabilistic approach adopted for a sample of buildings leads to qualitative assessments of vulnerability through the preparation of thematic maps and the adoption of Damage Probability Matrixes (from now on DPM). The paper reports the results obtained for the historical center of Ortigia.

### 3. THE HISTORICAL CENTER OF ORTIGIA

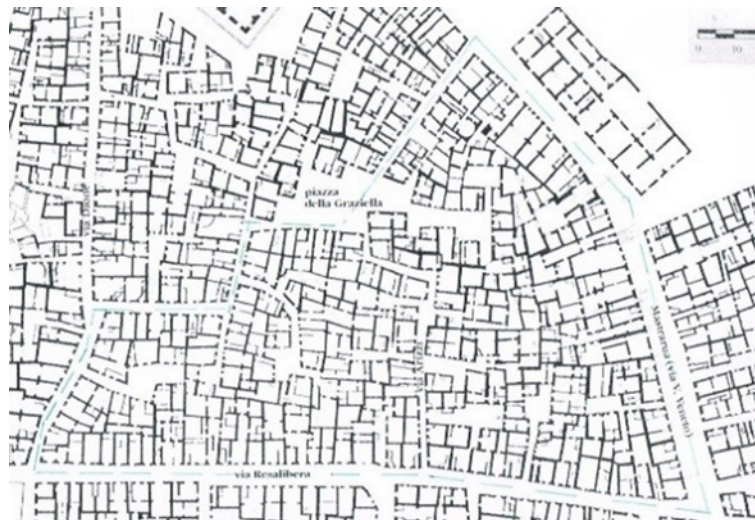
Fig. 2. The historical center of Ortigia, La Graziella district. (Giuffrè A. 2003).

In the district La Graziella, one of the oldest in Ortigia, already included in previous studies coordinated by Prof. Antonino Giuffrè [18], we note that its triangular layout is defined by three most notable streets: via Dione, via Resalibera, and via Vittorio Veneto, of medieval origin (Fig. 2). Inside there are more ancient road structures that are widely distributed through the “ronchi”, which are cul de sac routes that sometimes reach private or semi-public courtyards. At the beginning of the 19th century, the inhabitants of La Graziella district were poor people, such as fishermen and carters. The district consisted mainly of buildings with only one above-ground floor, such as terranean houses, stables, and warehouses. Only along the main roads, it was possible to find larger buildings.

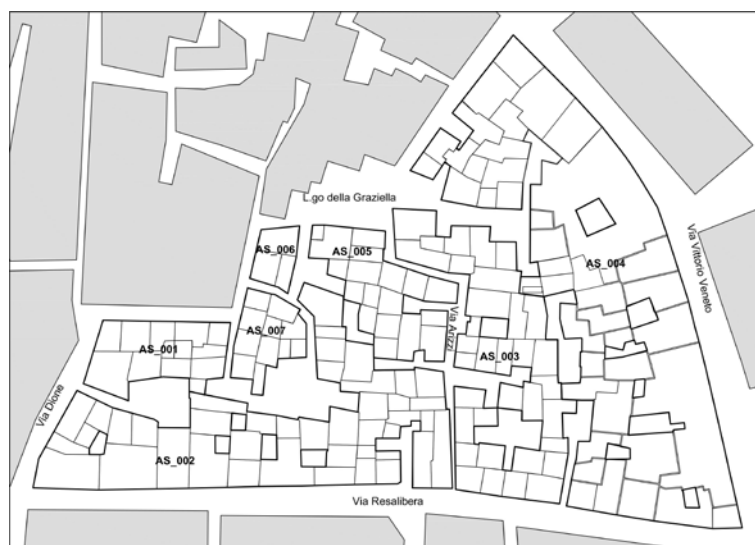
Fig. 3. The historical center of Ortigia, La Graziella district, the structural aggregates.

Seven structural aggregates and a total of 160 structural units were identified, including 8 buildings in ruins. Therefore, 7 AS sheets and 152 US sheets were filled in, of which 124 buildings in load-bearing masonry, 2 in reinforced concrete, and 24 US not totally surveyed [7, 19].
