Basalt fibre continuous stitchings for strengthening the dry stone masonry of the Lossetti Tower in Beura-Cardezza (Italy)

Vol. 3, No. 1 (2017)

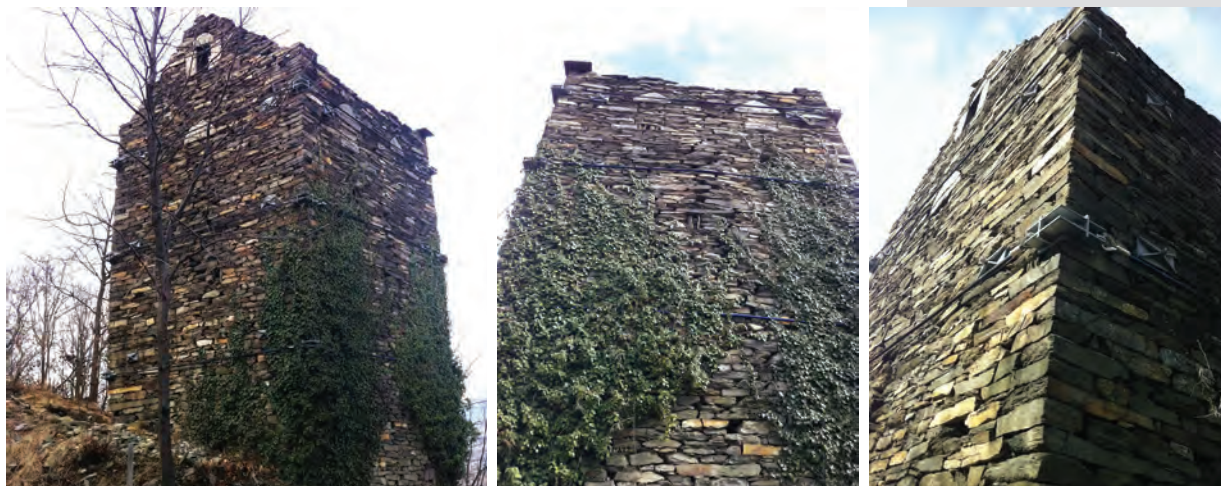
Figure 1a (left). The Lossetti Tower. Figure 1b (centre). One of the DSM walls of the tower: are clearly visible serious cracks. Figure 1c (right). Safety devices applied to the tower: steel ties and steel cables.

The Lossetti Tower (Figure 1a), built in the Middle Ages age as military watchtower, is located in municipality of Beura-Cardezza in the Ossola Valley (Piemonte Region) where can be seen a lot of rural architectures built with DSM technique. The name of “Lossetti” derives from the one of a small noble family existing in that age. It was part of the medieval fortification system used to control one of the busiest streets of the Middle Ages: the trade route from Switzerland to Milan [1]. Originally, it consisted of four floors of which the intermediate were used as house for the resident small garrison - the fireplace and latrine have been preserved and are visible nowadays - and the remainder were intended for defensive purposes and customs. It is a building out of the ordinary, as it is entirely built in DSM, is formed in the plant by a quadrilateral of about seven meters on each side (thickness of the walls at the base is about 105 cm) and grows up to fourteen meters in height, a considerable height for a DSM building. The stone locally available is the “beola”, a type of gneiss stone easy to be divided in blocks or plates in order to be used for both wall (blocks) and roof (plates). The area is typical for quarries of this particular kind of gneiss stone, so the constructions are related to the historical use of local materials. The best way of practice for restoration of this kind of building is currently object of studies and, from the recognition over time of the need to rediscover and revitalize historic buildings and their historic fabric, several research projects were created, based on use of traditional local techniques and materials. One of main themes of these is the development of compatible technical solutions for the seismic retrofit, without compromising the architectural value [2, 3]. All windows and doors appear coeval, with the exception of the current access to the tower. Over time, the tower has undergone alterations that suggest a change of use and conversion to a warehouse and storage of items. The period of total neglect that followed, and problems of instability caused by the partial collapse of the underlying rock, explains its current condition, with natural degradation characterized by

visible bulges and cracks (Figure 1b). For all the above reasons, steel ties and steel cables as confining rings have been recently inserted (Figure 1c).

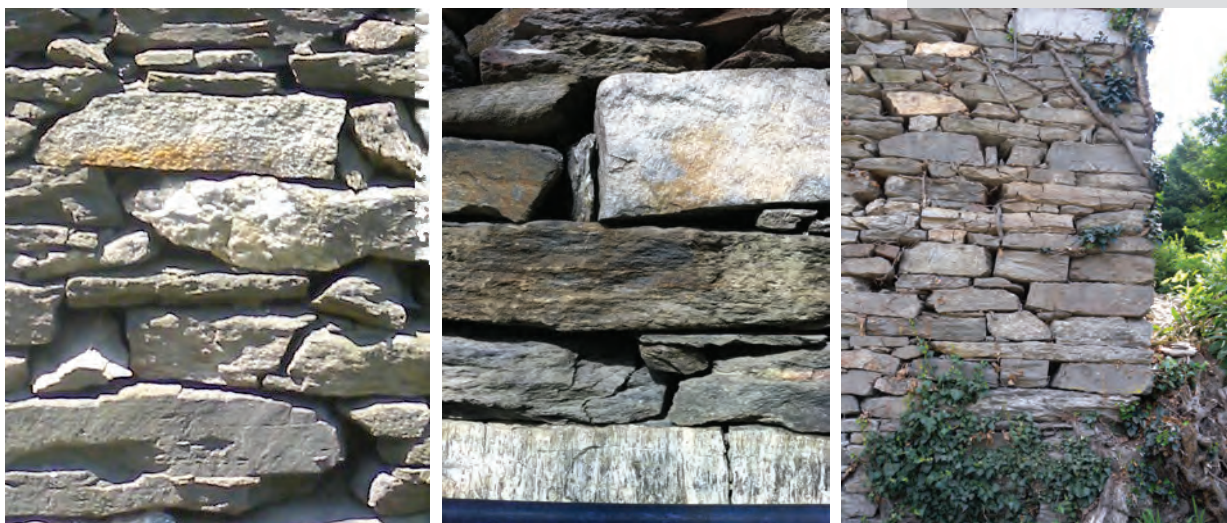
Figure 4a (left). Typical DSM texture. Figure 4b (centre). Flakes and small pieces of stone placed for filling the gaps left by the irregular shapes of the surrounding blocks. Figure 4c (right). Reinforced angles.

The technological study of the DSM of the Lossetti Tower has been very important to understand as the construction mode of this kind of masonry could represent a vulnerability for the building. From a first, external analysis, masonry appear made by selected interlocking medium–large stone slabs, not squared but broken, with a regular texture, arranged in almost horizontal courses and staggered joints (Figure 4a). Small pieces of stone are added in some places for filling the gaps left by the irregular shapes of the surrounding blocks (Figure 4b).

against each other. The voids between the facing stones are carefully packed with smaller stones (flakes and waste) to make the inside space of building guarded by wind, insects, etc. Greater staggered ashlar stones are used at the corners and better dressed (Figure 4c), probably to provide structural stability [3].

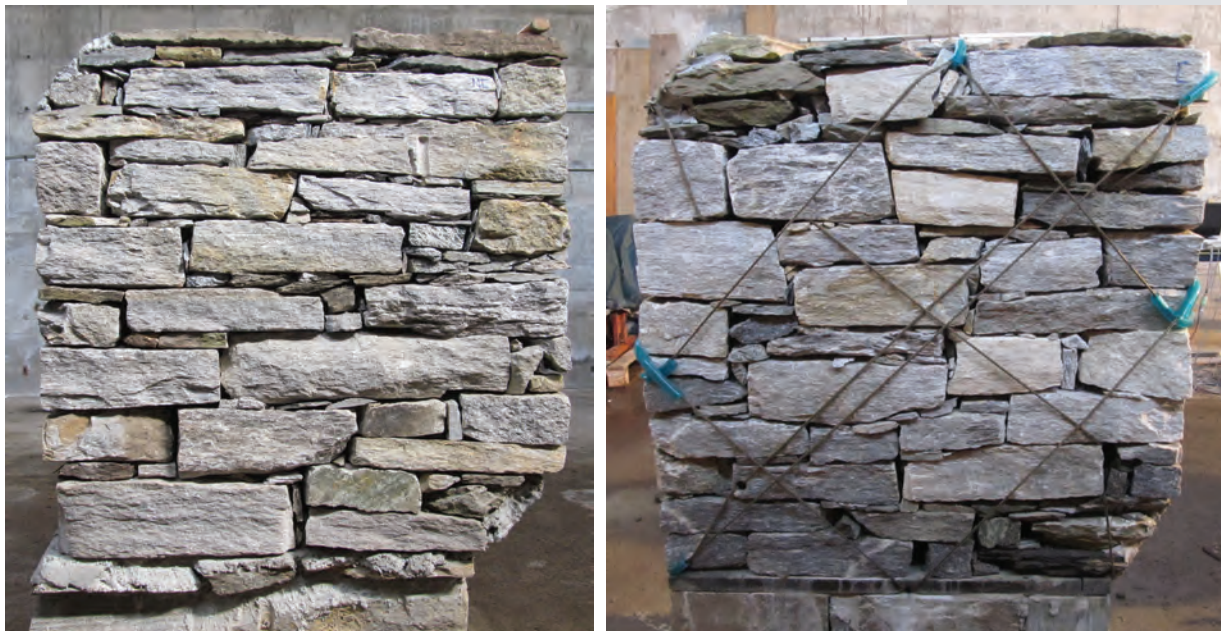
Figure 5. DSM specimens reproduced in laboratory to be tested under diagonal compression load with (right) and without (left) the BF strengthening stitching.

As regards mechanical characterization, two DSM square specimens (dimension: 110 x 100 x 70 cm) were reproduced in laboratory, the BF strengthening stitching was applied on one of these (“C” specimen), while

the other was tested in unreinforced conditions (“NC” specimen), as can be seen in Figure 5. The strengthening stitching technique was performed by choosing a drilling holes disposal (and so the resulting mesh) able to hold as many stones as possible.

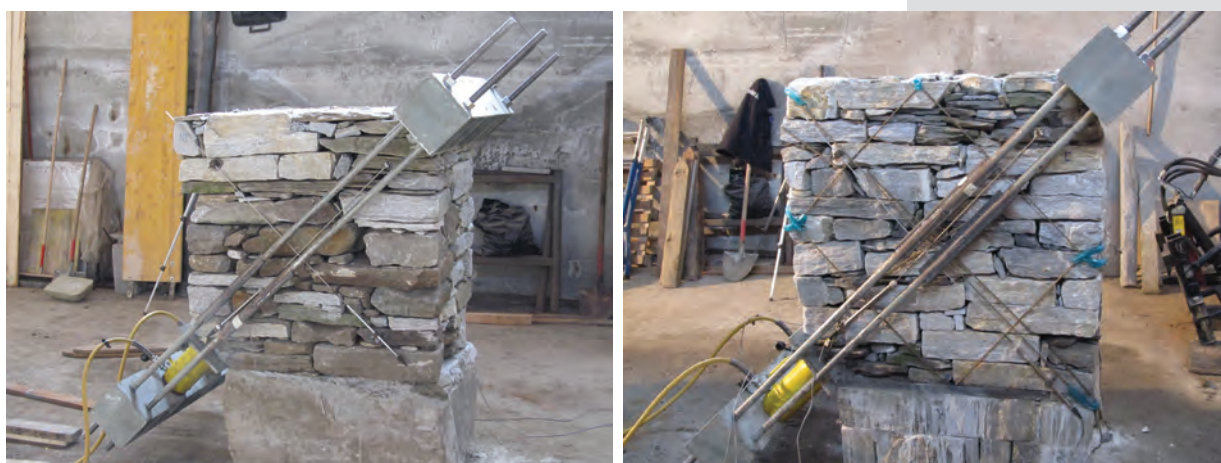
Figure 6. Test set-up for diagonal compression test conducted on DSM specimens.

The specimens were tested under diagonal compression load adapting the diagonal compression test to the in situ conditions (Figure 6), following similar experiences [19, 20]. The specimens were subjected to a compressive force applied on one of its diagonals. The test setup is performed with some steel elements placed on two edges of the panel and two steel bars set diagonally on the two sides of the panel. All the tests were carried out using a hydraulic, manually activated jack.

During the test the values of the applied load and the diagonal displacements, measured respectively by pressure transducer and Linear Variable Displacement Transducers (LVDT) placed on each side, were recorded. In Figure 7 is reported the diagram that put in relation shear stress (τ) and shear strain (γ), calculated following prescription of [21]. Both specimens seems to have a first “rigid” behaviour, where the specimens tends to settle and react by friction and through the ashlar interlocking, (no cohesion is present since there is no mortar). It is worth to note that this settlement load is practically the same for each specimen. From here, each masonry panel starts to differentiate its response: the “NC” specimen has substantially a perfect plastic behaviour (its ashlars slip along horizontal joints once prevailed over friction and interlocking), while the consolidated one (“C” specimen), instead, start to be stiffened by the BF stitching and a linear behaviour can be observed up to the end of the test, occurred when the BF ropes laying along the tensile stressed diagonal collapsed.

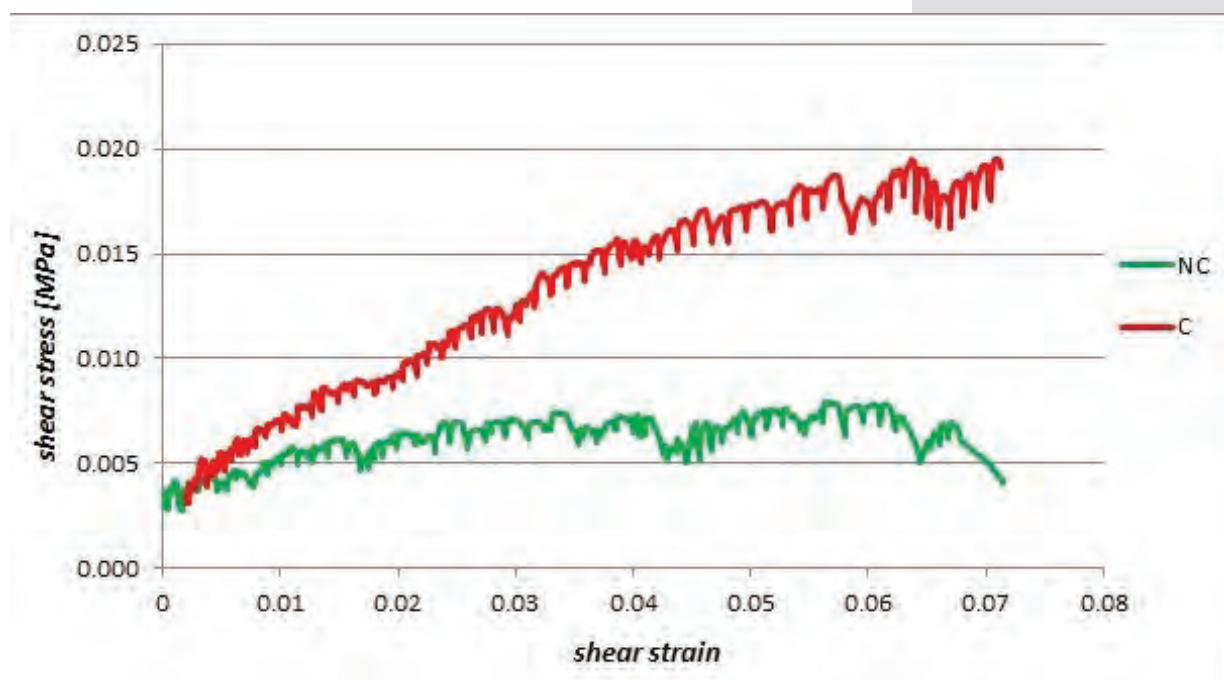
Figure 7. Shear stress–angular strain diagram of the DSM specimens subjected to diagonal compression test.

In Figura 7 è riportato il diagramma che collega lo sforzo tangenziale (τ) e la deformazione tangenziale (γ), calcolato applicando la formulazione proposta in [21]. Entrambi i campioni sembrano avere un comportamento iniziale totalmente “rigido”, dove

tendono ad assestarsi e a reagire per attrito e attraverso le interconnessioni (non si parla di coesione dal momento che non c'è malta). Va notato che questo carico di assestamento è praticamente lo stesso per entrambi i campioni.

Successivamente, i due pannelli differenziano la risposta: il non consolidato ha sostanzialmente un comportamento perfettamente plastico (i conci scorrono lungo i giunti orizzontali una volta vinta la resistenza dell'attrito e dell'ingranamento), mentre il campione consolidato

risente della presenza delle cuciture, e mostra un comportamento lineare ma più rigido, con andamento crescente fino alla fine della prova, che avviene per la rottura della corda disposta lungo la diagonale soggetta a sforzo di trazione.

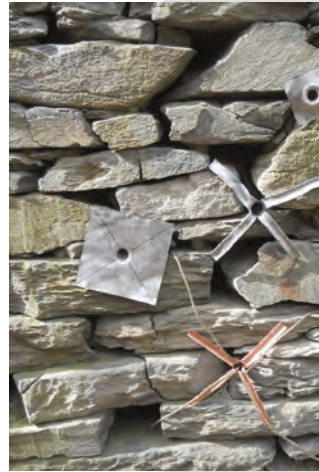
Figure 9. Study drawings and in situ tests for the definition of the final shape of the metallic devices used to avoid the problem of sharp edges.

Finally, to avoid the problem of sharp edges, which is critical for the fibres, flexible metallic elements were designed and used to protect the basalt ropes from the stones surface and its edges. To be effective, these “funnels” must be of the correct length to ensure good penetration within the masonry (Figure 9).

Infine, per scongiurare problemi di troncamento delle corde per effetto dei bordi taglienti delle pietre dove queste vanno sistemate, sono stati progettati appositi dispositivi di protezione metallici da inserire nei punti dove la cucitura attraversa lo spessore del muro.

Per essere efficaci, questi dispositivi devono avere dimensioni adeguate alla forma ed alla posizione delle pietre dove devono essere collocati. Solo grazie all’elevato livello di dettaglio ottenuto durante le fasi di rilievo è stato possibile ricavare tutti i dati (come lo scostamento relativo del filo esterno di ogni pietra) per ottimizzare la realizzazione dei “paraspigoli” riducendo i costi non necessari e garantendone l’efficacia (Figura 9).
