# Textile mills in Friuli (XIX-XX century). Building technique analysis and seismic refurbishment

Giorgio Croatto, Angelo Bertolazzi\*, Umberto Turrini

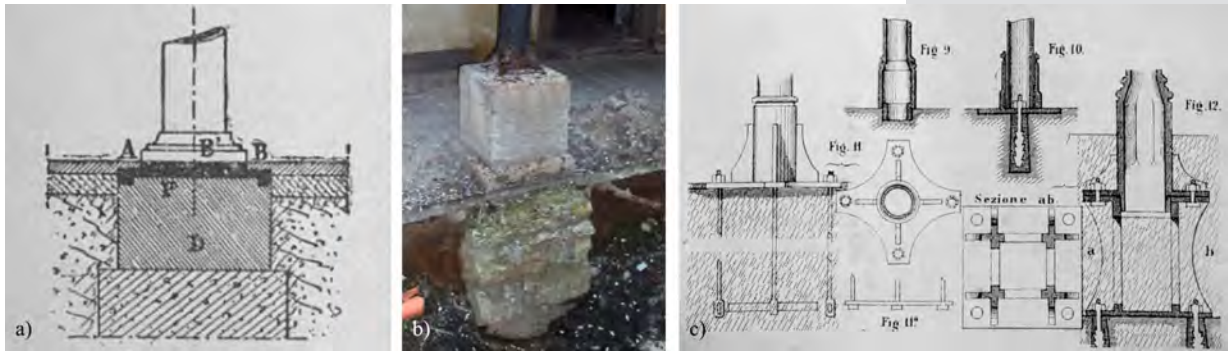
Figure 5. a) The base of the column resting on a weight-spreading metal plate (B) on top of a squared stone block (D) lying on a mortar-concrete substrate [Oslet 1898]; picture taken during a probe; various kinds of ground fastening [Oslet 1898].

A first analysis, mainly based on the handbooks of those times [21], reveals the widespread resort to both simply hinged brackets on the ground gravity working that is to say capable of ensuring that the foot of the foundation would be kept in place only if subjected to axial stress, and to semi-fitted joints, - the forerunners of modern fastening elements such as cast iron stud bolts able to withstand – though partially – seismic compound stresses.
