# New materials and technologies in in architectural heritage restoration: masonry columns confinement using basalt fibres ropes

Francesco Monni\*, Enrico Quagliarini, Federica Greco,  
Stefano Lenci

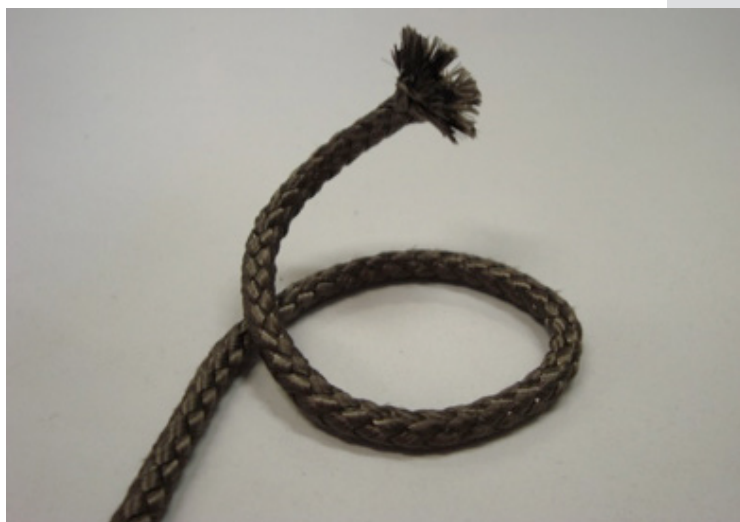
Figure 1. The basalt fibre rope.

In construction field, basalt is proposed in form of short fibres for insulating material, for reinforced concrete (chopped fibres) or like reinforcing material in rehabilitation of concrete [20] and masonry structures [21]. The basalt fibres can be processed with classic textile transformation to obtain also ropes (Figure 1), unlike other kinds of reinforcing fibres.

A mechanical characterization of this product was proposed in [22] and, following the reported suggestions, a series of three tensile tests was carried out on basalt fibres ropes specimens. According to [22], the results of these test is a nonlinear, almost parabolic, correlation between force and displacement with an increase of the stiffness approaching the breaking point. This work aims to evaluate the effectiveness of a strengthening technique based on the use of basalt fibres rope for masonry columns confinement. Two different matrixes were applied. One of the two matrixes used for the reinforcement is a commercial ready-to-use fine granulometry mortar made from hydraulic binders, used for structural consolidations. The second matrix applied is a two-component solvent-free epoxy adhesive mortar. Obviously, the epoxy adhesive mortar shows best bonding performances if compared to the hydraulic mortar, but this one presents a high compatibility with ancient masonry, making this matrix perfectly suitable for this kind of interventions.

“sciolte” (chopped) di basalto, costituiscono un ottimo rinforzo per evitare la fessurazione nei getti di conglomerato cementizio. Sotto forma di lana, possono costituire pannelli e tappetini con ottime caratteristiche di isolamento termo-acustico. Il basalto è un materiale durevole: risultati di test di laboratorio riportati in letteratura [18,19, 20] mostrano come l'esposizione ad ambienti aggressivi (acidi e basici), danneggia maggiormente le fibre di vetro che non quelle di basalto. L'esposizione alle alte temperature non penalizza le prestazioni in termini di resistenza delle fibre di basalto quanto quelle di vetro e di carbonio [21]. Per produrre la fibra di basalto è necessario portare la roccia alla temperatura di fusione (circa 1400 °C), il fuso è quindi estruso per produrre filamenti continui. Le fibre così ottenute, possono essere sottoposte a lavorazioni di “tessitura” che consentono di realizzare anche corde (Figura 1), per le quali esiste
