# A NOVEL SEISMIC VULNERABILITY ASSESSMENT OF MASONRY FAÇADES: FRAMING AND VALIDATION ON CALDAROLA CASE STUDY AFTER 2016 CENTRAL ITALY EARTHQUAKE

Letizia Bernabei, Generoso Vaiano, Federica Rosso, Giovanni Mochi

DOI: 10.30682/tema0702d

e-ISSN 2421-4574  
Vol. 7, No. 2 - (2021)

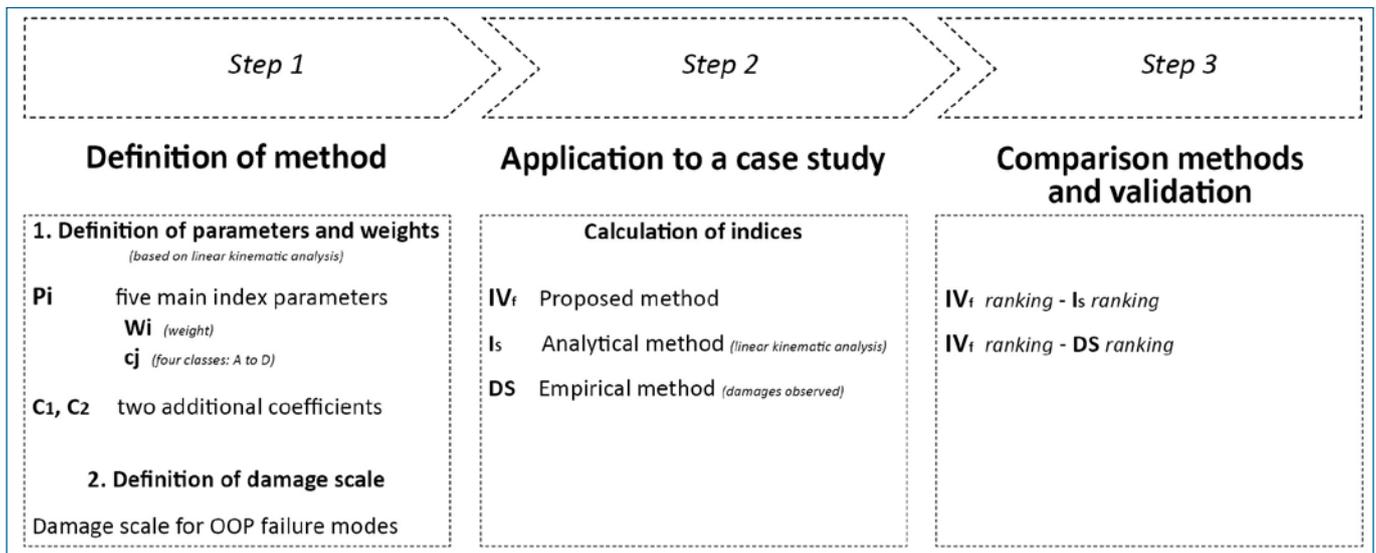
Fig. 1. Diagram flow of the novel expeditious vulnerability assessment method of masonry façades.

The methodological framework that is adopted in this study is illustrated in detail in the following subsection and is depicted in Figure 1, which describes the stages

of the definition of the novel expeditious vulnerability assessment method proposed in this study.

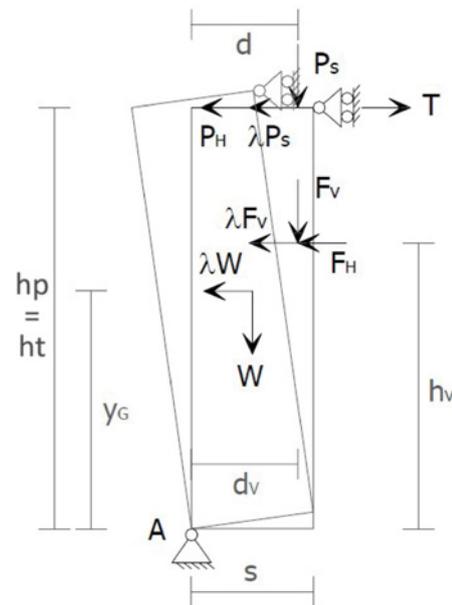
Fig. 2. Graphical representation of the forces in Equation 1.

The acronyms are as follows (Fig. 2) [23]:

- $W_i [F]$ , weight of the  $i^{th}$  macro-element;
- $s_i [L]$ , wall thickness;
- $F_{vi} [F]$ , thrust vertical component of arches or vaults in correspondence of the  $i^{th}$  floor;
- $d_{vi} [L]$ , horizontal distance of arches or vaults thrust at the  $i^{th}$  floor.
- $P_{Si} [F]$ , floor weight of the  $i^{th}$  level;

- $d_i [L]$ , horizontal distance of generic vertical load transmitted on the macro-element;
- $T_i [F]$ , action of metallic tie rods at the  $i^{th}$  floor;
- $h_{ii} [L]$ , vertical distance from the application point of the action transmitted by the floor and/or the metallic tie rod of  $i^{th}$  floor to the hinge of the  $i^{th}$  macro-element;
- $F_{Hi} [F]$ , thrust horizontal component of arches or vaults in correspondence of the  $i^{th}$  floor;
- $h_{vi} [L]$ , vertical distance of arches or vaults thrust at the  $i^{th}$  floor;
- $P_{Hi} [F]$ , static thrust transmitted by the top floor;
- $h_{pi} [L]$ , vertical distance from the action application point transmitted by the floor of the  $i^{th}$  level to the base hinge;
- $y_{Gi} [L]$ , vertical distance between the centroid of the  $i^{th}$  wall and the wall base.

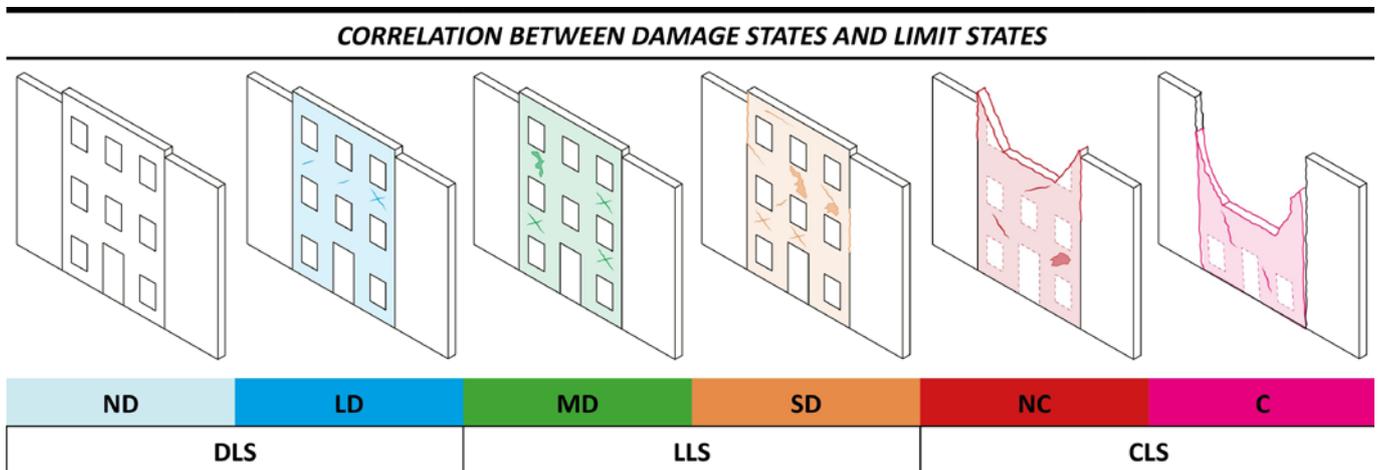
Fig. 3. Damage scale for OOP failure modes and correlation with the limit state of Italian building code [20].

Therefore, six Damage States (DS) have been identified, and the description of the related typical crack pattern is addressed as follow (Fig. 3):

- Severe Damage (SD): several vertical cracks on both the sides of macro-elements, related to OOP failure modes.
- Medium Damage (MD): few vertical cracks related to OOP mechanisms; detachment and loss of plaster or decorative elements.
- Light Damage (LD): no cracks due to OOP mechanisms.
- No Damage (ND): absence of any cracks.

The proposed damage classification is also set according to the limit states adopted by the Italian Building Code [20], which provides performance targets for building design and are directly related to the extent of damages. In the case of Damage Limit State (DLS), buildings can be affected by negligible to slight damages that do not affect the structural resistance, and in this case, we refer to ND and LD. In the case of Life Safety Limit State (LLS) instead, structural elements have light to moderate cracks, and small parts of plaster or stones fall (corresponding to MD and SD). In the case of Collapse Limit State (CLS), serious damages to load-bearing walls lead to partial or total collapse, as in NC and C.

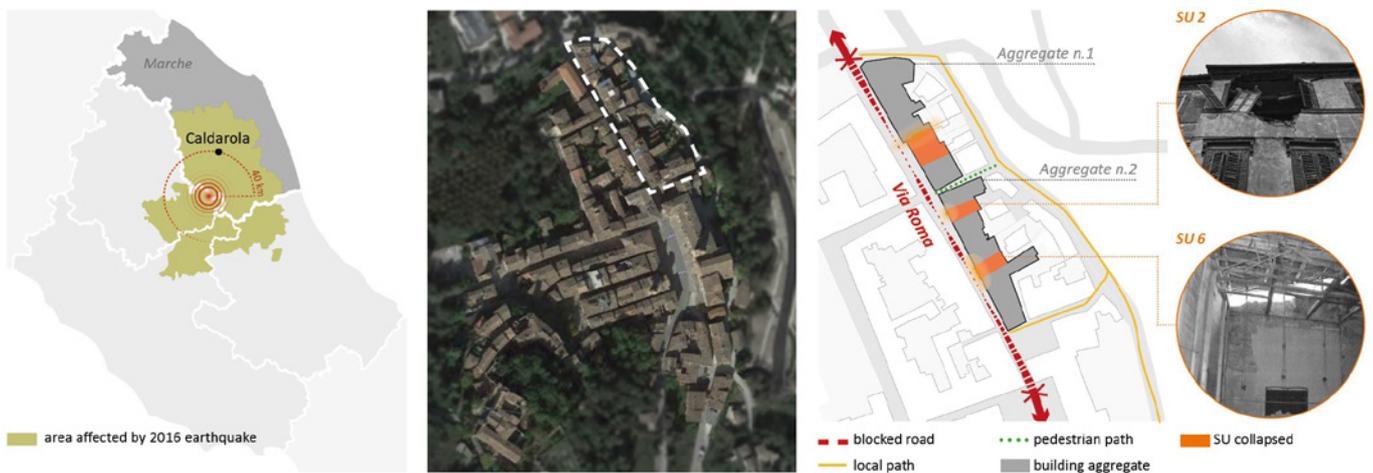
Fig. 4. The city of Caldarola (Central Italy). The access road, Via Roma, to the historical centre blocked from the debris of overturning façade: SU2 and SU6 (view from inside).

The most critical condition occurred at the urban block located at the entrance of the historical centre. The only access road, “Via Roma”, was blocked by debris due to the overturning façade of three SUs belonging to aggregate n. 1 and aggregate n. 2 (Fig. 4).

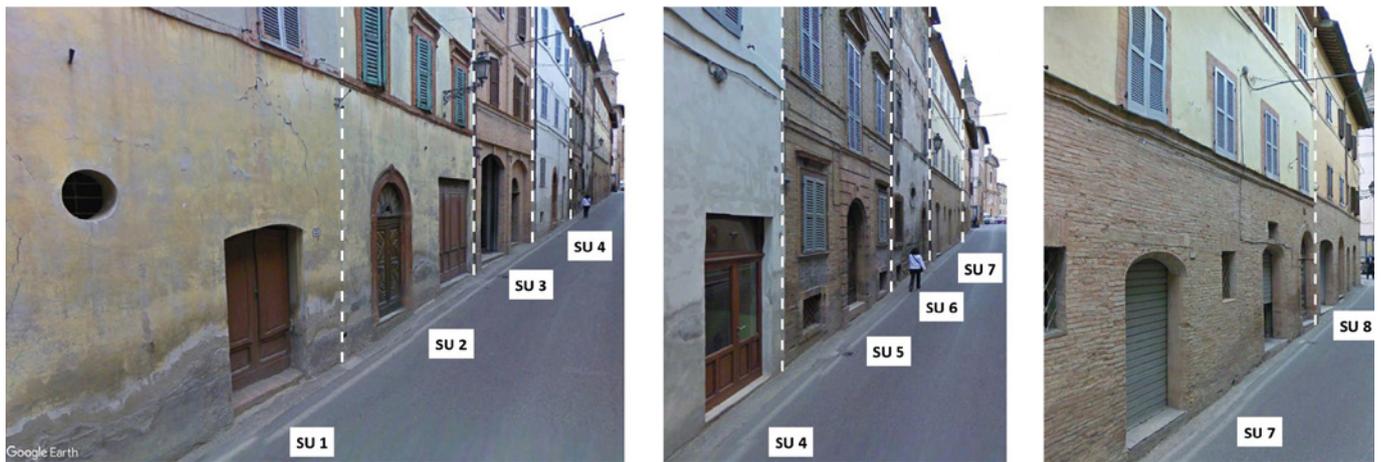
Fig. 5. Google street view images (2011) of the eight SUs before the 2016 earthquake.

regular blocks without headers elements, mud, and rubble inner core, weak mortar) as the prevailing masonry wall type called “rubble masonry” of Central Italy [8]. The constructions present regular elevation (e.g., three storeys), homogeneity of geometric features (e.g., regular opening layout), and construction techniques (e.g., roof types). However, different states of conservation of the facades emerge from pre-seismic facades images on Google street view according to the buildings being probably strengthened after the earthquake occurred in 1997 (Fig. 5).

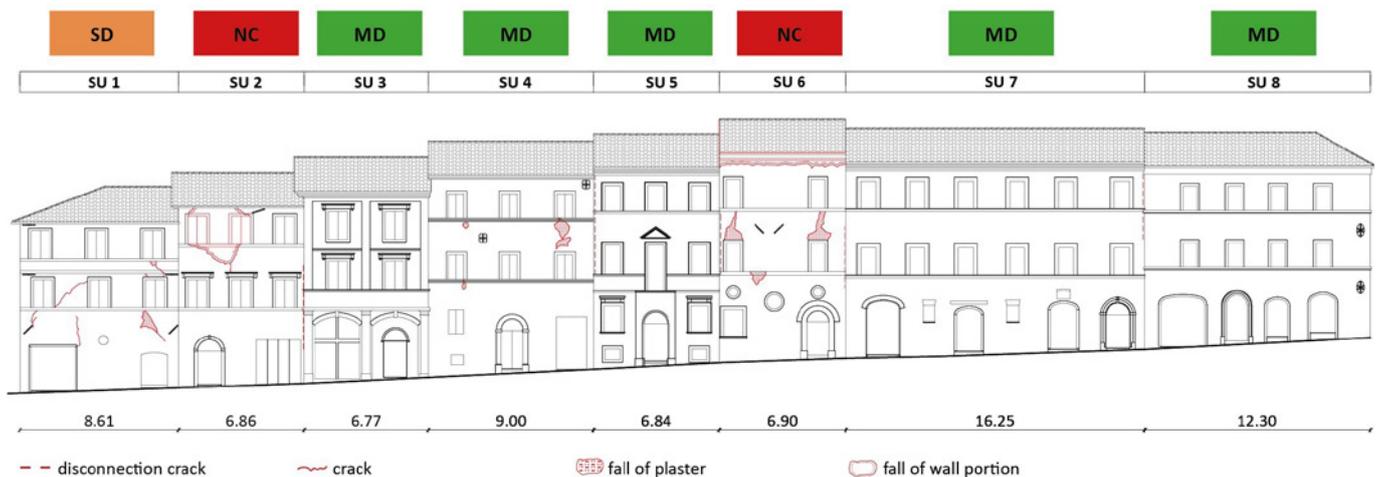
Fig. 6. Damage pattern and corresponding DS of each SU.

The empirical method consists in assessing damage after the 2016 Central Italy earthquake (Fig. 6). Facades of the aggregate are characterised by diverse crack patterns since they have different states of conservation. On the other hand, SUs 1, 2, and 6 were evidently in a state of neglect before the seismic event of 2016. However, the anti-seismic devices, even if not recently installed, seem to have been effective in avoiding the total collapse of the facade. Two SUs had a partial collapse. In SU2 there is an arch failure mode caused by the punching effect of the roof and the absence of an orthogonal load-bearing wall. In SU6, there is the overturning of the upper horizontal spandrel and fall of plaster portions. Therefore,

the damage state NC has been assigned to these SUs. SU1 suffered significant damage comparable to SD, and further seismic shock could trigger OOP failures. The presence of anti-seismic design certainly prevented the occurrence of such mechanisms. The other SUs had a slight crack pattern comparable to MD.

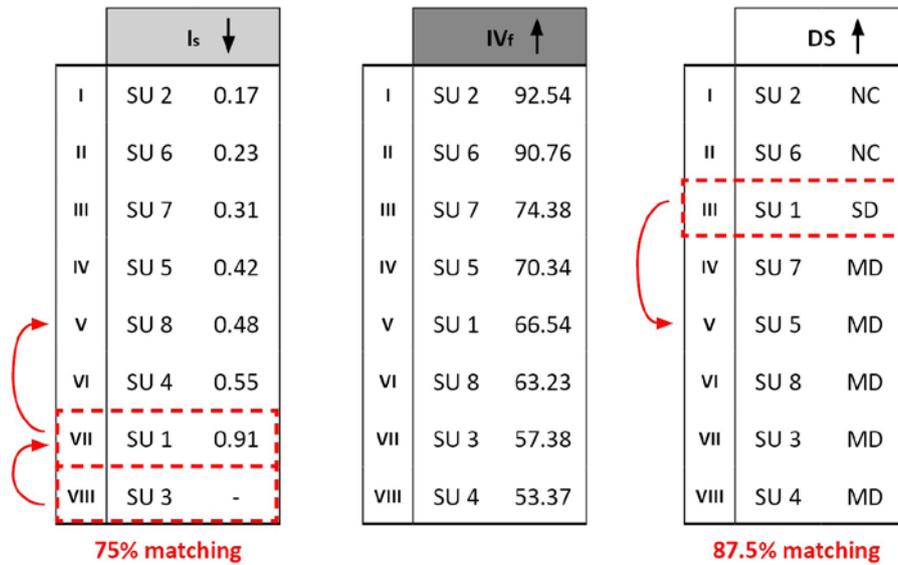
Fig. 7. Comparison between the vulnerability indices ( $IV_f$ ), the safety indices ( $I_s$ ) and the damage states ( $DS$ ). The % of matching is defined by the jumps among the classes (I-VIII) in the rankings.

The first comparison is conducted between the proposed method (section 2.1) and the analytical one (section 2.2) by ranking decreasing  $IV_f$  and increasing  $I_s$ . Then, the proposed method is compared with the empirical one (section 2.2) by ranking decreasing DS severity for each SU of the case study. The results of both comparisons are reported in Figure 7. The percentage of agreement is obtained by considering the correspondence of the indices calculated with different methods of the entire sample as 100% agreement, while lower agreement percentages are evaluated based on the number of SUs with corresponding results. By comparing the proposed method ( $IV_p$ ) and the analytical one ( $I_s$ ) there

is 75% coincidence, showing a good agreement among them. By looking at the two indexes, they have different trends due to their intrinsic definition, as  $I_s$ , which is referred to the safety level of the SU, is growing, while  $IV_f$ , which indicates the vulnerability to damage of the SU, is decreasing. With respect to the comparison of  $IV_f$  and the DS, as by the empirical method, there is an 87.5% agreement between the two. In this case,  $IV_f$  and DS have the same trend and comparable values (especially for higher damaged and vulnerable SUs).

Moreover, it is also crucial to highlight that when there are differences among the two, the  $IV_f$  overestimates the vulnerability/damage, thus allowing to have a prudential approach. There are two exceptions in the similarity of results from the comparison: that of SU3 and SU1. These exceptions indicate the limit of the proposed method, but they can be explained. The SU3 has curbs preventing OOP mechanisms. Indeed, it is not possible to detect some detailed construction features when they are not visible from the outside (e.g., they are covered by plaster). In the case of SU1, from the kinematic analyses it turns out as the least vulnerable SU (with respect to overturning), which was assigned after a critical-historical study on the documentation of the SU. From the documentation, it was possible to know that the ties were realized according to NTC2008, thus most probably showing high effectiveness and adherence to regulations. As the proposed method would not have this
