**Remarkable historic timber roofs. Knowledge and conservation practice.  
PART 2 - Investigation, analysis, and interventions**

# REINFORCEMENT METHODOLOGIES OF TIMBER ELEMENTS IN HISTORIC TIMBER ROOFS

Jorge Branco, Filipa S. Serino, Eleftheria Tsakanika, Paulo B. Lourenço

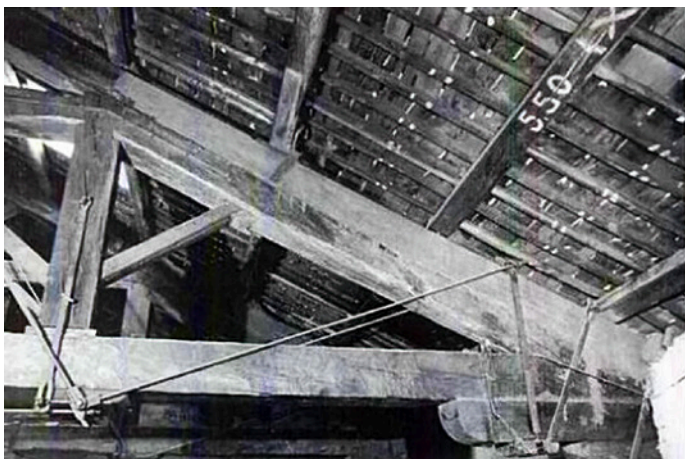
Fig. 3. Reinforcement of a truss tie-beam. Detail and design schemes of the Savona Theatre project. (Image source: courtesy of the designer, ing. L. Paolini).

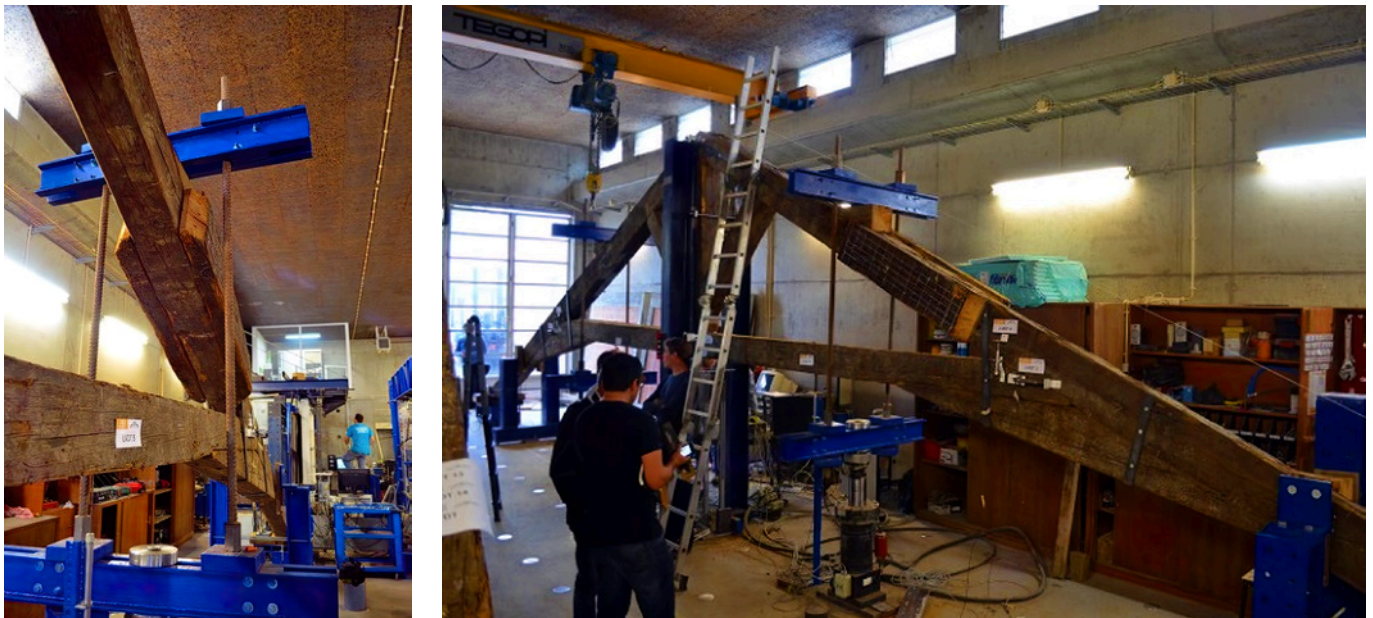
Fig. 5. Repair of a timber rafter using large pieces of wood screwed at the sides of the rafter [14].

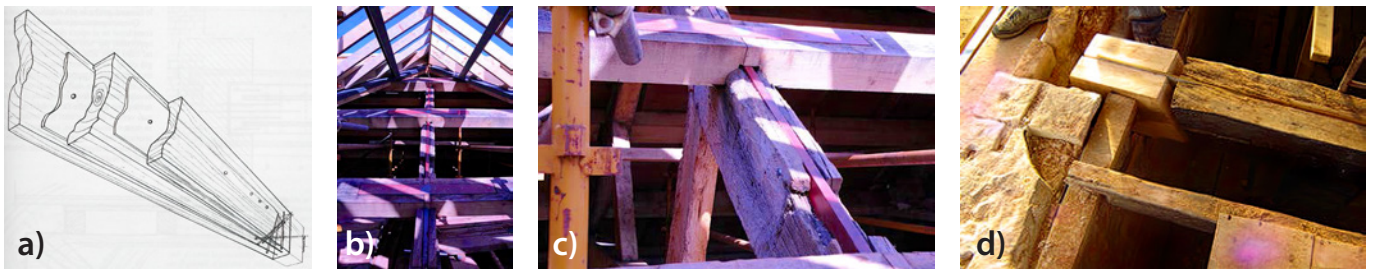
Fig. 6. Strengthening of a timber member by insertion of steel plates. Invention patent G. Tampone, L. Campa, 1987 (a) [12]. Barn (14th century) in Herefordshire, UK (Sinclair Johnston, 2009). Truss repair using a 20-mm thick steel flitch plate and resin. If resins were not used, many bolts would have been required, further cutting away the fabric and having less aesthetic appeal (b-d) [15].

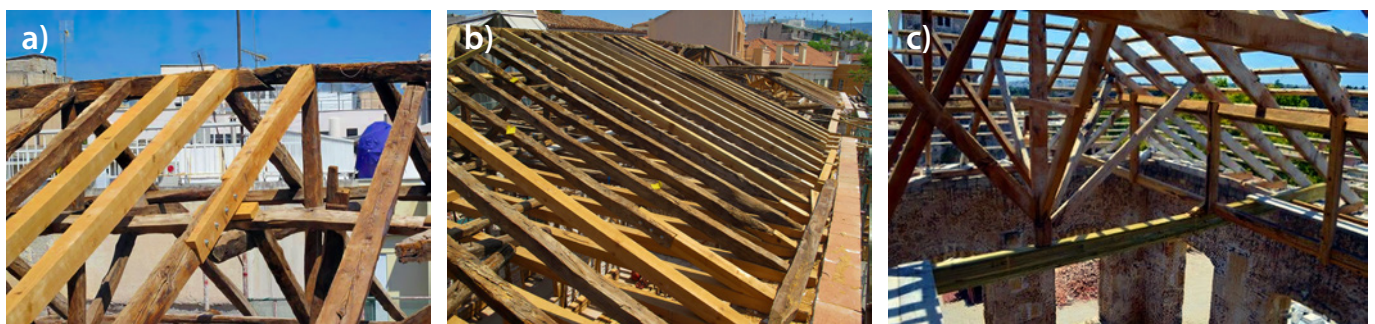
Fig. 9. New timber beams used to replace only the severely damaged rafters (a, b) [18]. The Neoclassical School in the Medieval city of Rhodes: New timber glued laminated beam replaced the poorly constructed original horizontal beam (c).

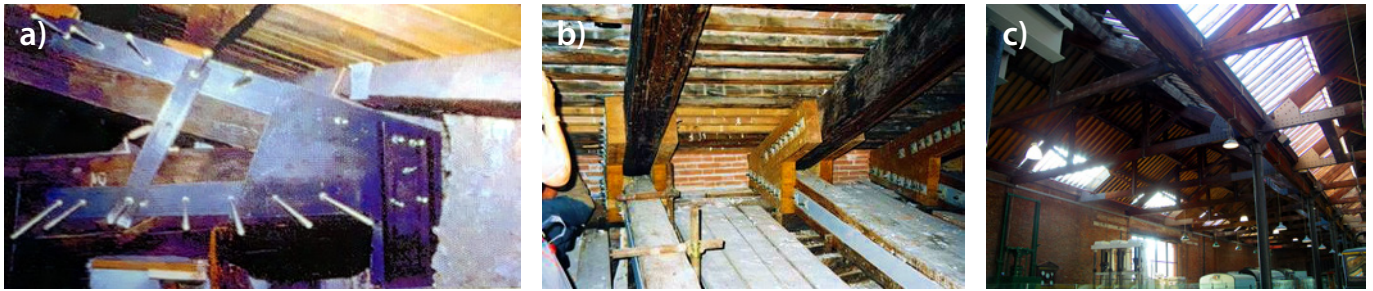
Fig. 11. Interventions that may change the stiffness properties of the original semi-rigid joints [20].

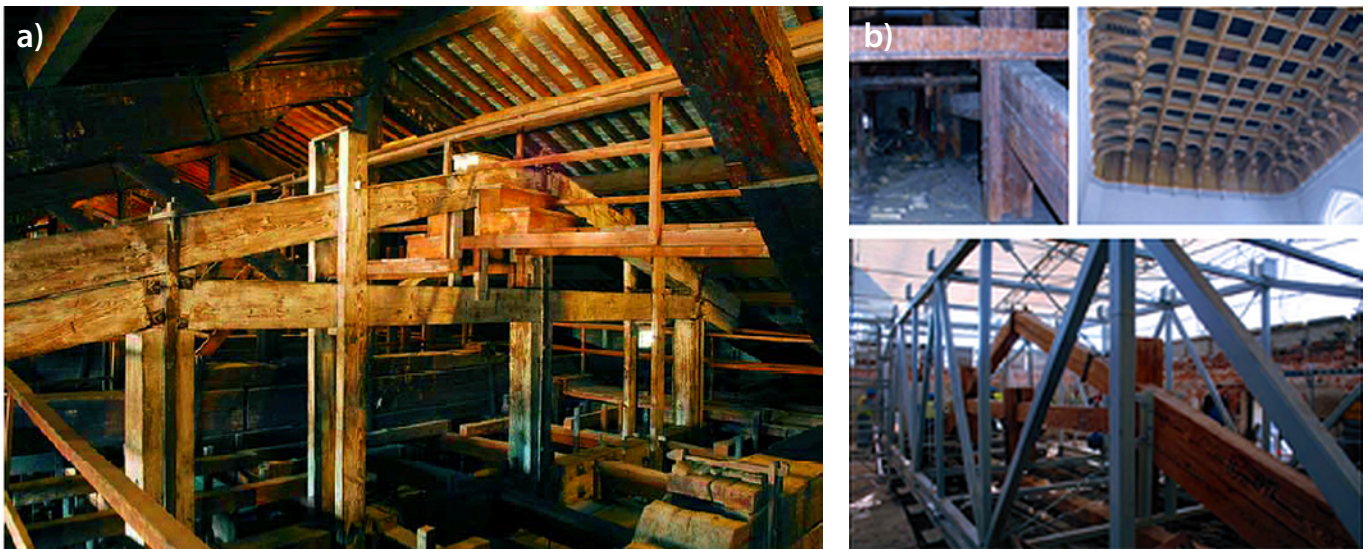
Fig. 13. Salone dei Cinquecento in Palazzo Vecchio, Florence. General view of the two trusses for the roof at the back of the photo (the original one) and the new one at the front (a) [25]. Main Railway Station in Wroclaw: A new load-bearing structure for the ceiling (a steel space frame) was used to relieve the roof truss from the coffer ceiling loads (b) [26].

Rafters or tie beams (see 3.1.5), or even a whole roof truss, can be introduced between the main beams or the main trusses (placed parallel to them). An example of an added parallel system can be found on the roof of the Salone dei Cinquecento in Palazzo Vecchio in Florence (Fig. 13a) and in the main railway station in Wrocław, Poland (Fig. 13b).

heavy ceiling of great artistic value. The ceiling was soon affected by sagging caused by creep effects. A reinforcement work was carried out in 1854 by Arch. D. Giraldi, who constructed new timber trusses, placed at a lower level as a parallel system between the original ones without any intervention at the old ones (Fig. 13a) [25].

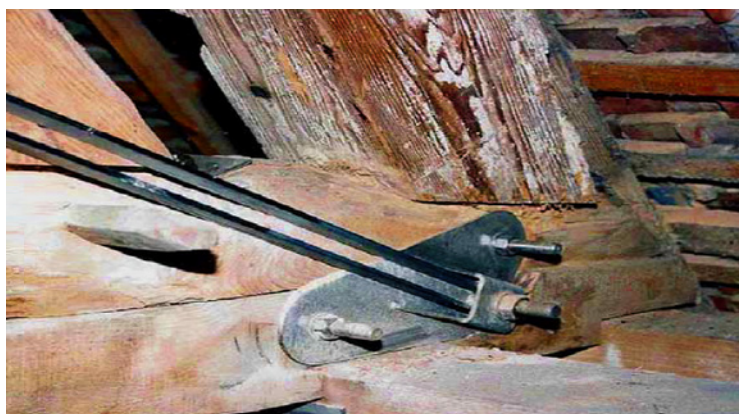
Fig. 14. St. Marien Church. Reinforcement of the timber roof using unbounded pin-loaded CFRP straps [27].
