**Remarkable historic timber roofs. Knowledge and conservation practice.  
PART 2 - Investigation, analysis, and interventions**

# THE ROOF STRUCTURE OF THE MEN'S ORATORY OF THE ALBERGO DEI POVERI IN GENOA

This paper describes the building features, the state of preservation, and the restoration and consolidation project of the roof and the underlying vault with timber ribs and plastered reed mats on the intrados of the Men's Oratory of the Albergo dei Poveri in Genoa, one of the largest still preserved in the monumental complex and one of the most imposing among those still present in the city.

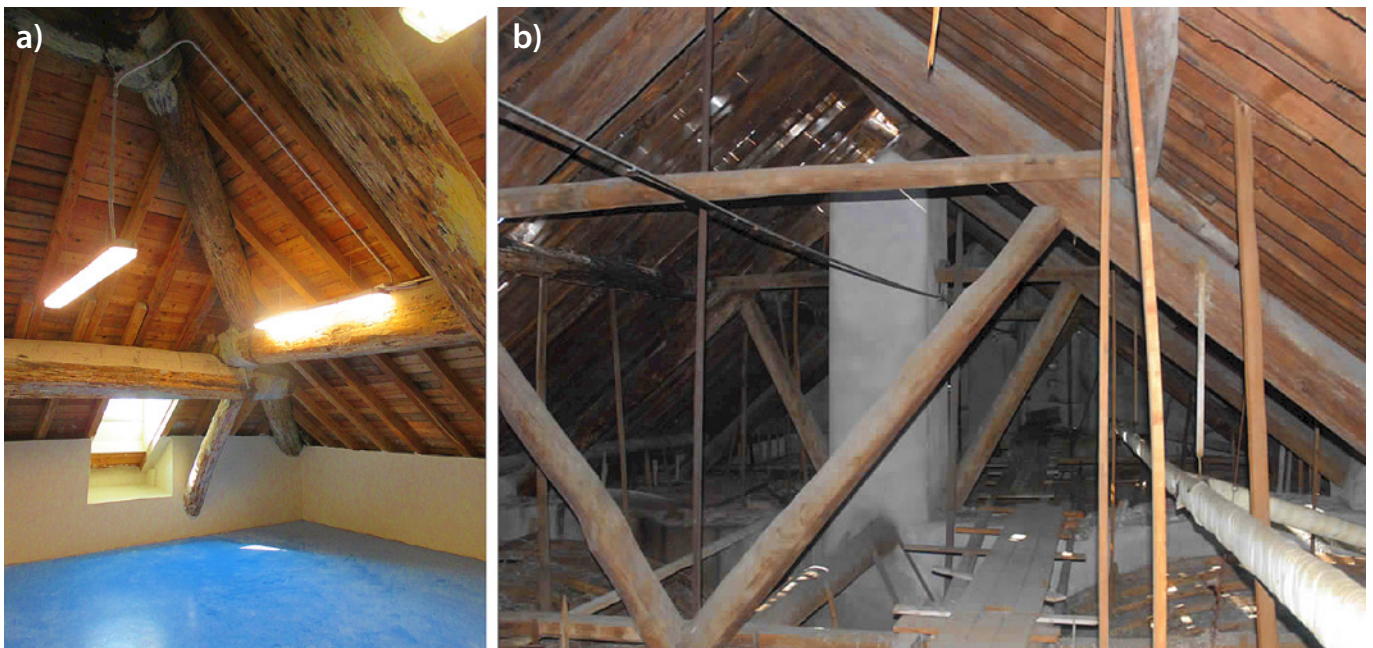
Fig. 1. Examples of the two types of roof structures present in the Albergo dei Poveri complex: (a) the roof structure of the west tower in the south wing of the complex; (b) the roof structure of the west side of the north wing.

The Albergo dei Poveri offers examples of both types of traditional Genoese roofing identified in the literature [Fig. 1], as it includes both elongated buildings (dormitories, church, oratories, and corridors) and towers located in the corners and the central bodies. The prevailing typology in the arms of the central cross and the wings, i.e., the parts connecting the corner towers to the central ones, are characterized by pitched beams perpendicular to the external fronts, carried by pillars resting on solid brick arches fitted with iron tie-rods. Above the main frame, the rafters follow the slope of the pitch and rest on the dormant beam at the masonry; a fairly regular board is nailed to them, which supports the slate roofing (slate slabs, usually square in shape, 55 ÷ 61 cm wide and 4 ÷ 7 mm thick) fixed with lime mortar. In almost all rooms, there were self-supporting wooden ribbed vaults underneath the roof structures with pendants connected to the roof structures as a static reserve in case of deformation or subsidence.

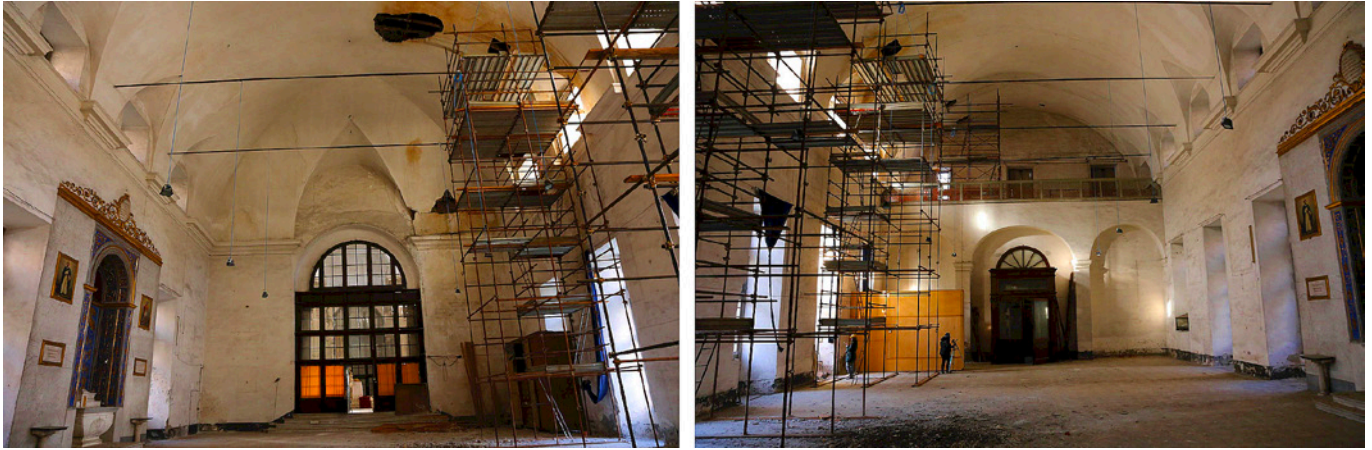
Fig. 3. East and West views of the men's Oratory.

The large room of the Oratory, 15.5 m wide and 25.6 m long, is connected on one side to the church, from which it is separated only by an imposing wooden and glass door, and on the opposite side to the west wing of

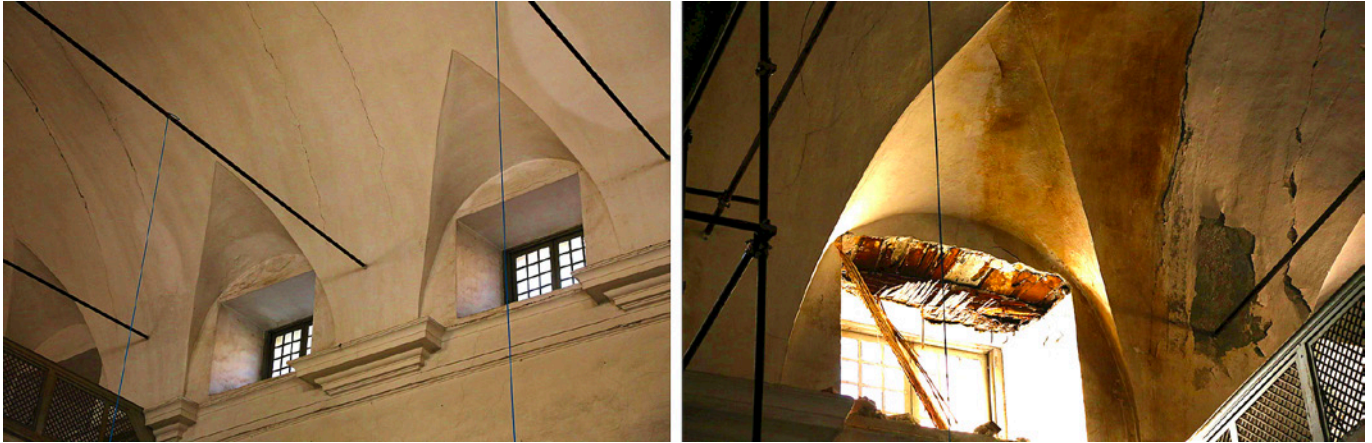
Fig. 6. Longitudinal cracks in correspondence of the arches and partial lack of the wattle of the ceiling above a window on the south side.

In fact, the vault shows numerous cracks near the tie-rods, arranged transversely, parallel to the short side of the Oratory, in correspondence with the masonry arches (Fig. 6). The most cracked portions are, in particular, those along the pavilion head of the vault on the east side, where the central lunette meets the vault. Here, there are also two important bulges on the sides of the lunette, and the plaster is in the process of becoming detached, and on the lower right-hand side near the impost of the pavilion head, where there is also a deficiency affecting not only the layer of plaster but also the underlying supporting reed mat.

- grouting the cracks in the soffit of the vault with mortar made of slaked lime and river sand that is compatible in color, size, and shape with the existing mortar and after stripping the cracks;

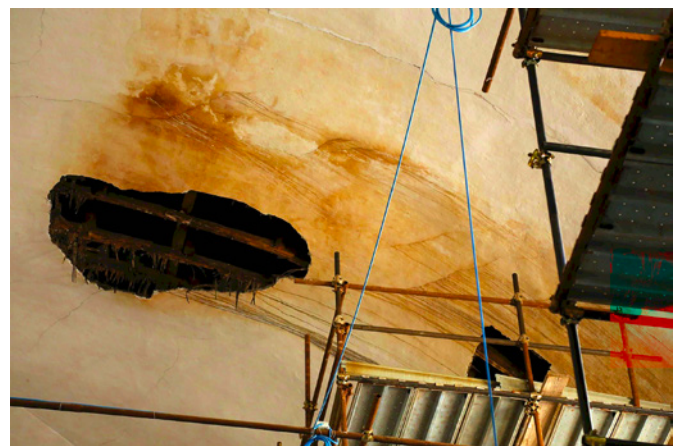
The second collapse of a portion of the vault (plaster and reed mat) occurred near the south wall, at the second southeast window, due to rainwater infiltration from the roof (Figs. 7 and 8). In the southeastern corner of the vault, there are drips and stains from infiltration. At the points of rainwater infiltration, especially along the south

Fig. 7. Detail of the vault with the collapsed portion of wattle and plaster.

- reconstruction of the collapsed portion of the vault. Reconstruction will be carried out by laying a stainless steel wire mesh plaster holder connected to the wooden ribs, on which a fiber-reinforced hydraulic lime mortar will be applied to reconstruct the portion of the collapsed vault;

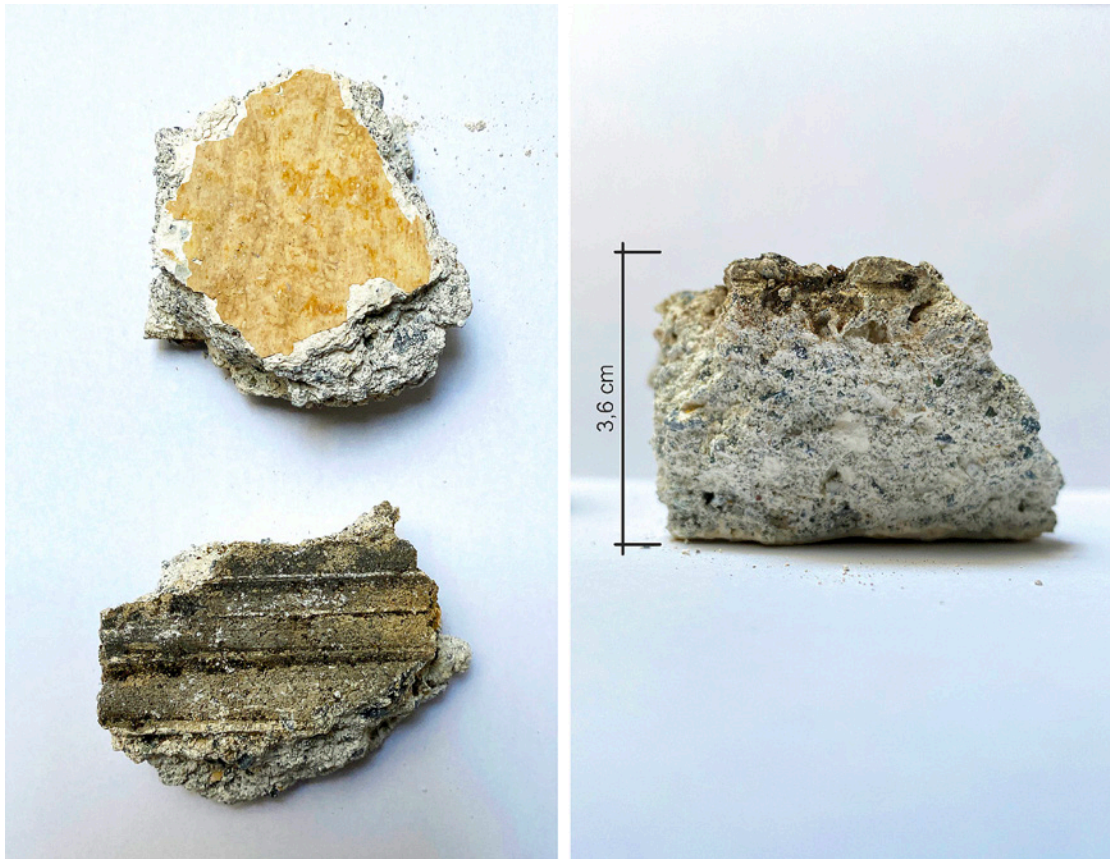
Fig. 8. Detailed photo of a portion of plaster of the timber structure vault.

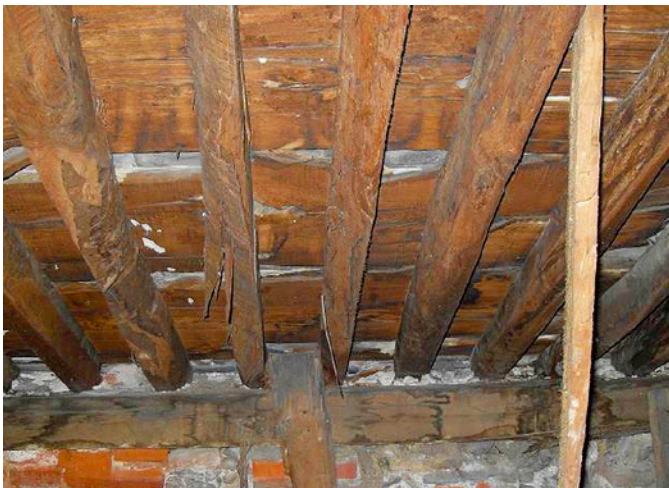
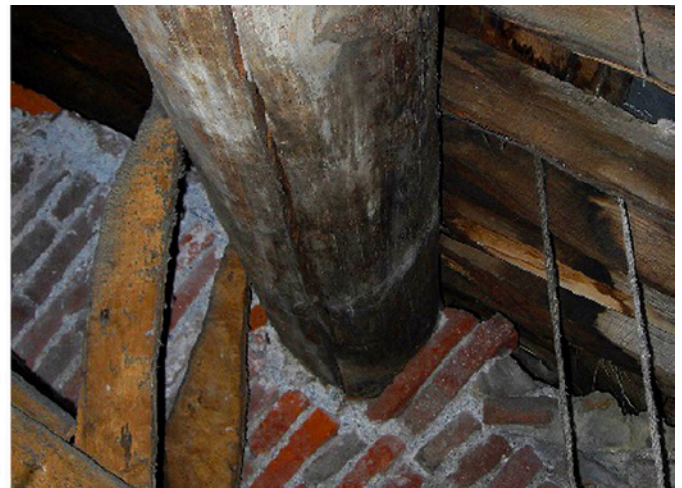
Only limited parts of the roof structure could be inspected due to the difficulty of access (Fig. 9). The main phenomena of degradation are:

- wall disarticulation in correspondence with the connection of the wooden struts to the masonry;
- cracking due to shrinkage of the wooden struts;
- deterioration of the wooden elements (related to the level of humidity and biotic attacks);
- bending damage to some purlins;
- bending damage to several arches;
- loss of shape of the vault (buckling) in the areas between the masonry arches.

Fig. 9. Cracks and rotting of the rafters.

The purlins showing shrinkage cracks will be consolidated by inserting a hooping with metal straps in order to limit the degradation phenomenon in progress and ensure their structural functionality. The hooping will be carried out by adopting a system of 5 mm metal cables connected through a turnbuckle system consisting of two bolted hollow metal rods. To avoid damage to the wooden elements due to the stripping of the metal straps, they will be inserted in transparent PVC tubes. The maximum spacing between the single straps will be 50 cm to guarantee homogeneous reinforcement of the elements.

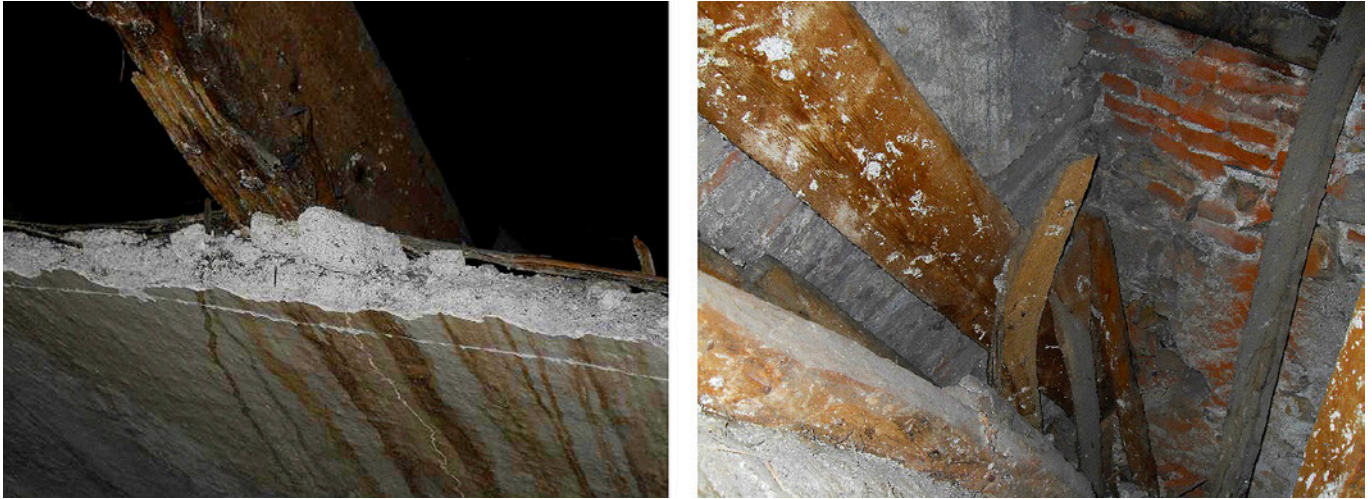
Fig. 10. The collapsed area of the vault and masonry wattle and disjoining in the support area of the struts.

As for the perimeter masonry, the masonry will be split and stitched in the areas where the struts are supported, where the masonry has become disjointed, creating a lack of support. The masonry pillars above the arches will be stiffened by the insertion of steel frames made of cold-galvanized UPN120 profiles (S275 class steel) and anchored to the pillars using threaded through-bars (Fig. 12). The construction of the reticular system is necessary to inhibit any instability of the pillars and to avoid the loss of support of purlins on the pillars themselves, especially in the case of horizontal actions.

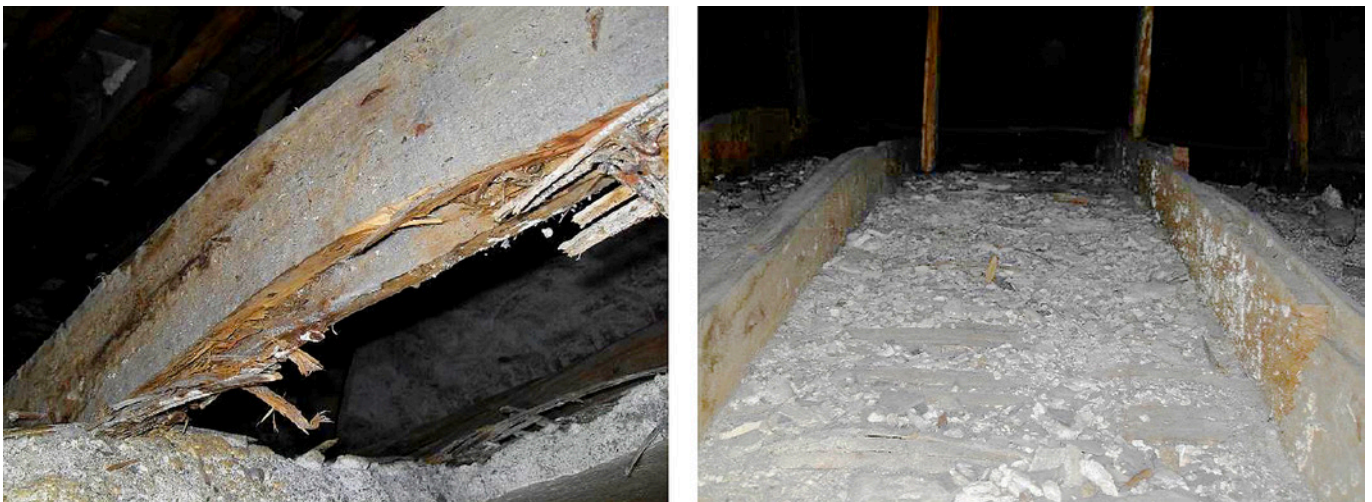
In addition, the vault observation through the collapsed portions and the assays revealed the presence of inconsistent material at the extrados, the inadequate connection between the ribs and the roof, and the lack of connection between the ribs and the reed mat.

Fig. 11. Degradation of the ribs and presence of loose material on the vault.

areas. Cleaning will be carried out by forced suction of the loose and powdery material deposited. The elimination of loose material on the vault is, in fact, a fundamental operation to permit subsequent consolidation work;

- consolidation of the ribs. The very advanced state of deterioration of many of the wooden elements making up the ribs led to the decision to place new 20 mm wooden boards alongside the damaged existing ribs, where necessary, on both sides, connected by 4 mm diameter screws;

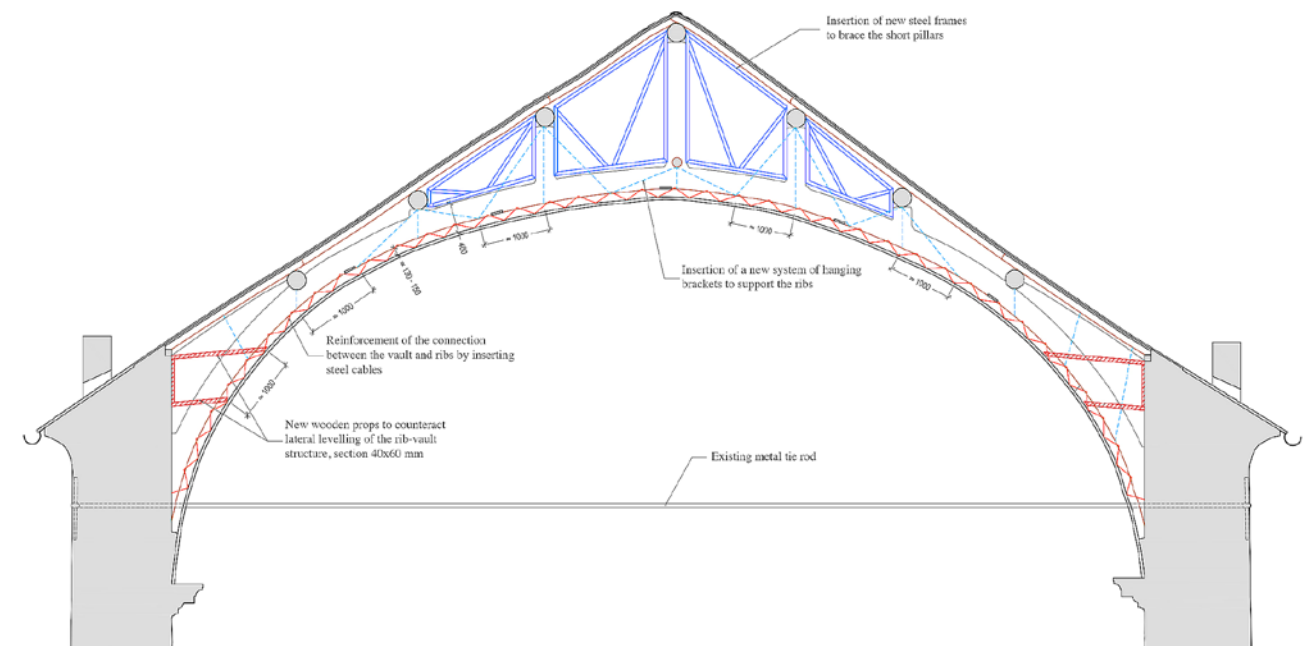
In addition, a flat reticular ring beam at the top will be constructed on top of the masonry, consisting of class

S275 steel plates (60 mm wide and 5 mm thick) welded to form a reticulated grid. The steel plates will be embedded in a thin cast (less than 50 mm) made of hydraulic lime mortar and connected to the underlying wall employing anchor bolts made of threaded rods embedded in the masonry. The advantages of this flat metal reticulated ring beam are many: on the one hand, the negligible increase in mass and rigidity means that the seismic action at the top does not change, and on the other hand, the widespread connection of the roof with the top of the masonry (primary and secondary elements) prevents the occurrence of hammering mechanisms that can trigger overturning mechanisms in the attic strip. All wooden elements will be treated against woodborers and fungi. The existing planking, previously removed, will be replaced by a double planking with crossed metal strips, recovering the existing planks in a good state of preservation. The new package will consist of a double-crossed planking with a thickness of 30 mm + 20 mm screwed mutually and to the joists below. Pre-drilled steel strips of a limited thickness (2 mm) will be placed between the two layers of boards to create a regular criss-cross mesh with a spacing of about 1 m. This intervention will make it possible to connect the various elements, avoiding mutual disarticulation, without, however, determining critical points at an overall level or modifying the overall

Fig. 12. Cross-section in correspondence of an arch, consolidation project.

- insertion of reinforcing elements in the areas where the vaults are deformed. At these points, two 40 mm x 60 mm section wooden elements will be inserted, anchored to the perimeter masonry by means of chemical anchors, and screwed to the ribs in such a way as to maintain the shape of the vault and avoid further deformation phenomena (Fig. 12);
