**Remarkable historic timber roofs. Knowledge and conservation practice.
PART 2 - Investigation, analysis, and interventions**

Attics are often the most interesting rooms where to investigate historical construction techniques. Above the eight domes of the medieval Basilica of St. Anthony in Padua, lightweight timber structures attest to the use of rather archaic frameworks. The ongoing research on the domed roofs confirmed the preservation of their 13th-century configuration and the perpetuation of this model during later interventions until the 18th century.

1. THE TIMBER DOMES OF ST. ANTHONY

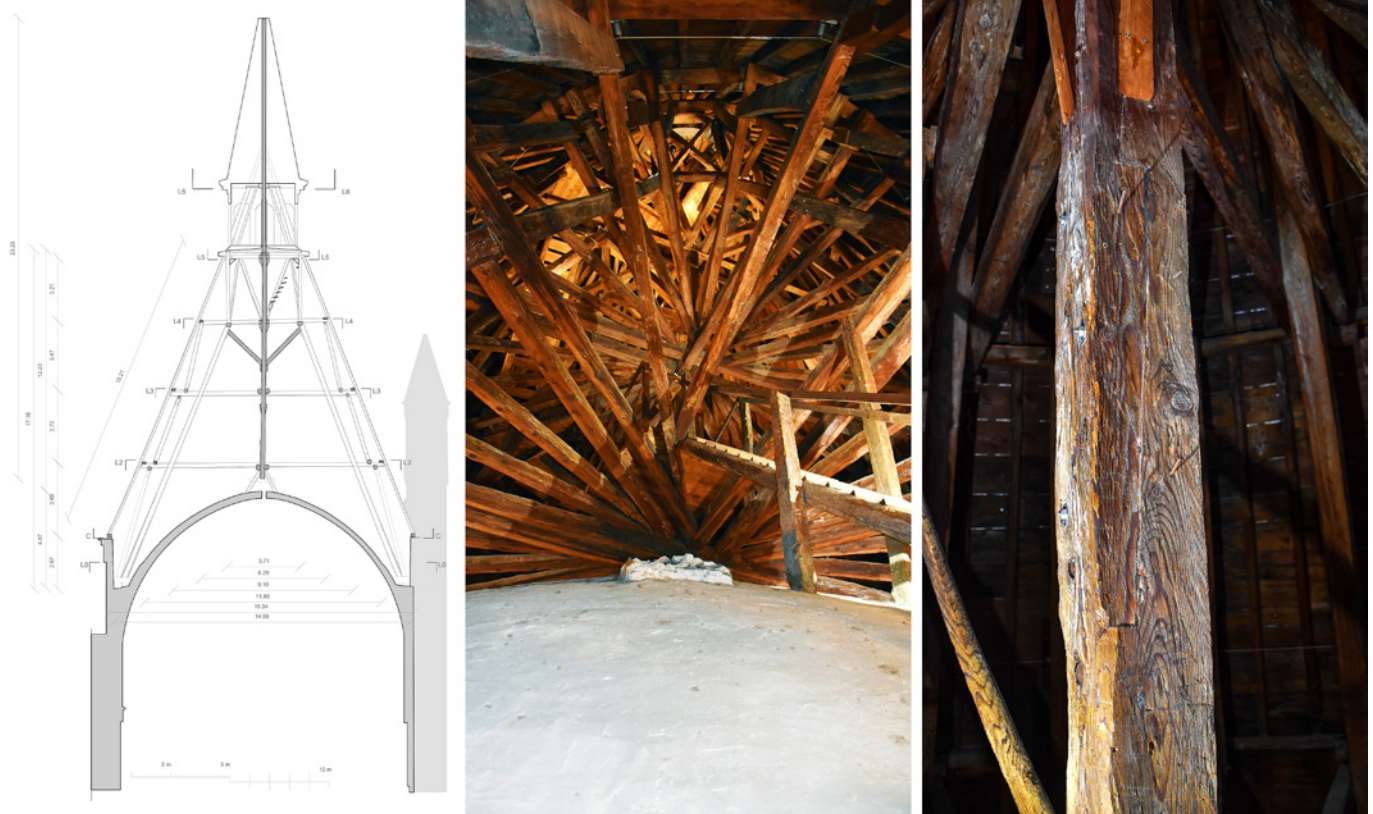
Fig. 3. The Angel cone and a king-post's joint.

As reported by previous authors, the Angel cone likely evokes the Holy Sepulchre in Jerusalem [7]. Unlike the other domes, its drum is raised on a square masonry base. Most authors tend to date the completion of the masonry shell to the first Saint's translation to the crossing in 1263 [1–3]. Destroyed by fire in 1749, a description dated two years earlier confirms that its reconstruction followed the previous outline. In elevation, it is divided into five stories: the base, three intermediate levels, and an external one on top of the truncated cone (Fig. 3). The vertical bearing system counts 24 struts bearing the first horizontal grid, and as many others running in between the two following upper levels. They rest on short transversal elements, settled between the collar-beams, or directly on the spokes. Eight 13.9-meter-long struts resting on the floor reach the third horizontal level. The king-post is composed of three segments assembled by stop-splayed under-squinted scarf joints with V ends for a total length of 23 meters (Fig. 3). In the third story, a bundle of braces branches out from the king-post and stabilizes the connection with the major struts.

The two lower horizontal levels, L2 and L3, are composed of two couple of collar-beams connected to the rafters with half lap-joints, for a total length of 12 m and 9 m, respectively. In L2, these are composed beams assembled with a scarf joint. In both levels, sixteen spokes are symmetrical split into the quadrants. In the upper levels, L4 and L5, the length of the collar-beams is further reduced to 6.3 m and 3.7 m. Moreover, the number of spokes is limited to a couple in each quadrant. On the last level, vertical posts lean on transversal elements and host wind-bracings linked by lap joints. Except for the first ring on the parapet, the upper rings of the skeleton are segmented into polygonal chains. Seventy-two straight ribs spring from the first ring and lean on the upper ones.

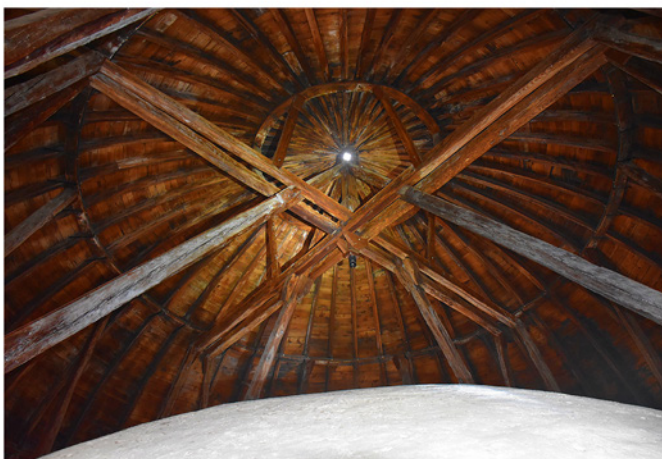
Fig. 4. The St. Jacob dome.

In the St. Jacob (Fig. 4) and the Choir domes (Fig. 5), there is only a high level of collar-beams, with a length of 10.5 and 9.9 m, respectively. In both cases, there are no spokes. The lateral struts, and the shorter ones around the parapet, support the third and the second rings. In the western part of the Choir dome, due to the polyg-

onal contour of the masonry drum, some main struts that support the collar-beams rest on the first chain. In both frameworks, the king-post has a square profile with sharp edges and a thin cover-box at the top. Forty-eight ribs composed of two layers rise from the inner edge of the first ring. The ribs are composed of three layers, the last of which consists of short segments lodged between the ribs. The ribs are tightened to the upper rings with metal straps and curved protruding boards. In general, the similarities between the two skeletons might suggest a common campaign of replacements dated the 19th century (Fig. 6). Eventually, the outer shell on the choir is characterized by a projecting profile, resting on twenty-four putlogs set along with the polygonal masonry and partly covering the gallery on top of the ambulatory.

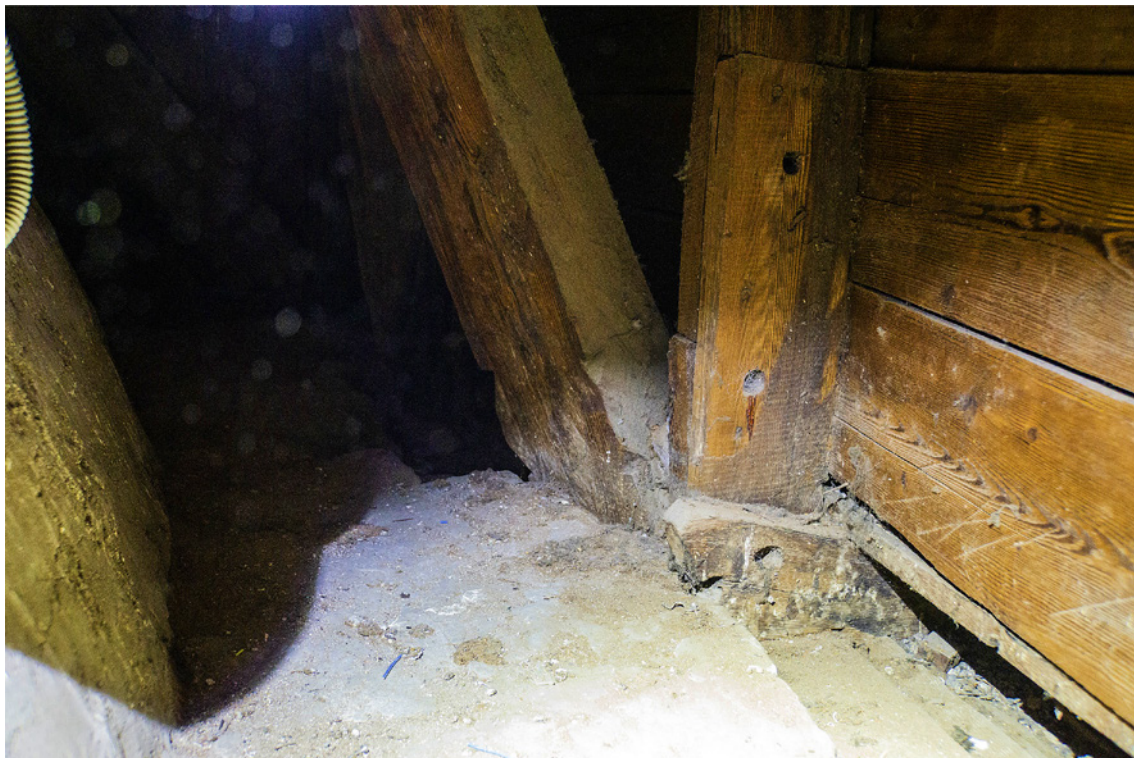
Fig. 7. Relics dome: cover plates supported by short wooden blocks to follow the projecting profile of the outer shell.

has an almost straight profile, like in the dome of the presbytery. Other analogies with the foregoing frames are the ensemble of forty-eight double-profile ribs, the iron straps and curved protruding connections between ribs and rings, and the modern reinforcement with wooden segments between the first and second levels of the ribs (Fig. 6). Finally, the wooden boards of the cover do not reach the floor level, they are instead supported by short wooden blocks and follow the projecting profile of the outer shell, like in the Choir dome (Fig. 7).

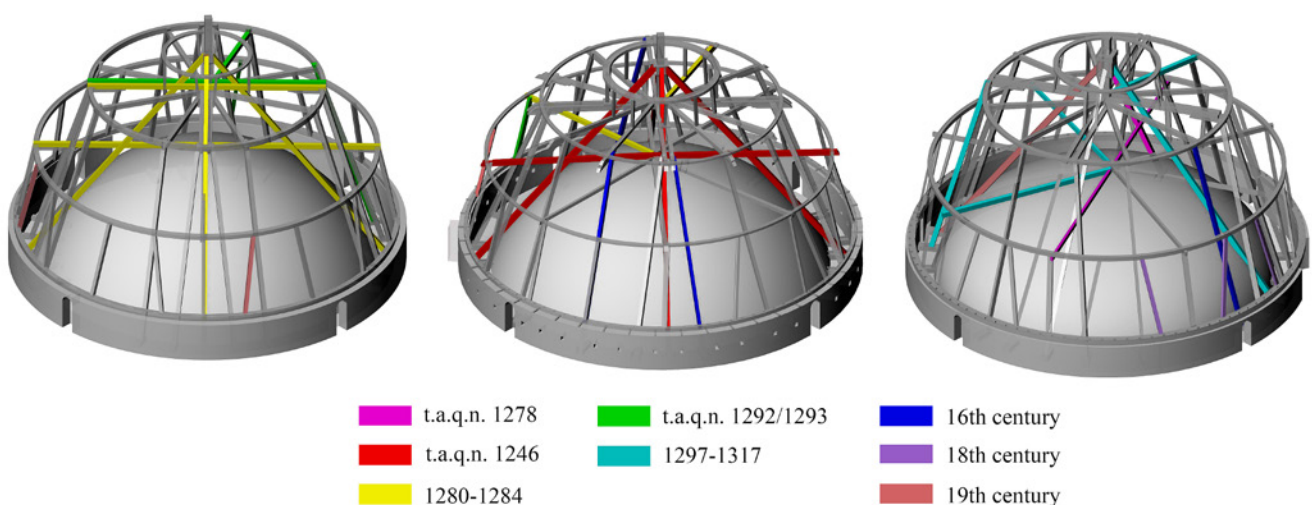
Fig. 8. Dendrochronology results in the façade, intermediate, and St. Anthony domes.

Findings from dendrochronological investigations and on-site traces help construct a chronology for the erection process of the domed attics. Xylotomy analyses confirmed all the samples and the cover boards are of larch (*Larch Decidua* Mill.). The dendrochronological activity revealed some precise dates and other *termini ante quem non* (t.a.q.n.) depending on the presence of the bark and sapwood on the elements. During four on-site campaigns, 70 samples (of 7 mm diameter) were collected. Results identified the following four time-spans [17] (Fig. 8):

1. between 1282 and 1284;
2. between 1297 and 1305;
3. between 1300 and 1317;
4. between the first and second half of the 16th century;
5. between the first and second half of the 18th century;
6. between the first and second half of the 19th century.

Between the first and second groups, there is a 10-year gap that could be explained by a preliminary stock of material or two consecutive stages of the same erection phase. These groups include rafters, struts, collar-beams, and spokes spread in the intermediate and St. Anthony domes, hereby confirming their original configuration.

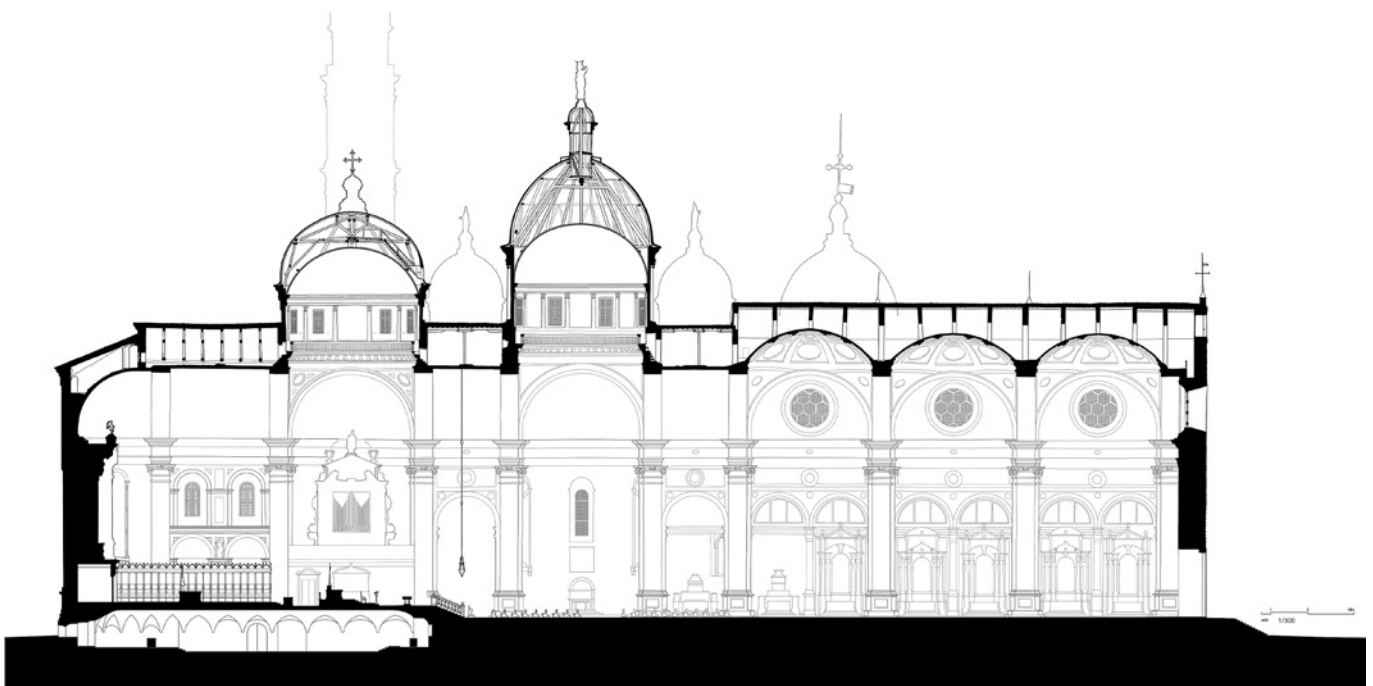
Fig. 9. St. Justine Abbey: longitudinal section. (Image source: photo courtesy of Pfister, 2022).

Closer to the Basilica of St. Anthony, the Abbey of St. Justine provide another bevy of domes in the skyline further south (Fig. 9). Many architects took part in the long worksite, repeatedly reshaping the silhouette of the church. The erection of the domes started in 1587 with the internal vaulting and finished in the first decade of the 17th century. They vary in size and construction techniques. A central dome rests on the crossing, and three others crown the transept arms and the presbytery. Four additional minor domes surround the crossing at square corners. The larger domes, about 13 meters in diameter, are double wooden shells. The rafters lean on the first wooden ring and support perpendicular trusses. There is a unique horizontal level of collar-beams. The joinery includes mortise and tenon connections, scarf and nailed joints, and iron brackets typical from the late Renaissance period. In short, the joints and frames relate to a trussed roof, unveiling a more modern concept than the structures of St. Anthony. The smaller domes, about 7.5 m in diameter, are composed of a brick shell and a light-

er timber superstructure, resembling St. Anthony's ones. Trademarks in the timber elements refer to 19th century replacements that could have changed the frameworks' original configurations. The differences among these seem to reflect changes of carpenters and construction practices over the centuries.
