**Remarkable historic timber roofs. Knowledge and conservation practice.
PART 2 - Investigation, analysis, and interventions**

THE TIMBER ROOF STRUCTURE OF CHAPEL XVI AT SACRO MONTE OF ORTA: AN EXAMPLE OF CONSERVATIVE STRENGTHENING WORK

This paper describes the methodological approach, the design process, and the execution of the maintenance works for the timber structures and roof cover-

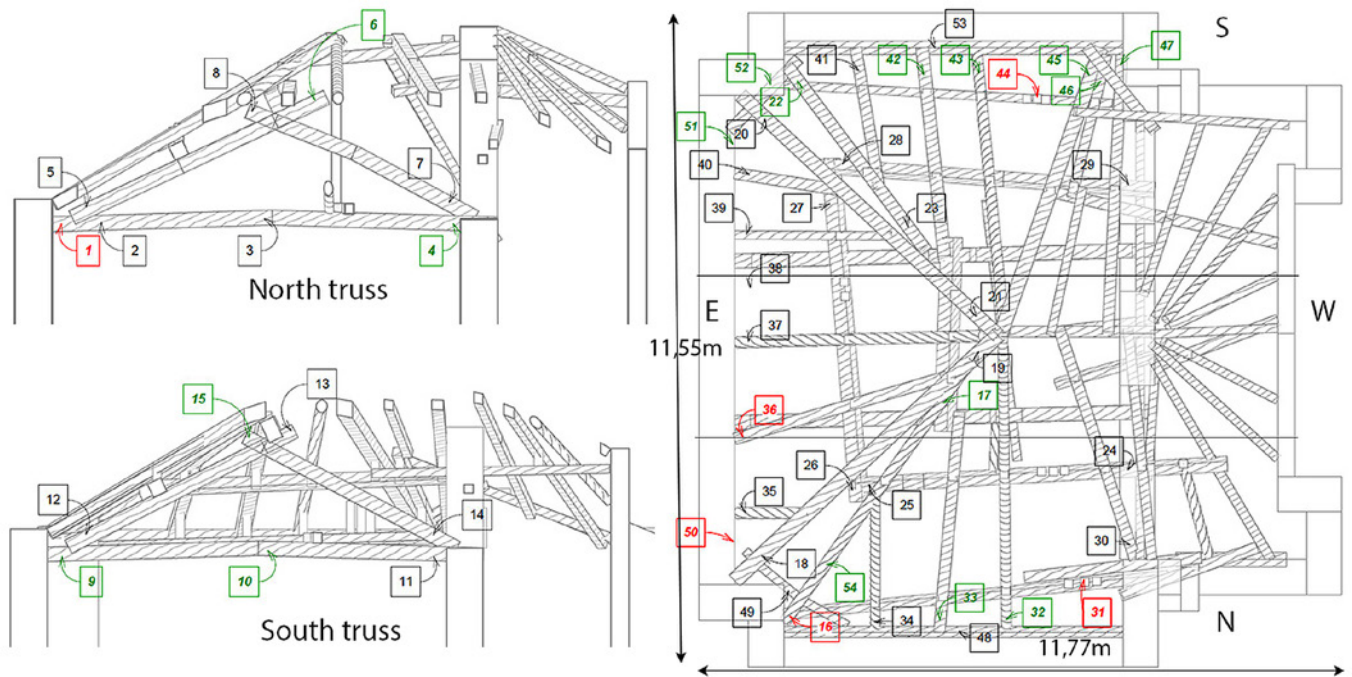
The timber structures were investigated using a resistographic test conducted at the final part of the elements, repeating the test at a short distance when a potential degradation has been identified. The most significant degradation was found near the support of the truss, (corresponding to point 1 in Fig. 4), strongly compromised by humidity and infiltrations of rain from the roof covering (stone slabs).

Fig. 4. Results of resistographic tests carried out on wood structures: in black, the points in good conservation, in green, those corresponding to slight or moderate degradation, in red, those corresponding to advanced degradation.

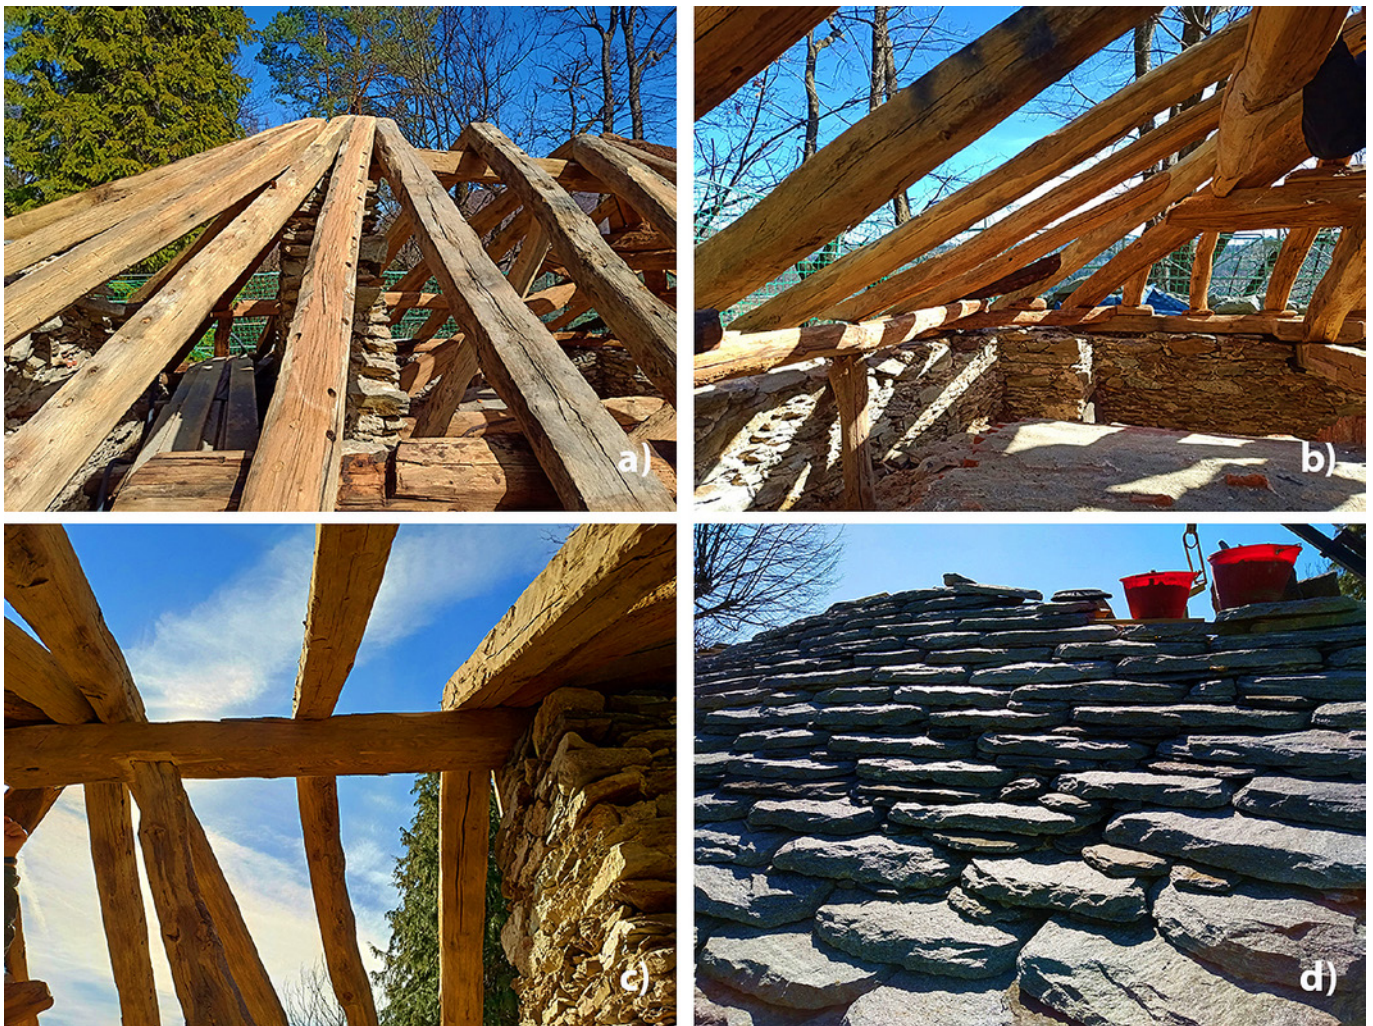
Fig. 10. (a) Placement of new timber elements alongside the original ones cleaned up; (b) integration of the new quay beams into the original structural scheme; (c) cleaning and static improvement of the area around the ridge beam; (d) reconstruction of the original stone roof covering.

During disassembly, the timber elements were separated by distinguishing elements in good conservation conditions from degraded elements to be eliminated (Fig. 10a). The separation of the elements was submitted to the Work Director for approval. The direction of the work was carried out by eng. Giovanni Vercelli, with the support of the technicians of the Ente di Gestione dei Sacri Monti. Recoverable elements have been cleaned and treated to improve their conservation (Fig. 10b, c). During the repositioning phase, the timber elements were remodeled in order to adapt to the geometry of the bearing structure, alternating the recovery elements with the replacement elements in chestnut wood (Fig. 10a, b).

The existing stone roof covering has been relocated following the traditional construction techniques (Fig. 10d), replacing the minor support degraded elements and adapting to the new stone slabs.
