TECHNIQUE AT THE SERVICE OF A NEW LITURGICAL MODEL: THE TIMBER ROOF OF THE CHURCH OF SAINTS MARCELLINO AND PIETRO IN CREMONA

Angelo Giuseppe Landi, Emanuele Zamperini

Church of Saints Marcellino and Pietro in Cremona, Historical timber trusses, Palladian trusses, History of construction, Timber shipping.

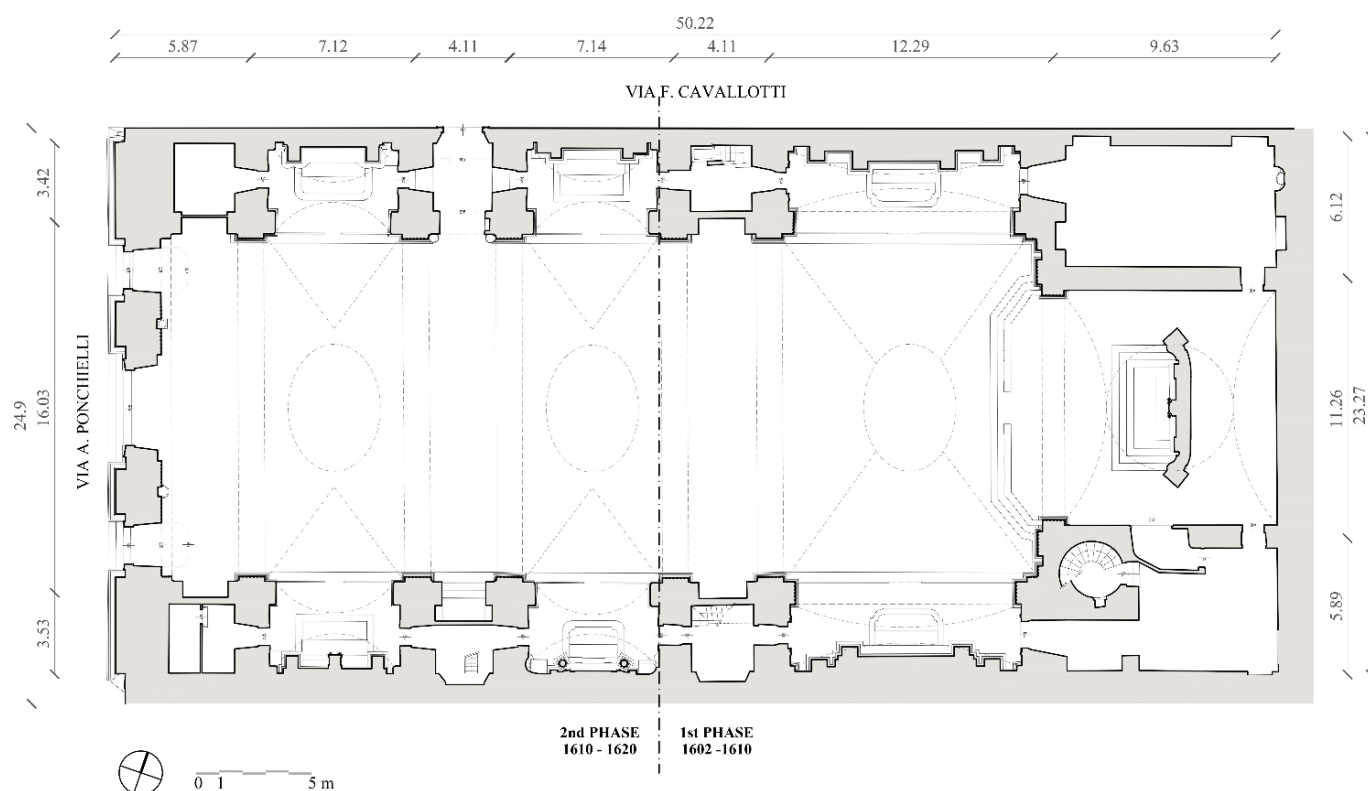
Fig. 2. Plan of the church of the Saints Marcellino and Pietro with the projection of the vaults: a brick vault separates the large (about 15 m wide) Latin cross liturgical hall with a pseudo-transept from the attic space and the wooden roof. (Image source: geometrical survey, courtesy of R.T.C. di Colturato & Pedrini).

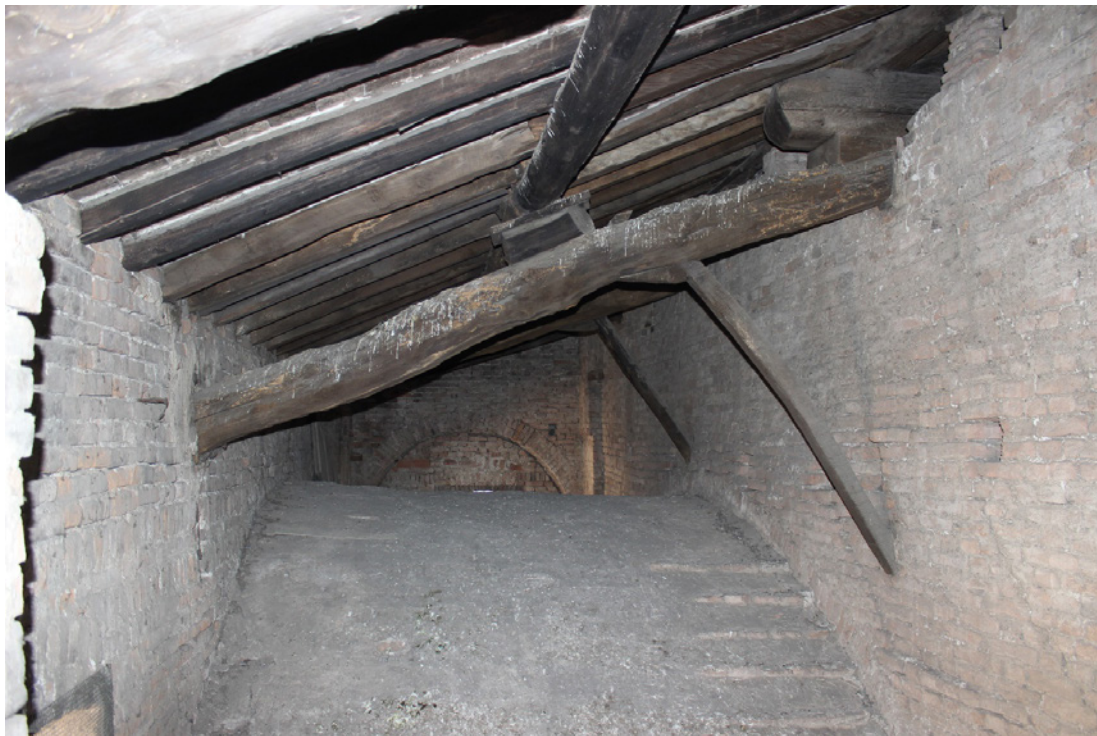
Fig. 4. Roof of the band on the northern side of the nave; it is possible to see the extrados of the barrel vault of the pseudo transept. (Photo by Emanuele Zamperini).

and placed between those) which support a single purlin placed in the middle of the pitch on which the joists rest. The rafters and the purlins are almost all made of oak timber, but some of them – probably even these still original – are made of larch, and others of spruce, which are probably recently replaced or added. The joists are mainly made of oak and discontinuous in correspondence with the purlin, but there are some made of poplar and some others of spruce which are recently added and usually continuous on the two spans. In this part of the roof, no significant differences are visible between the two construction phases of the church.

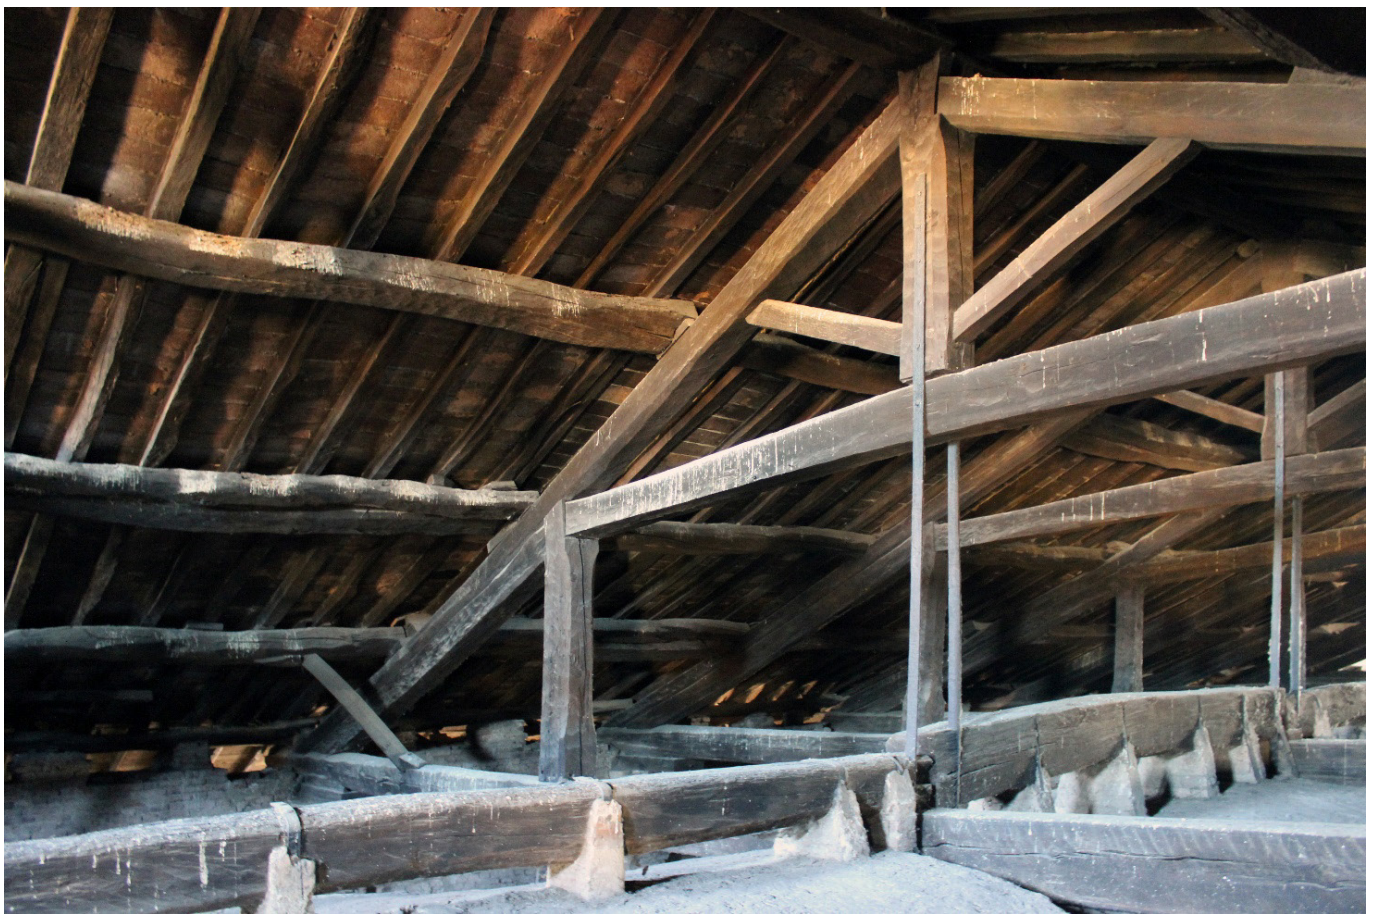
Fig. 6. Unmodified truss of the first phase: T3 truss seen from the north-east. (Photo by Emanuele Zamperini).

The nine trusses of the nave roof are all “Palladian” or queen post trusses. Also in the case of the trusses, differences can be noted between the first and second phases, to which are added others connected to the reinforcement interventions carried out over the years. Observing the trusses that have not undergone significant alterations, it can be seen that: in those of the first phase (T3-T4-T5), the queen posts rest on the tie-beam, which in its mid-point is hung from the king post by means of a long metal bracket; in the unmodified trusses of the second phase (T6-T7-T8), instead, we see that the queen posts are

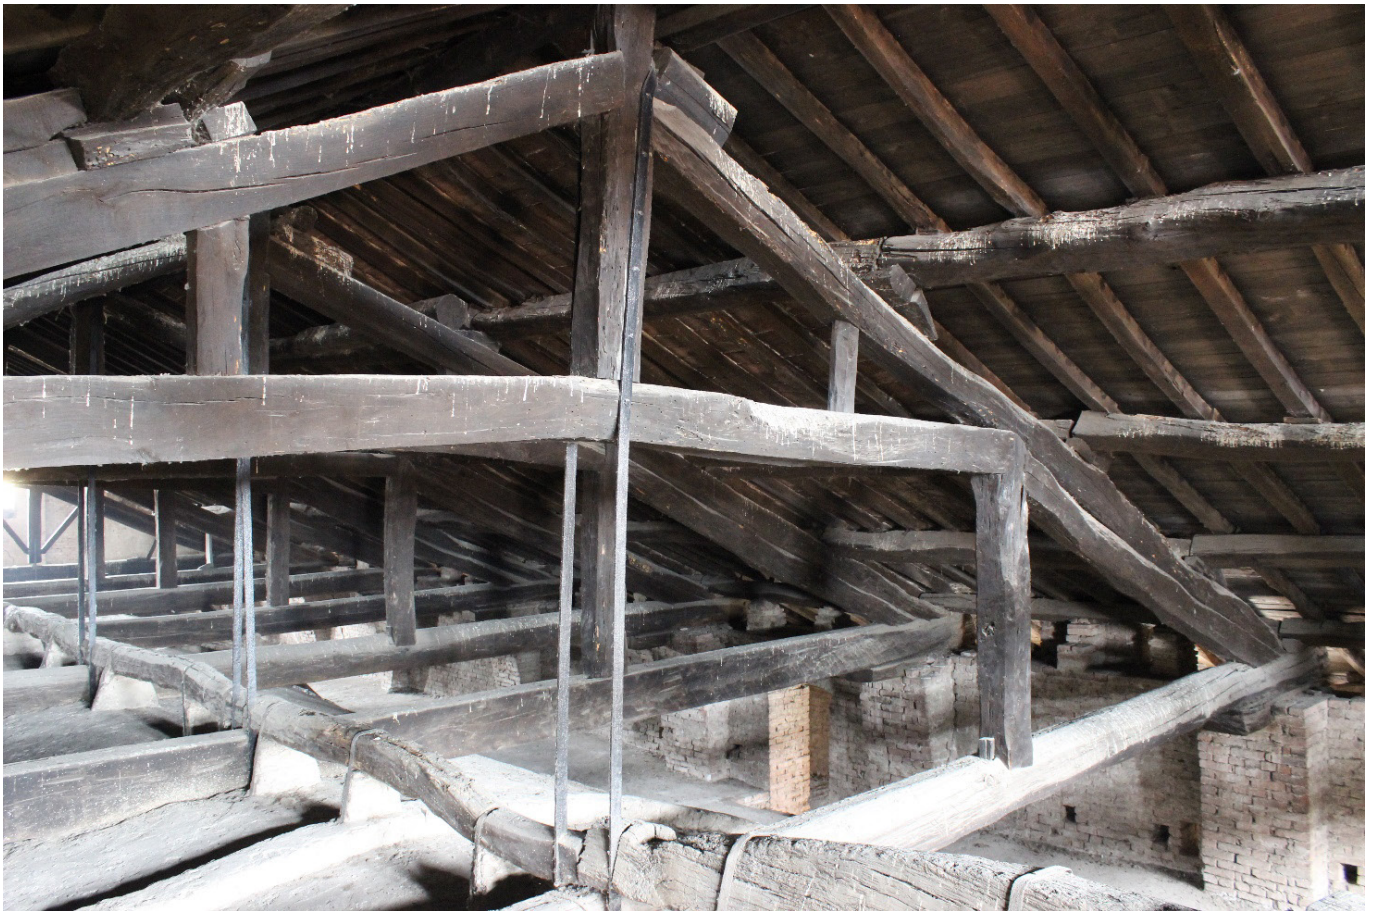
Fig. 7. Unmodified truss of the second phase: T8 truss seen from the north-west. (Photo by Emanuele Zamperini).

ond phase, the queen posts are connected to the tie-beam with a joint capable of resisting both compression and traction; therefore, in case of asymmetrical loads, one of them will press against the tie-beam, and the other will lift it, subdividing the force necessary to stabilize the structure between two points, in one of which it would also reduce the bending of the tie-beam induced by its own weight and by the other loads applied to it. In the trusses of the first phase, instead, the queen posts simply rest on the tie-beam, and this ensures that in case of asymmetrical deformation, only one of them comes into action, pressing on the tie-beam and increasing the stresses induced in it by the other loads.

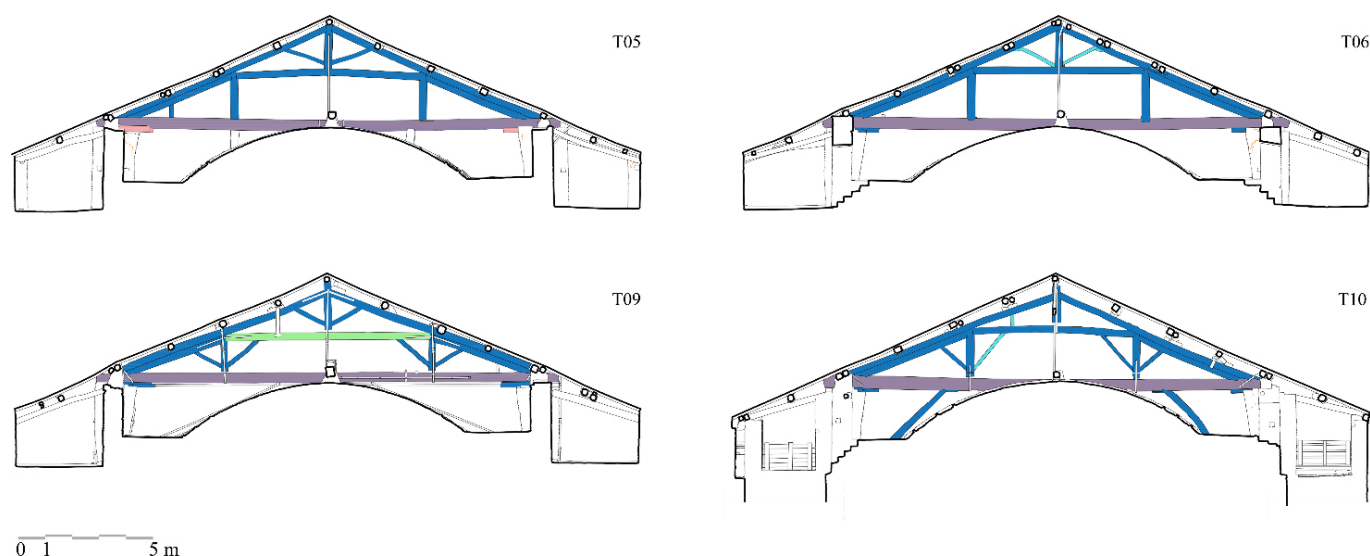
Fig. 8. Survey of the trusses of the nave: on the top left, T5; on the top right, T6; on the bottom left, T9; on the bottom right, T10. (Geometrical survey: Courtesy of R.T.C. di Colturato & Pedrini). The colours represent the wood species of each truss member: purple for larch; blue for oak; light blue for poplar; green for ash; pink for chestnut.

The T9 truss underwent the most radical modifications, perhaps after the breakage of heavy damage to its tie-beam, which has been, in fact, substituted. The new tie-beam is made of two pieces connected with a keyed

and nibbed scarf joint, reinforced with lateral plates and through bolts, and it is placed at a slightly higher level than that of the other trusses in order to place the wrought iron horizontal tie-rod, to which other two in-

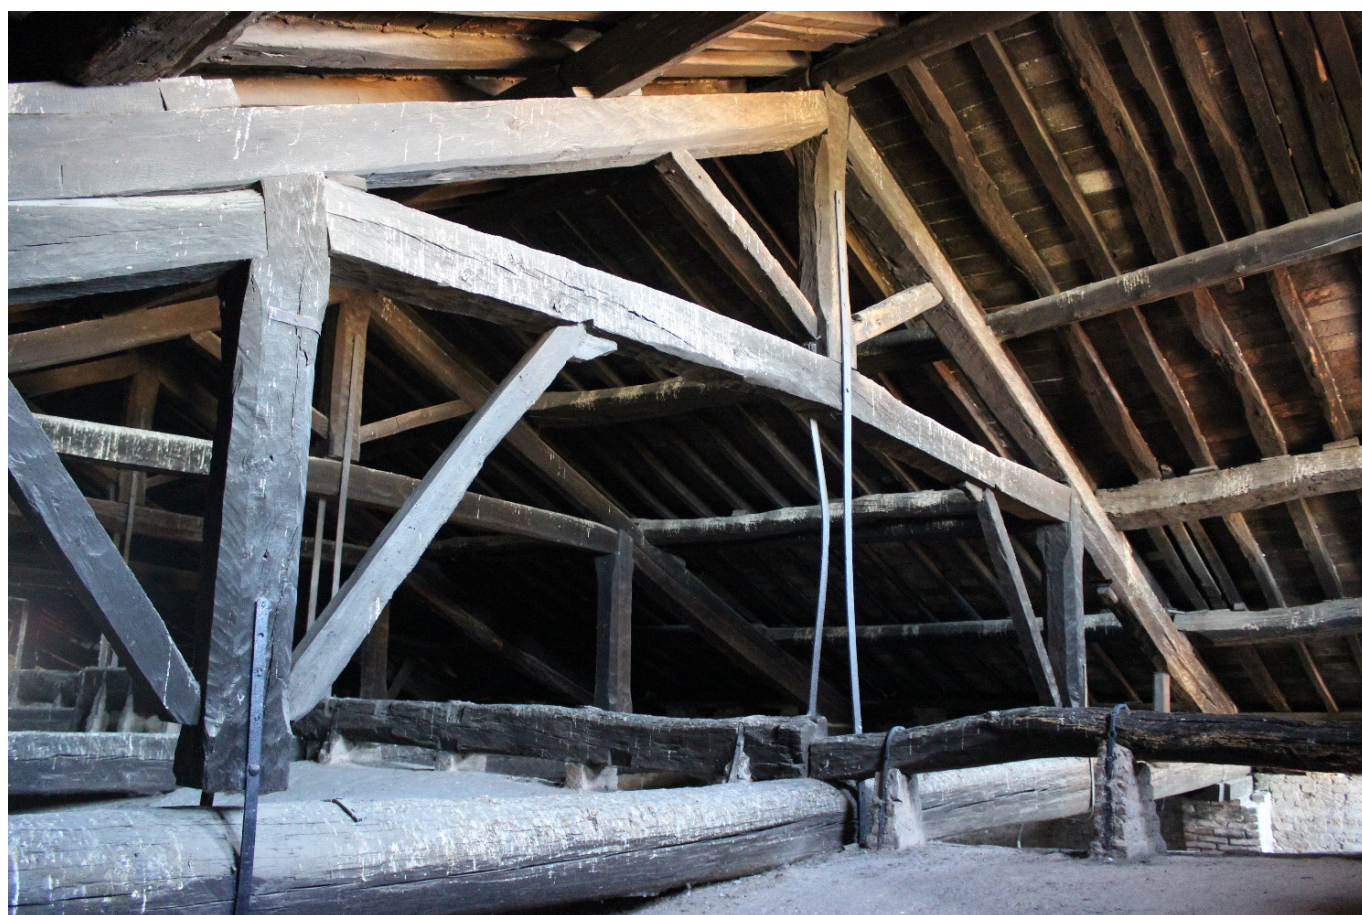
Fig. 9. Modified truss of the first phase: T2 truss seen from the south-east. (Photo by Emanuele Zamperini).

As already written, three of the trusses of the nave (T2, T9, and T10) underwent significant modifications and, therefore, now present a different structural configuration. As regards two of them (T2 and T10), it is possible to date the interventions with certainty, thanks to the archive documentation.

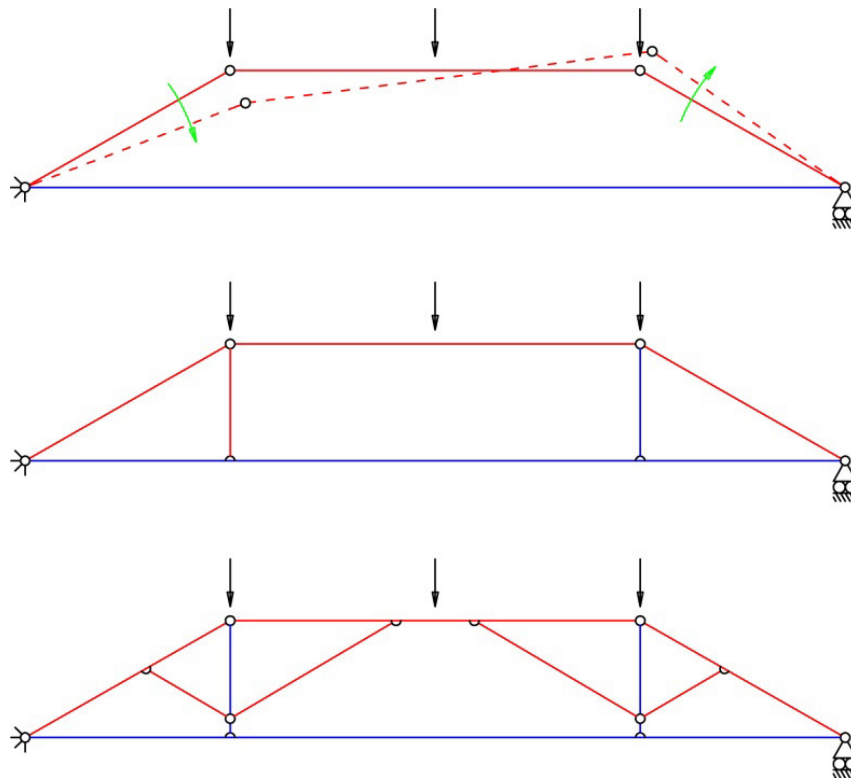
Fig. 10. Schemes of the structural behavior of the trapezoidal structure inside the Palladian truss (in red, the compressed members; in blue the stretched ones): on the top, the structure without queen posts; in the middle, the structure with the queen posts; on the bottom, the structure with queen posts and two struts for each of them. (Drawing by Emanuele Zamperini).

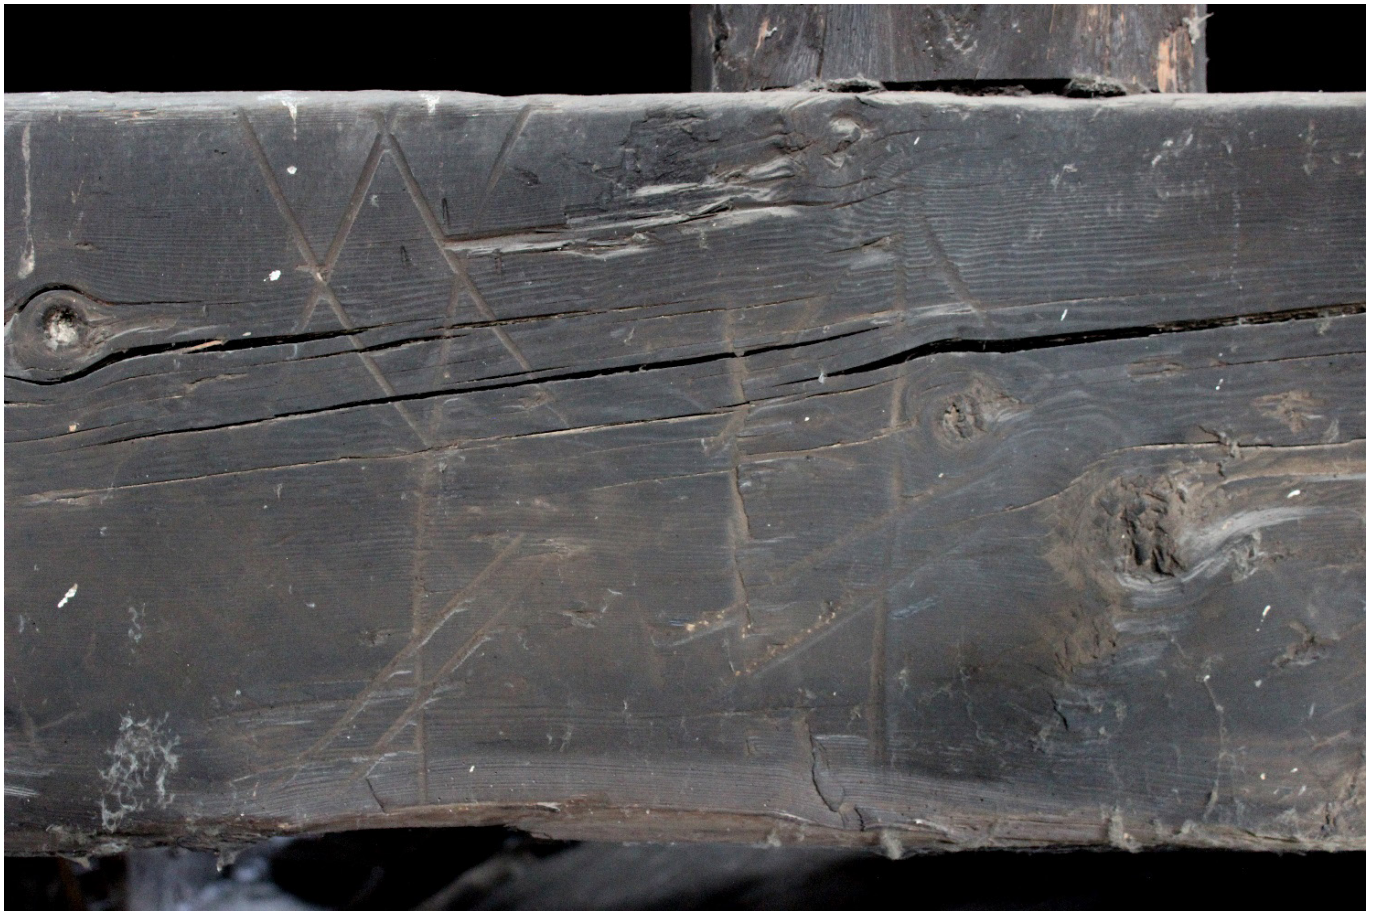
Fig. 11. Trading mark on the west side of the tie-beam of the T7 truss. (Photo by Emanuele Zamperini).

The original tie-beams of the church's trusses – and also some of the other elements of larch wood – keep both holes that testify to its transport in the form of a raft and transportation marks. The survey of these marks and their comparison with the repertories of marks relating to the eastern Dolomites [39], the only ones published so far with a certain systematicity, while showing strong similarities, did not allow for recognizing exact correspondences and therefore to identify with certainty the timbers provenance.
