Automatic Recognition of Bio-Colonization Processes on Historic Facades: Application on Case Studies

Francesco Monni^{1*}, Marco D'Orazio¹, Andrea Gianangeli¹, Enrico Quagliarini¹.

1 - Dipartimento di Ingegneria Civile, Edile e Architettura (DICEA) - Università Politecnica delle Marche, Ancona, Italy

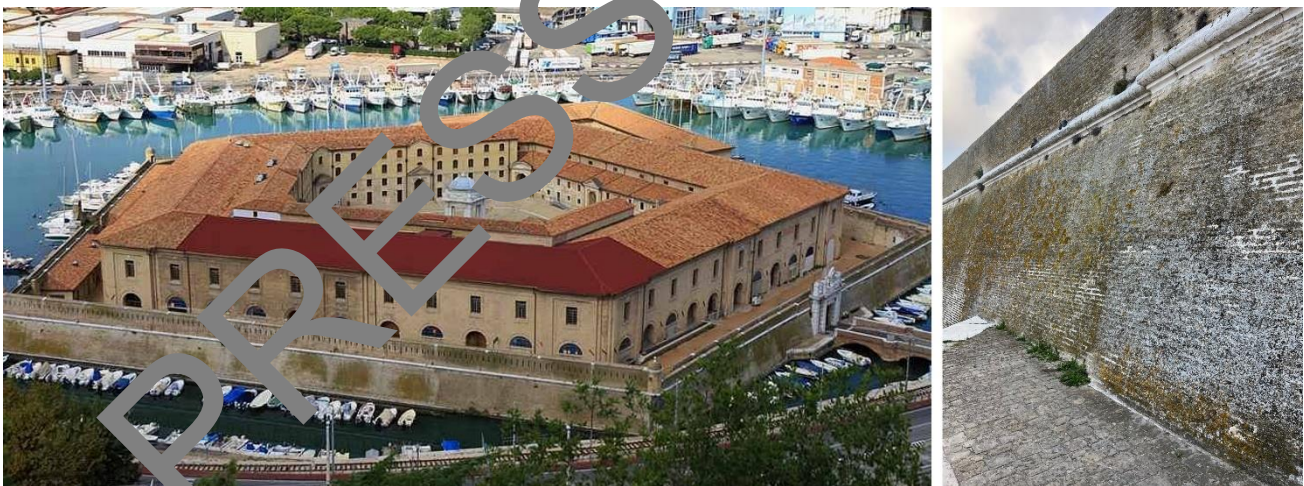
169
170 Figure 2 – The Mole Vanvitelliana – Ancona – Marche Region - Italy
171

159 The “Mole Vanvitelliana” (Figure 2) is a large, pentagonal architectural complex from the 16th century, located by the sea
160 in the port area of Ancona (Marche region, Italy). This structure, also known as the “Pizzaretto,” originally served as a
161 quarantine station for those arriving by sea in Ancona (a precautionary measure to monitor and control the spread of
162 contagious diseases). Over the years, the building has been repurposed for various uses, including military and commercial
163 functions, and today, it operates as a multifunctional cultural center. Designed in the 16th century by the architect Luigi
164 Vanvitelli, the “Mole Vanvitelliana” is a unique example of architecture and a notable symbol of the city of Ancona. The
165 main building of the complex is enclosed within a perimeter wall. Both the primary structure and the surrounding wall are
166 constructed with brick-facing masonry. Notably, the sloped, rain-exposed perimeter walls show significant signs of bio-

167 colonization, whereas the vertical walls of the main building, which are sheltered from the rain, do not exhibit such issues.
168

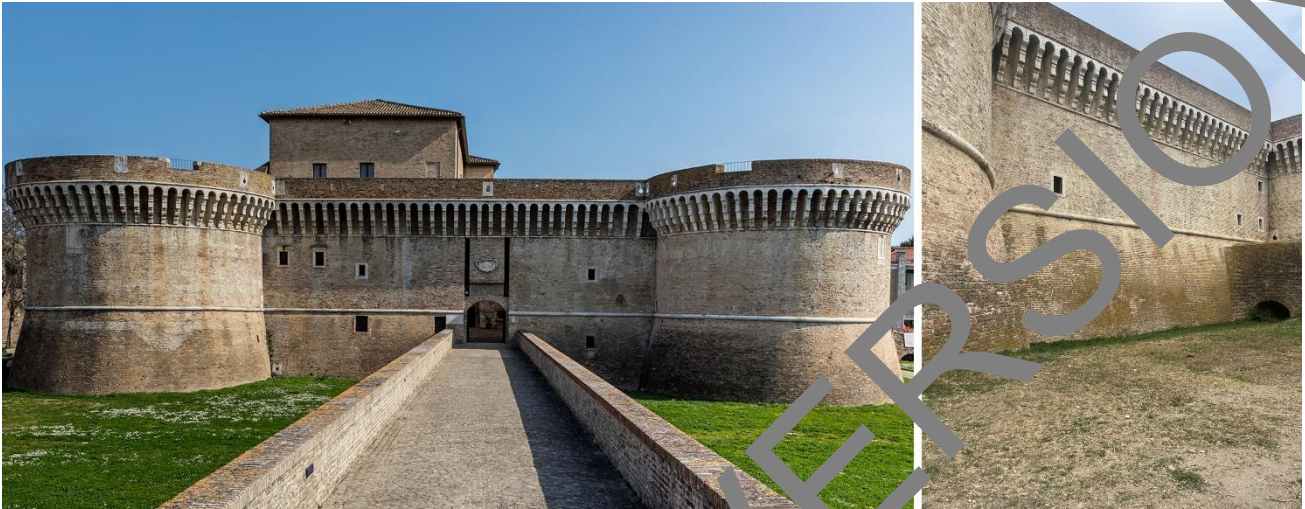
185
186 Figure 3 – The Rocca Roveresca – Senigallia – Marche Region – Italy
187

172 The “Rocca di Senigallia”, also known as “Rocca Roveresca” after the Della Rovere family who commissioned its
173 construction (Figure 3), is located in Senigallia (Marche region, Italy), and it stands as one of the most significant
174 monuments of both the city and the region. As it appears today, the fortress is the result of centuries of transformation.
175 Originally built during the Roman era as a defensive tower, it evolved into a medieval fortress in the 14th century and
176 eventually took its current form as a typical Renaissance fortified residence in the 15th century. The monument consists of
177 two interconnected structures: the central body, intended as a noble residence, is surrounded by a military defensive
178 structure. The noble residence is encircled by a highly regular structure: a quadrilateral enclosure with four low circular

179 towers at the corners, all connected to each other and the central building by an integrated system of vertical and horizontal
180 communication routes. As in the previous case, the perimeter walls are made of brick-facing masonry. As shown in the
181 figure, some portions of the structure, particularly those with a sloped configuration that makes them more exposed to
182 weather conditions, exhibit signs of bio-colonization (specifically, the lower parts of the perimeter walls). In contrast, other
183 areas are more protected and do not suffer from this issue.
184

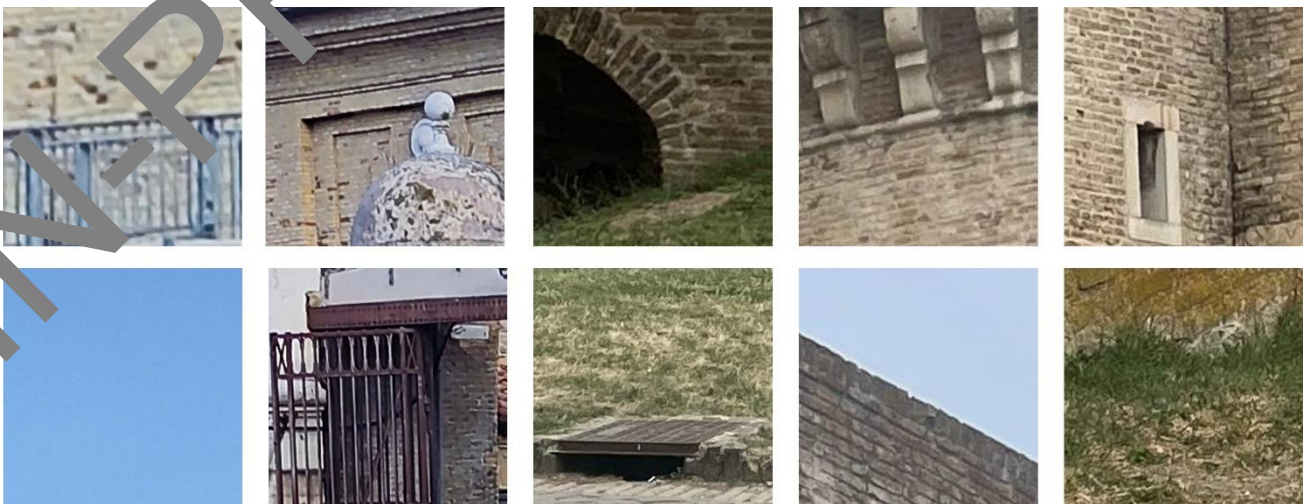
219 Figure 5 – Some examples of images extracted from HD security cameras installed at the Mole Vanvitelliana and the
220 Rocca Roveresca.

207 The trained model was applied iteratively to verify its recognition ability in real cases. The trained network was first used
208 to detect bio-colonization presence in images collected by security IP cameras. The application of the method to this
209 group of images highlighted that the ability to recognize bio-colonization on the brick-facing masonry facades is affected
210 by several factors. Dividing images from surveillance cameras results in low-resolution sub-images, reducing recognition
211 effectiveness. Moreover, images acquired from security cameras include other elements (ground, grass, roads, roofs, stone,
212 metallic elements, etc.) that were not included in the original dataset. If the cropped image contains objects different from
213 the bricks, convolutional neural networks frequently fail, reducing total accuracy to unacceptable values. This clearly
214 highlights two things. First, there is a need for higher resolution images, and second, there is a necessity to expand the

215 dataset used to train the convolutional neural networks by including images of the brick surface and images featuring all
216 elements present on and around building facades (Figure 5).
