TOOLS FOR THE KNOWLEDGE OF THE BUILT HERITAGE

Critical analysis of restoration practices against rising damp*Graziella Bernardo, Cristina Rinaldi, Antonella Guida*

Graziella Bernardo, Cristina Rinaldi, Antonella Guida

The paper focuses on the restoration processes of two significant case studies: the Church of San Gennaro in Capannori (Lucca) and the Church of San Giuseppe in Rosate (Milano). The research results provide valuable insights into the effectiveness and durability of different intervention methods. Moreover, the critical analysis facilitates the choice of best practices for sustainable building heritage conservation.

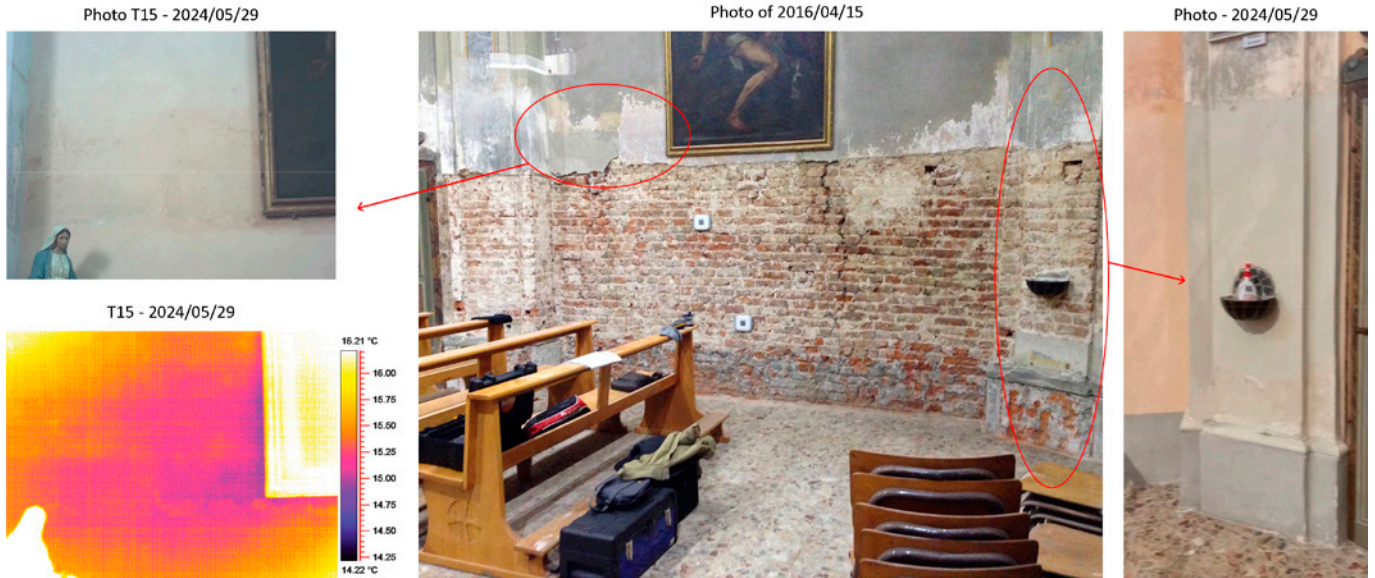
Fig. 6. Monitoring of restoration in the Church of San Giuseppe, Rosate (Milano).

The plaster applied during the last restoration of the Church of San Giuseppe showed whitish deposits and detachments due to efflorescence. The presence of hygroscopic salts was confirmed by thermographic surveys that highlighted colder areas in the form of “leopard spots” (Fig. 6). This drawback underlines the importance

of cleaning surfaces from hygroscopic salts before any other intervention in the restoration process.

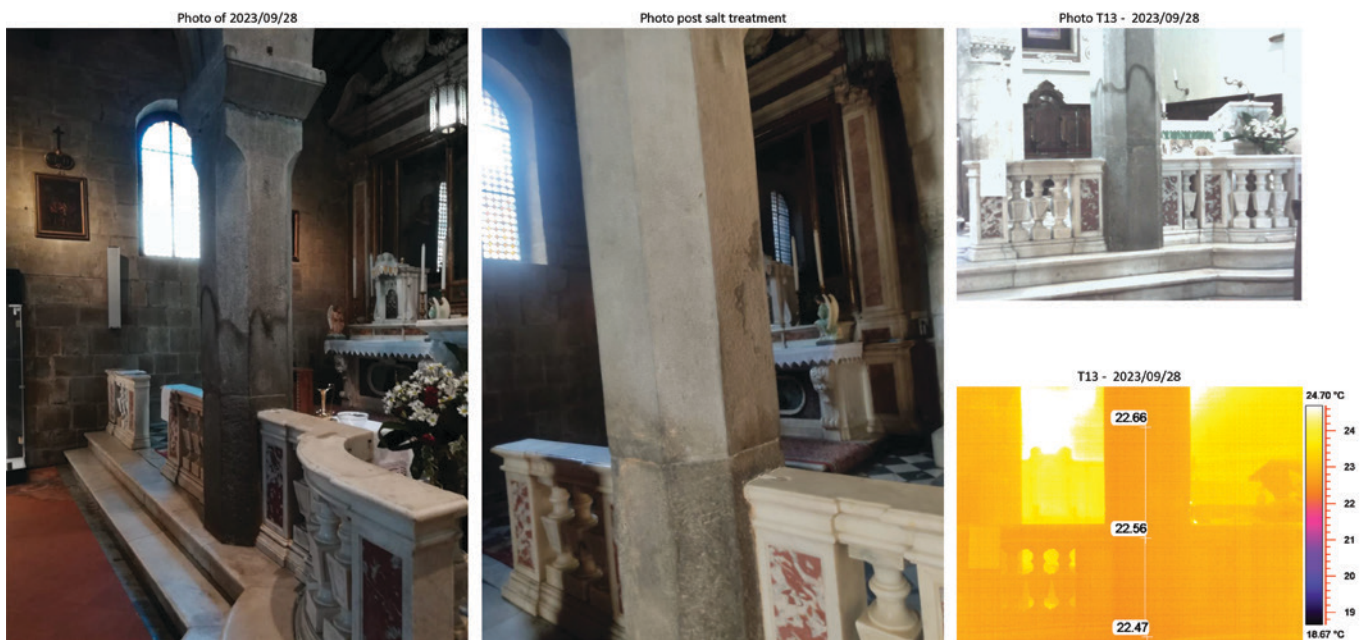
Fig. 7. Monitoring of restoration in the Ancient Church of San Gennaro, Capannori (Lucca).

A preliminary survey, using drones and 3D laser scanning, mapped areas of degradation and critical conditions to ensure safe and informed interventions. Prior to consolidation, chippings and damaged mortar were

mechanically removed. Petrographic analysis using a polarizing optical microscope of original plaster and masonry stones allowed the choice of lime plaster. After the last restoration of the Church of San Gennaro, the only issue was the persistence of dark stains on the columns whose surfaces were not cleaned from hygroscopic salts (Fig. 7). Thermographic analysis confirmed that the stains were not caused by moisture. After an initial drying process by natural evaporation, the next step was the removal of hygroscopic salts using compresses using Japanese paper and sepiolite and subsequent washing

with deionized water. This method of salt removal was chosen for its effectiveness and minimal impact, reducing the risk of damage to historic surfaces while ensuring thorough cleaning that preserves the original structure. The compresses were left in place long enough to absorb and remove the salts. This experience provides a model for the management of moisture and salts in other historic buildings and demonstrates the effectiveness of combining natural drying techniques with salt removal. Moreover, the salt removal showed that the stain may be due to a reaction between previous paint and moisture/salts, resulting in discoloration and flaking. Further analysis is underway to determine the type of paint used.
