**Remarkable historic timber roofs. Knowledge and conservation practice.
PART 2 - Investigation, analysis, and interventions**

HISTORIC TIMBER ROOFS, A KNOWLEDGE-BASED APPROACH TO STRENGTHENING: THE CASE STUDY OF A RENAISSANCE PALACE IN FERRARA

Lia Ferrari

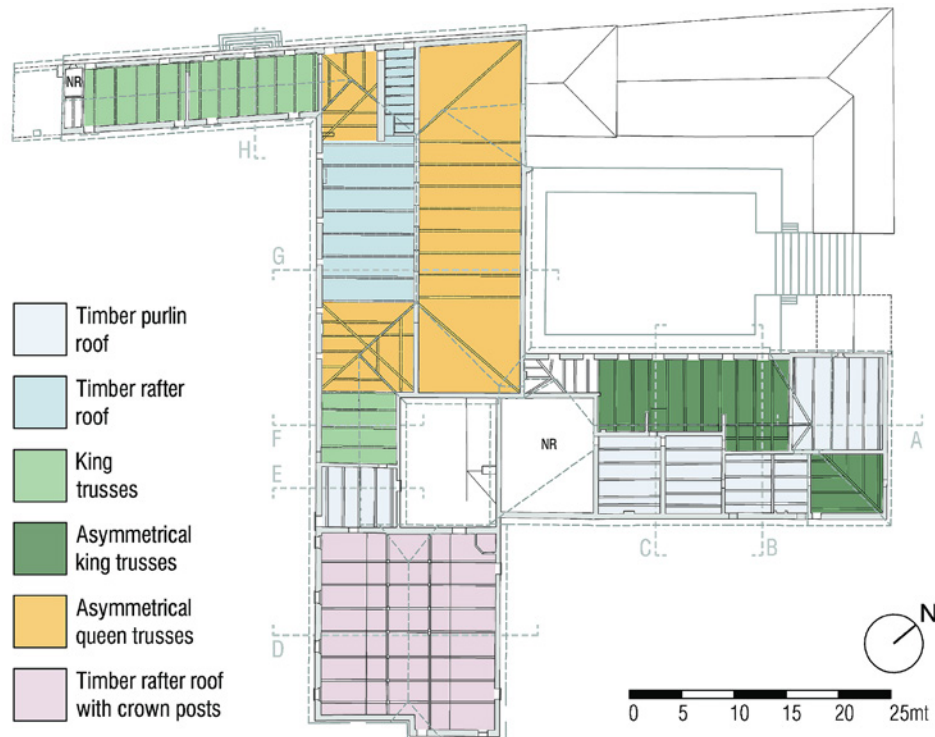
Among timber roof structures, areas with a common morphology (e.g., similar span and type of load-bearing structure) have been identified. In the following sections, a short description of each one is provided to highlight their main features (Fig. 3).

Fig. 3. Site diagram of the timber roof with different types of timber structures.
