AUTOMATIC RECOGNITION OF BIO-COLONIZATION PROCESSES ON HISTORIC FAÇADES: APPLICATION ON CASE STUDIES

Francesco Monni, Marco D'Orazio, Andrea Gianangeli, Enrico Quagliarini

DOI: 10.30682/tema100016

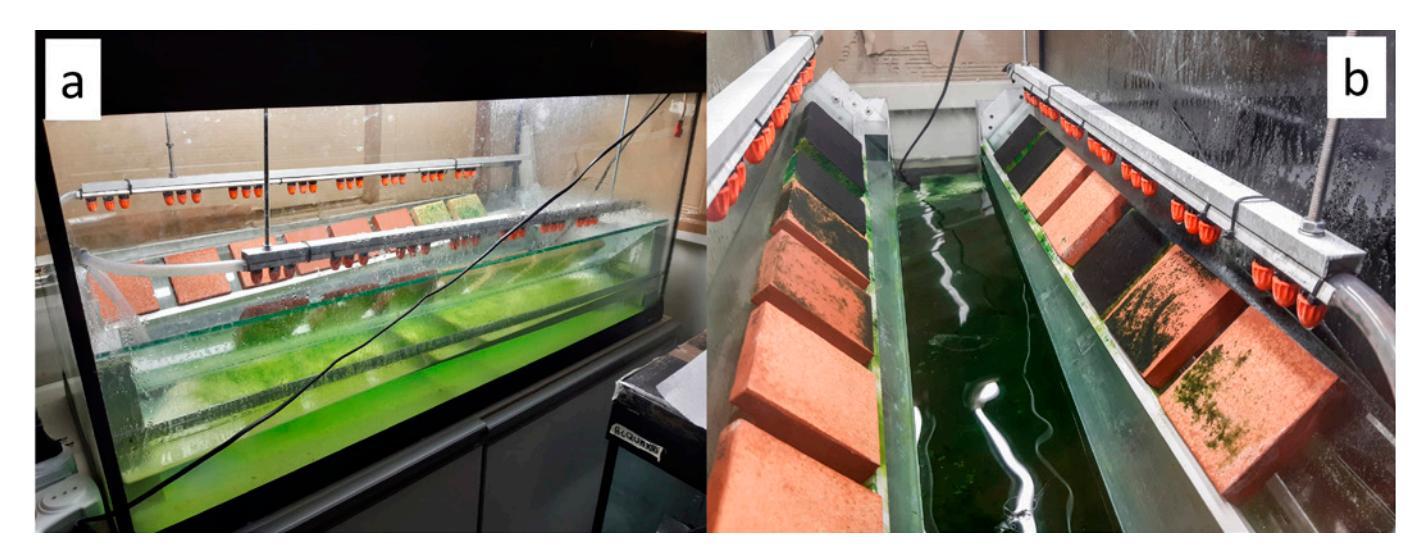
Fig. 1. The test setup used to evaluate the effects of relative humidity on microalgae growth development (a) and the one used to investigate the impact of temperature (b).

The digital images to be used to train the convolutional neural network were obtained from an experimental campaign in which five types of clay bricks (designated as AH, AL, B, CH, and CL) were selected and tested in five different environmental conditions, reproduced using climatic chambers to accelerate the growth process. Clay bricks differ by color, porosity, and roughness. Considering that bio-colonization causes a shift of the original color towards green-blue nuances, and the initial color spectrum is influenced due to the transition between wetted and unwetted conditions, were chosen three different brick colors: light-red (AH and AL types), dark-red (B type), yellow (CH and CL types). Because the "shape" of the bio-colonization (e.g., spots, lines, areas) is influenced by the surface features and the water retention characteristic of the clay bricks, different microstructures were considered. Different environmental conditions were considered and characterized by different temperatures, RH%, and wetting processes to include a wide range of expected environmental conditions. Surface properties like porosity (according to ASTM D4404-10 [17]) and roughness (according to UNI EN ISO 4287:2009 [18]) of the tested clay bricks were measured. A green alga (Chlorella mirabilis strain ALCP 221B) and a cyanobacterium (Chroococcidiopsis fissurarum strain IPPAS B445) were used to reproduce the bio-colonization process [7]. Microbial strains were cultivated in a Bold's Basal Medium (BBM), formulated following ASTM D5589-09 prescriptions [19]. To reduce testing times, the tests were conducted under accelerated conditions (a visible biological degradation mostly begins after at least one year of natural environmental exposure). Five distinct environmental conditions were chosen to take into account a wide variety of potential real exposures. To find out how changing relative humidity (RH) levels affected algae growth on clay brick surfaces, three distinct RH conditions were replicated in three different climatic chambers.

Saturated solutions were used to condition the indoor environment, as recommended by EN ISO 12571:2013 [20]. The first RH condition (RH1, around 75%) was obtained using a saturated solution of NaCl; the second RH condition (RH2, around 87%) was obtained using a saturated solution of Na₂CO₃; the third RH condition (RH3, about 98%) was obtained using only deionized water. Tests were conducted at constant temperature (27.5 \pm 2.5°C) in order to examine the impact of RH only. Each sample had nine distinct locations on its surface that were inoculated with 5µl of the mixed culture at the start of the test. After that, samples were placed, with an inclination of 45°, on aluminum-glass racks inside the climatic chambers, front-to-front along the chamber's long length. In order to protect the test equipment from outside influences such as light, temperature, and relative humidity, it was housed in a closed room. Two neon lights (Sylvania TopLife 39W) able to faithfully reproduce natural light conditions were installed in each growth chamber with the aim of recreating day/night cycles 14/10 h (Fig. 1a). The impact of temperature on algae growth was investigated in the wake of previous studies available in the literature [8, 9]. Until the stagnation phase was reached, accelerated tests were conducted using periodic water sprays on the material's surface (Fig. 1b). Growth chambers ($100 \times 40 \times 53$ cm³) containing 35 liters of BBM inoculated with the mixed cultures represent the test apparatus for this phase of the work. Algal suspension was applied (sprayed) to sample surfaces $(8 \times 8 \text{ cm}^2)$ situated on two 45°-inclined racks made of aluminum and glass. Run/off cycles were programmed to occur every 15 minutes for a total of 6 hours a day (3 hours of run time and 3 hours of rest time). Two 39W neon lights (Sylvania TopLife) have been used to reproduce a day/night lighting cycle of 14/10 hours. Following existing literature [21, 22], two distinct temperatures were chosen for the accelerated tests: 27.5 ± 2.5 °C, which falls within the range of ideal growth values (which span from 20°C to 30°C), and a lower value of 10 ± 2.5 °C, which falls within the range of suitable growth. A properly modi-

fied refrigerator (Electrolux RC 5200 AOW2) was utilized to set the lower test temperature. The presence of the wetting cycles makes it reasonable to assume that the relative humidity was always 100%. Temperature and relative humidity sensors (Sensirion SHT31-D) were used to monitor all test settings, with data taken every 10 minutes. During each accelerated growth test, specific analyses were performed to evaluate the algal extent and the biofouling process on the samples' surface [8]. First, colorimetric analysis was done to check how the color changed over time. A spectrophotometer (Konika Minolta CM-2600dD) was used to quantify the chromatic variation (ΔE^*) [17]. According to UNI EN 15886:2010 [23] and UNI 11721:2018 [24], the CIELAB color space was used to represent the results. Equation (1) was used to determine color variation in terms of total color difference (ΔE^*)

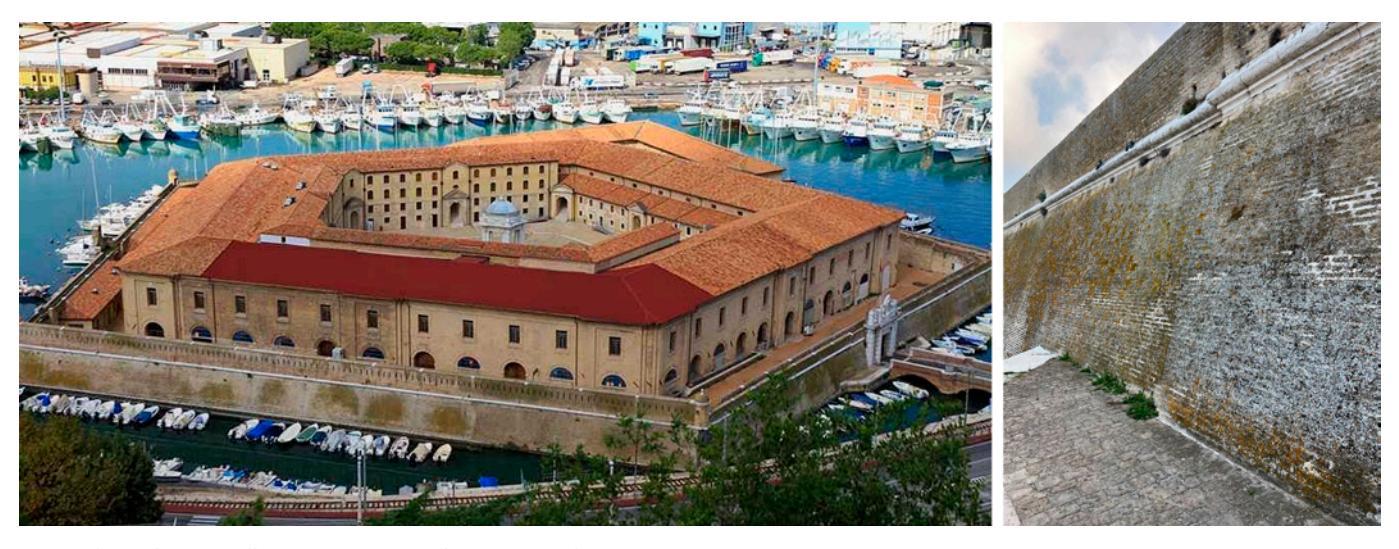
Fig. 2. The Mole Vanvitelliana, Ancona, Marche Region, Italy.

The Mole Vanvitelliana (Fig. 2) is a large, pentagonal architectural complex from the 18th century, located by the sea in the port area of Ancona (Marche region, Italy). This structure, also known as the Lazzaretto, originally served as a quarantine station for those arriving by sea in Ancona (a precautionary measure to monitor and control the spread of contagious diseases). Over the years, the building has been repurposed for various uses, including military and commercial functions, and today, it operates as a multifunctional cultural center. Designed in the 18th century by the architect Luigi Vanvitelli, the Mole Vanvitelliana is a unique example of architecture and a notable symbol of the city of Ancona. The main building of the complex is enclosed within a perimeter wall. Both the primary structure and the surrounding wall are constructed with brick-facing masonry. Notably, the sloped, rain-exposed perimeter walls show significant signs of bio-colonization, whereas the vertical walls of the main building, which are sheltered from the rain, do not exhibit such issues.

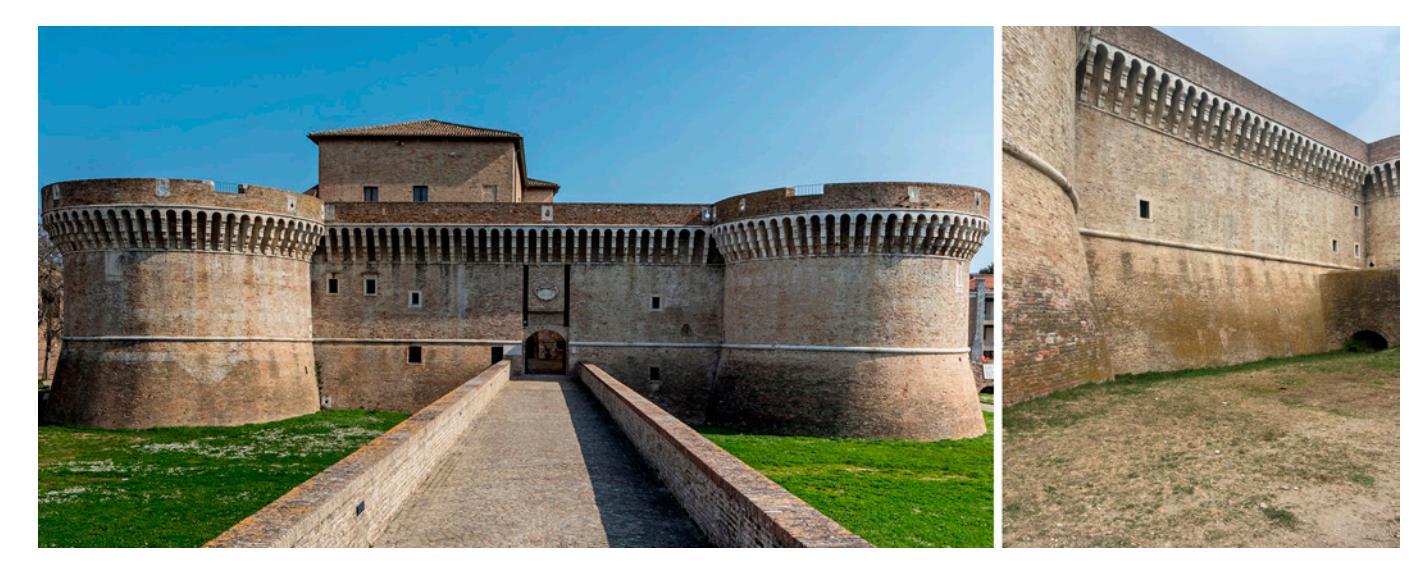
Fig. 3. The Rocca Roveresca, Senigallia, Marche Region, Italy.

The Rocca di Senigallia, also known as Rocca Roveresca after the Della Rovere family who commissioned its construction (Fig. 3), is located in Senigallia (Marche region, Italy), and it stands as one of the most significant

monuments of both the city and the region. As it appears today, the fortress is the result of centuries of transformation. Originally built during the Roman era as a defensive tower, it evolved into a medieval fortress in the 14th century and eventually took its current form as a typical Renaissance fortified residence in the 15th century. The monument consists of two interconnected structures: the central body, intended as a noble residence, is surrounded by a military defensive structure. The noble residence is encircled by a highly regular structure: a quadrilateral enclosure with four low circular towers at the corners, all connected to each other and the central building by an integrated system of vertical and horizontal communication routes. As in the previous case, the perimeter walls are made of brick-facing masonry. As shown in the figure, some portions of the structure, particularly those with a sloped configuration that makes them more exposed to weather conditions, exhibit signs of bio-colonization (specifically, the lower parts of the perimeter walls). In contrast, other areas are more protected and do not suffer from this issue.

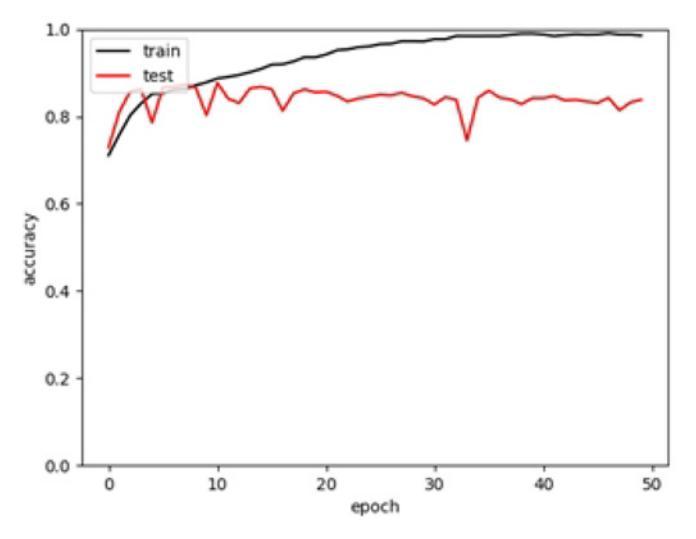
Fig. 4. Plot of the "training and test" history process. The black line represents the accuracy obtained at the end of each epoch during the training process. The red line represents the accuracy obtained at the end of each epoch during the test process.

A trained, tested, and validated convolutional neural network has been used to determine the beginnings of the microalgae development process. The plot of the historical training and test procedure is displayed in Figure 4. The accuracy using the "training" and "test" datasets has

been displayed after each epoch (iteration on the whole dataset). When the final accuracy or the ratio of accurate predictions to all predictions produced by the model is 0.83, meaning that 83% of the photos, whether they included microalgae or not, were identified correctly.

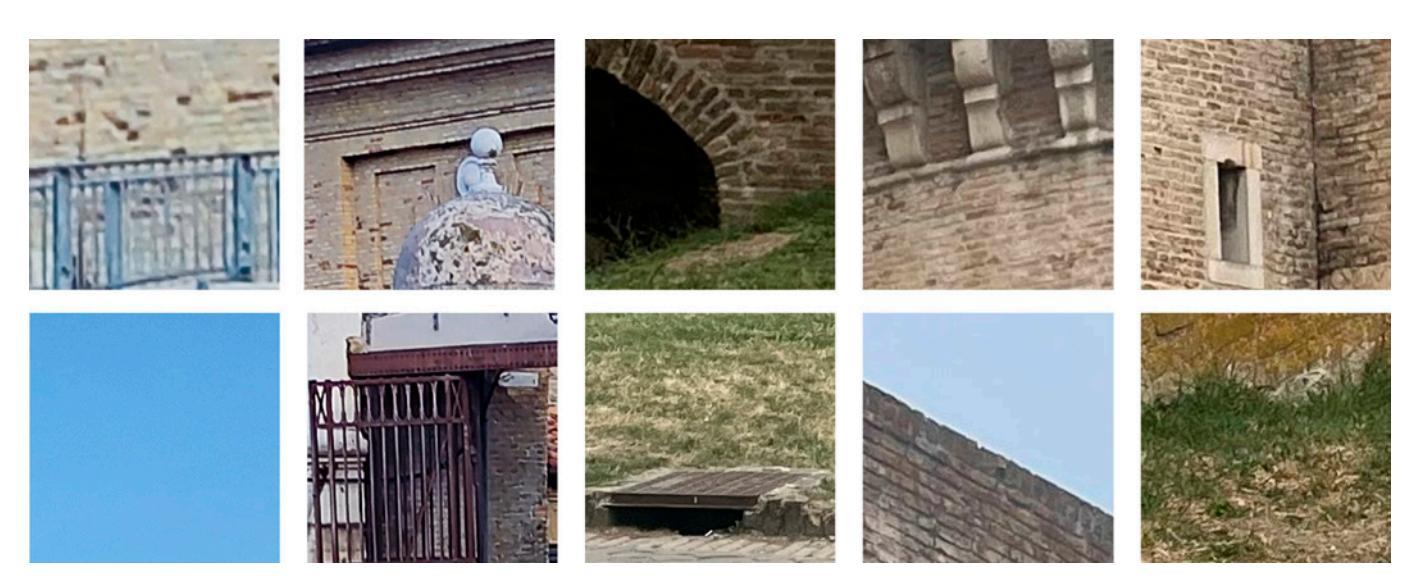
Fig. 5. Some examples of images extracted from HD security cameras installed at the Mole Vanvitelliana and the Rocca Roveresca.

The trained model was applied iteratively to verify its recognition ability in real cases. The trained network was first used to detect bio-colonization presence in images collected by security HD cameras. The application of the method to this group of images highlighted that the ability to recognize bio-colonization on the brick-facing masonry façades is affected by several factors. Dividing images from surveillance cameras results in low-resolution sub-images, reducing recognition effectiveness. Moreover, images acquired from security cameras include other elements (ground, grass, roads, roofs, stone, metallic elements, etc.) that were not included in the original dataset. If the cropped image contains objects different from the bricks, convolutional neural networks frequently fail, reducing total accuracy to unacceptable values. This clearly highlights two things. First, there is a need for higher resolution images, and second, there is a necessity to expand the dataset used to train the convolutional neural networks by including images of the brick

surface and images featuring all elements present on and around building façades (Fig. 5).

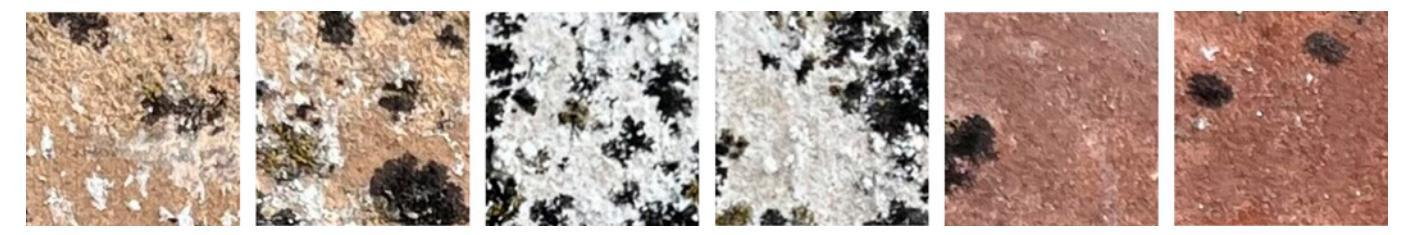
Fig. 6. Some examples of images collected with HQ resolution cameras at the Mole Vanvitelliana and the Rocca Roveresca.

Then, the trained network was used to detect bio-colonization presence in the second group of images, those directly collected near the building façades, which include only bricks with and without bio-colonization (Fig. 6). In this scenario, accuracy improves to 0.68 but remains below the one achieved after the training and testing phases (0.83). Thus, enhancing resolution and excluding nonbrick elements improved the recognition performance of the trained convolutional neural networks.
